Operational Inspection

Nashmills Parish Council

Bunkers Lane Play Area

Bunkers Lane, Hemel Hempstead, Hertfordshire, HP3

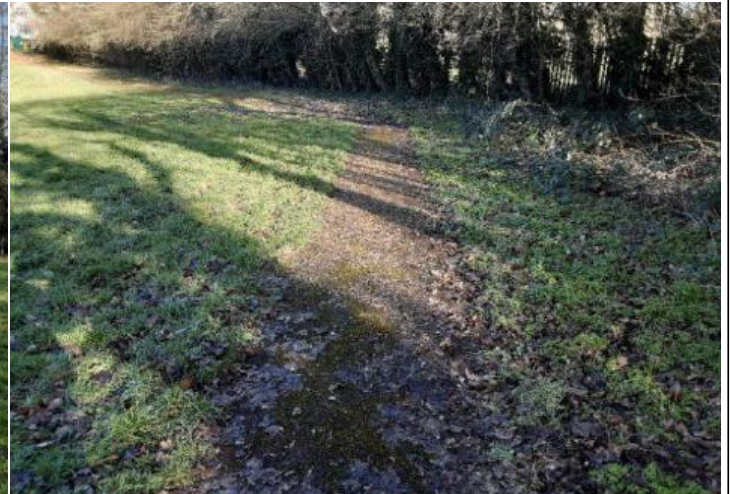
Item: Ancillary Items - Site General
Manufacturer: Owner/Operator

Finding: There is algae, silt or moss growth on the pathway surface resulting in slippery conditions

Action: Clean and treat appropriately

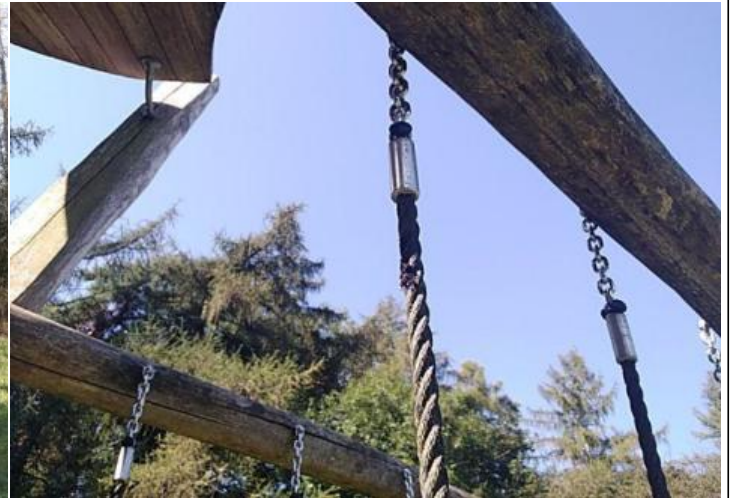
Item: Activity Equipment - Climbing Frame
Manufacturer: Kompan Ltd

Finding: The ropes/nets are worn/damaged in places

Action: Monitor for any further deterioration and repair or replace as required

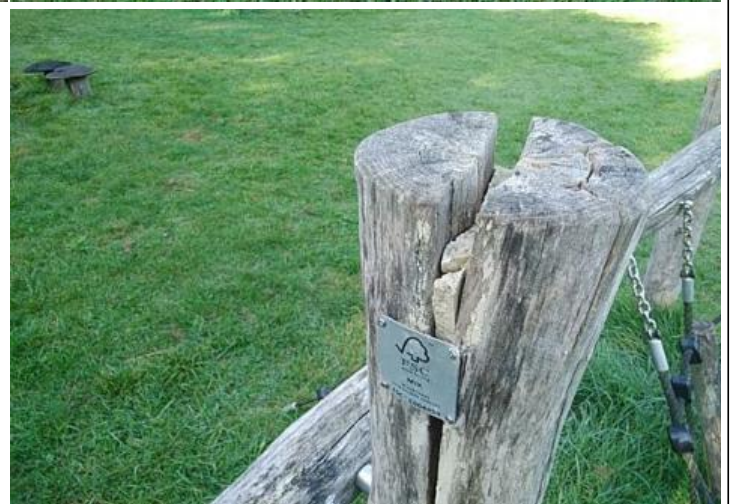
Item: Activity Equipment - A Frame Climber
Manufacturer: Kompan Ltd

Finding: The timber has a number of splits/shakes or air cracks and this may affect the stability or allow water ingress which will accelerate the rotting process

Action: Monitor to ensure the splits do not cross through fixing points of the structure and/or cause any instability

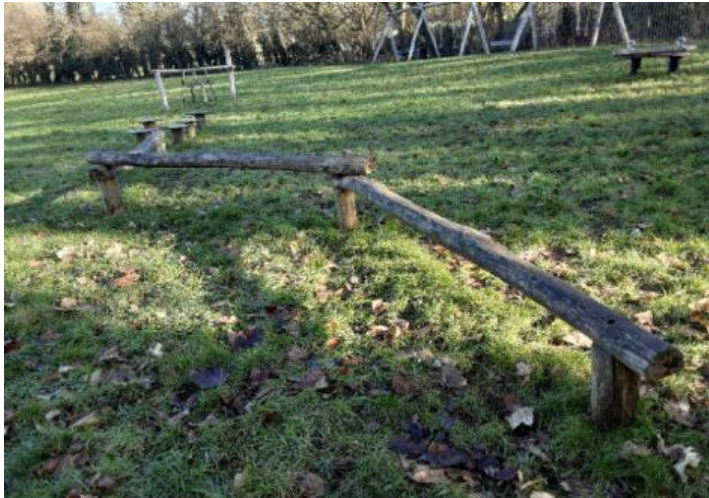
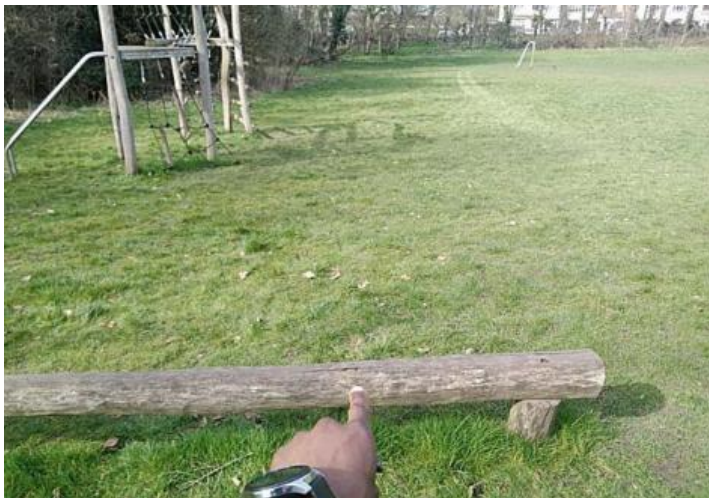
Item: Activity Equipment - Balance Beam
Manufacturer: Kompan Ltd

Finding: There is some evidence of rot in the timber

Action: Monitor for any further deterioration and replace as required

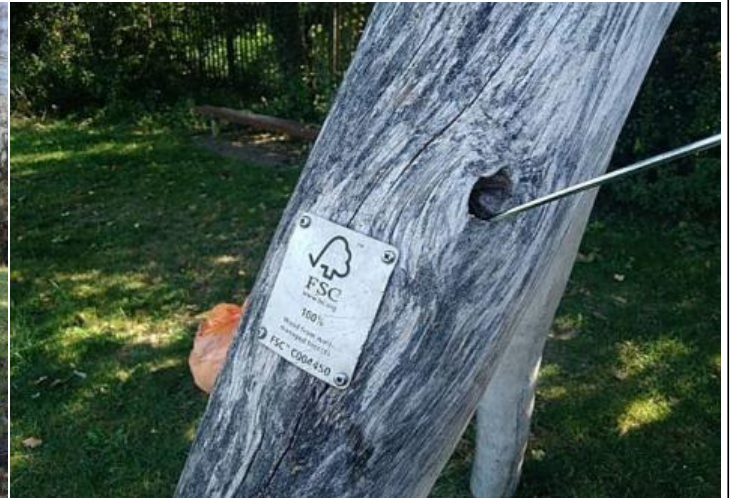
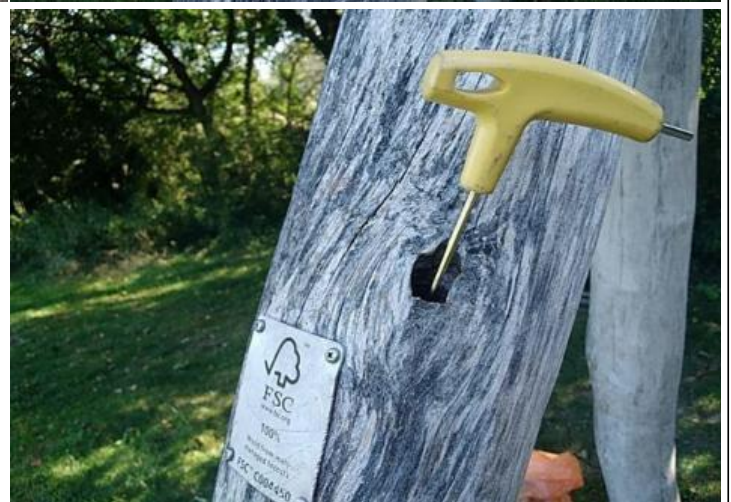
Item: Swings - 2 Bay 2 Flat 1 Basket Seat
Manufacturer: Kompan Ltd

Finding: There is a large cavity within the timber support and the inspector has some concerns about the internal condition of the timber and was unable to verify the structural integrity without further testing. We recommend a Resi-PD survey to establish the condition of the timber at it's core.

Action: Contact the Play Inspection Company office for further information

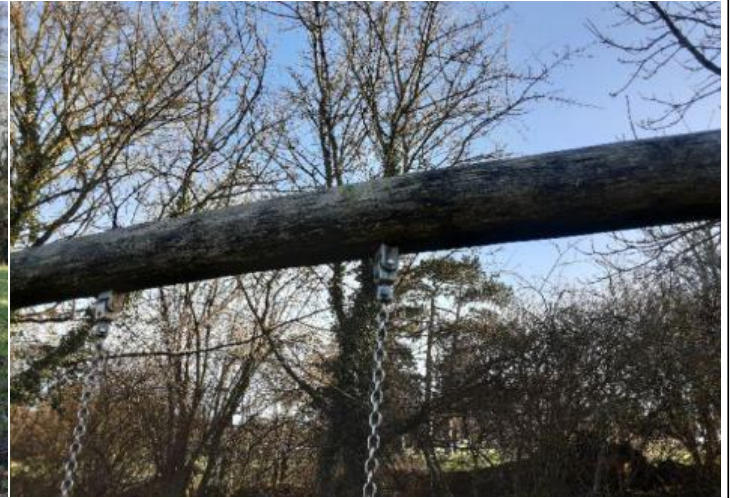
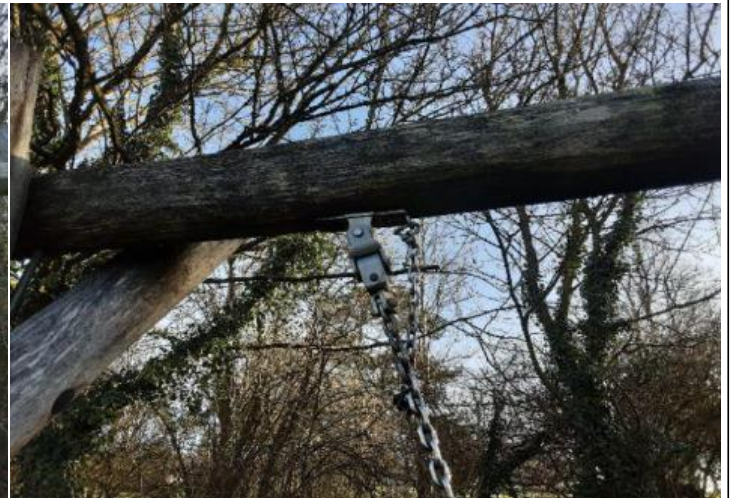
Item: Swings - 2 Bay 2 Flat 1 Basket Seat
Manufacturer: Kompan Ltd

Finding: A number of fixing(s) have worked loose on the suspension mounts

Action: Secure all loose fixings

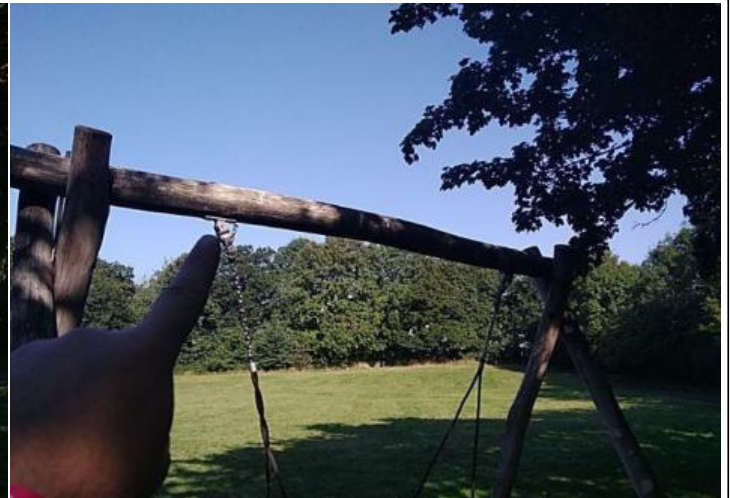
Item: Swings - 2 Bay 2 Flat 1 Basket Seat
Manufacturer: Kompan Ltd

Finding: A number of fixing(s) have worked loose on the secondary safety chain

Action: Secure all loose fixings

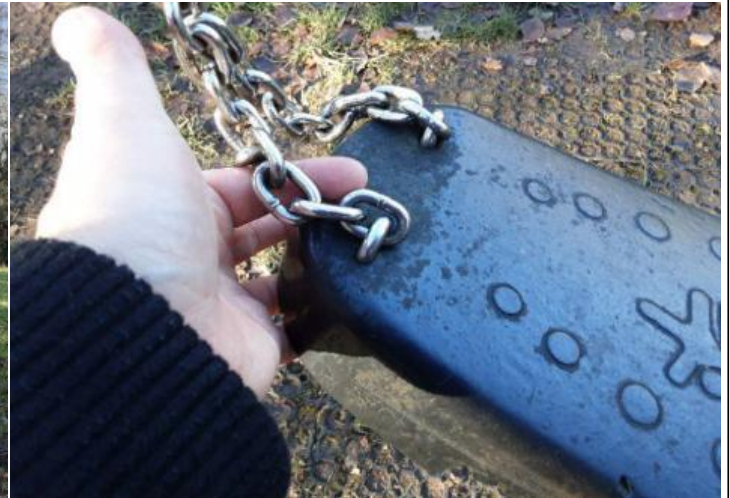
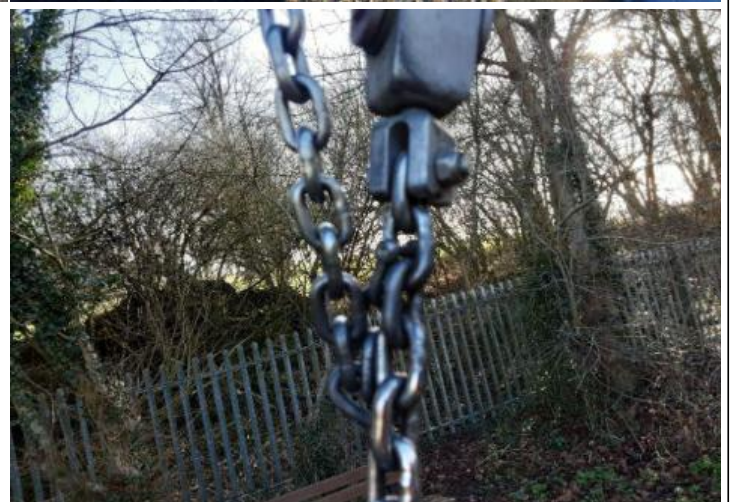
Finding: There is some notable evidence of chain wear

Action: Monitor for any further deterioration and replace when 40% worn

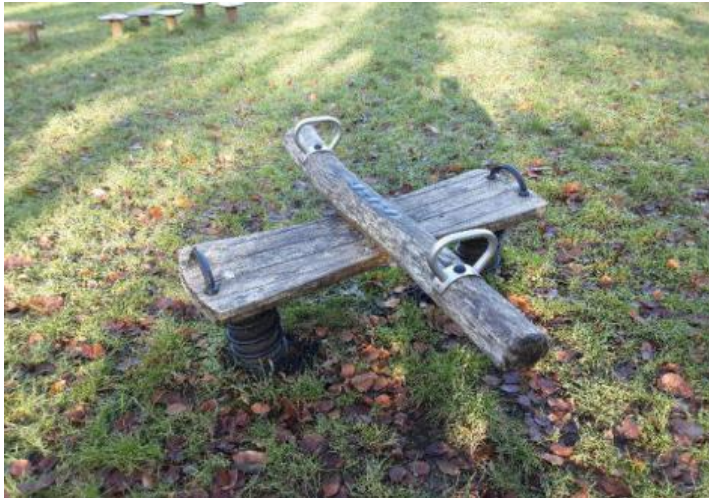
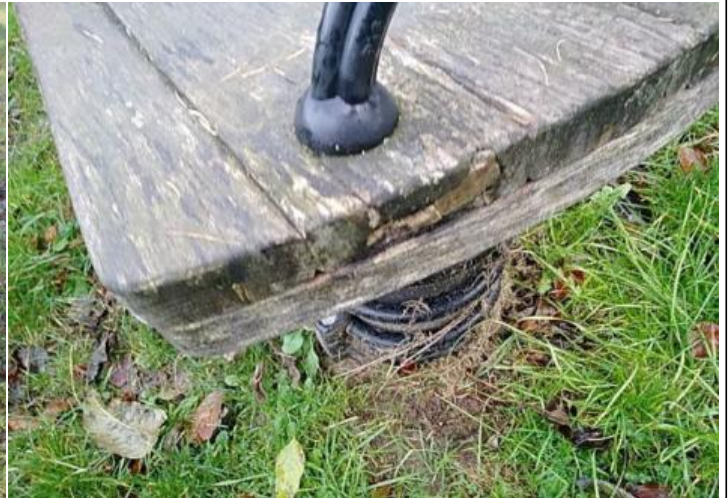
Finding: The use of synthetic fillers in timber is not recommended; timber being a natural material will expand and contract as the moisture content changes and the use of fillers can exacerbate the length and depth of these cracks or shakes in the timber. The only treatment that is normally required is the removal of any rough or sharp edges unless the structural integrity of the item is affected.

Action: Remove any rough or sharp edges and monitor timber for any further deterioration

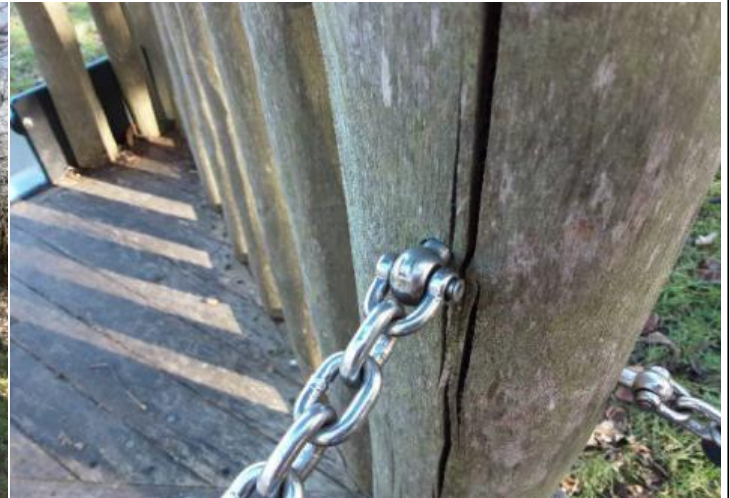
Finding: A number of fixing(s) have worked loose

Action: Secure all loose fixings

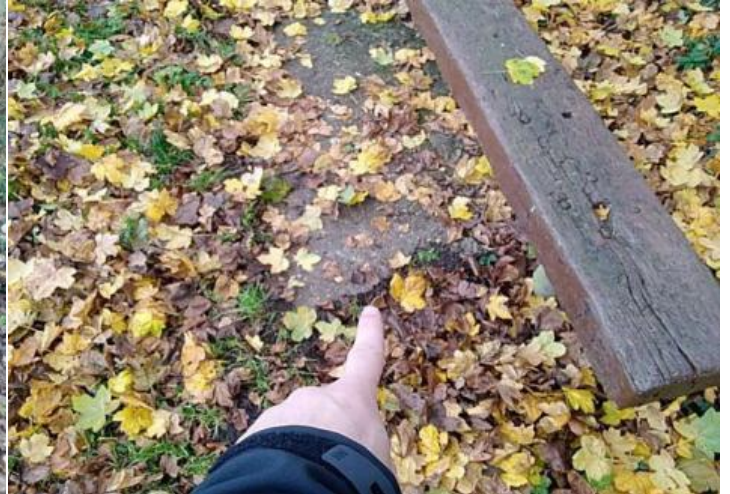
Finding: There are trip hazards at the edges of the surface

Action: Reinstate surrounding surface levels to remove the trip points

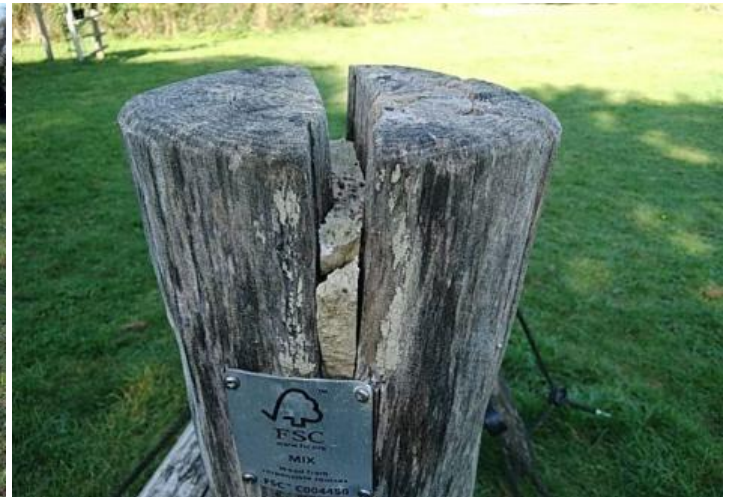
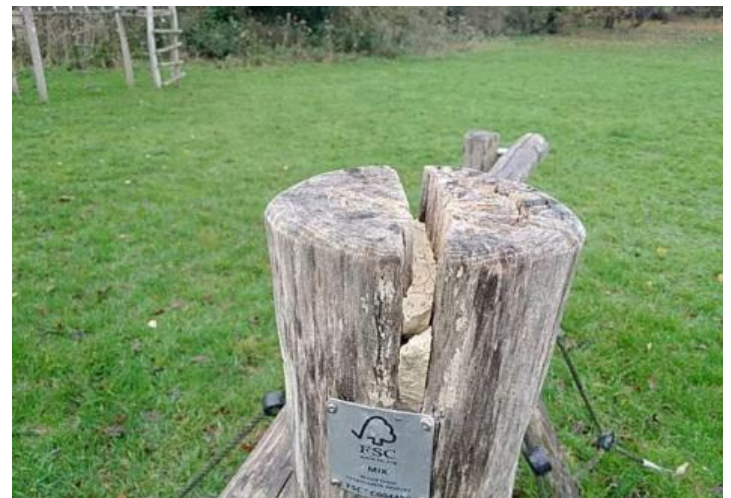
Finding: The use of synthetic fillers in timber is not recommended; timber being a natural material will expand and contract as the moisture content changes and the use of fillers can exacerbate the length and depth of these cracks or shakes in the timber. The only treatment that is normally required is the removal of any rough or sharp edges unless the structural integrity of the item is affected.

Action: Remove any rough or sharp edges and monitor timber for any further deterioration
