# NASH MILLS

## PARISH COUNCIL

### Clerk Report April 2023

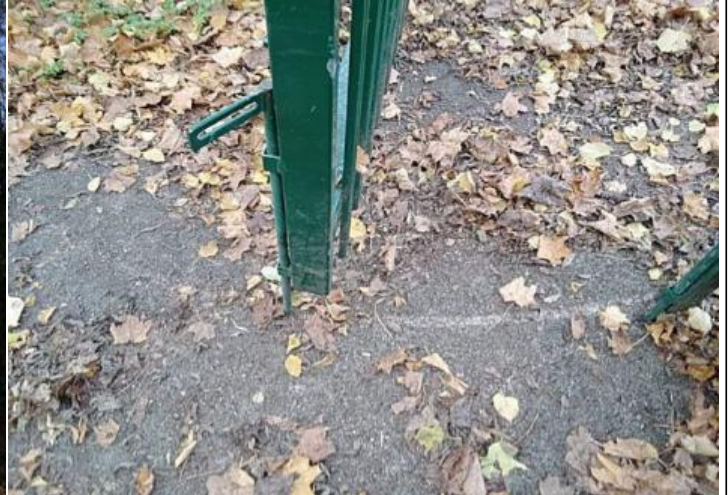
**Item:** Gates - Maintenance Gate  
**Manufacturer:** Not Identified

**Risk Level:** L - Low Risk  
**Surface:** Bitmac

**Finding:** The bitumen surface is worn or damaged

**Action:** Repair the bitumen to provide a uniform surface

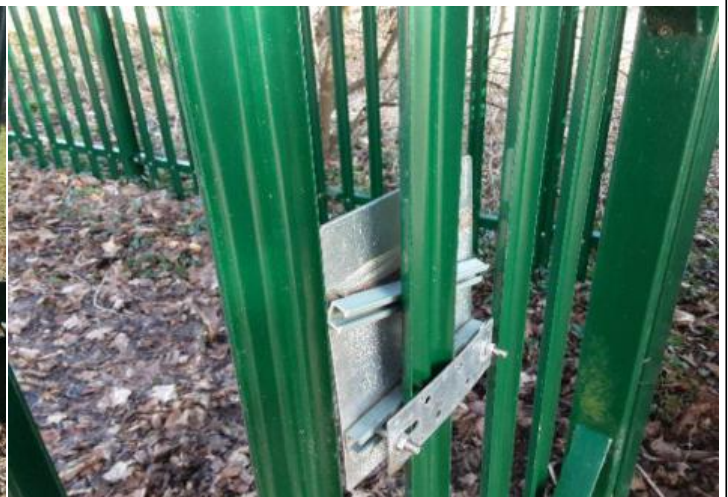
**Item:** Ancillary Items - Sign  
**Manufacturer:** Owner/Operator

**Risk Level:** L - Low Risk  
**Surface:** N/A

**Finding:** There is or are fixings missing on the item

**Action:** Replace all missing fixings

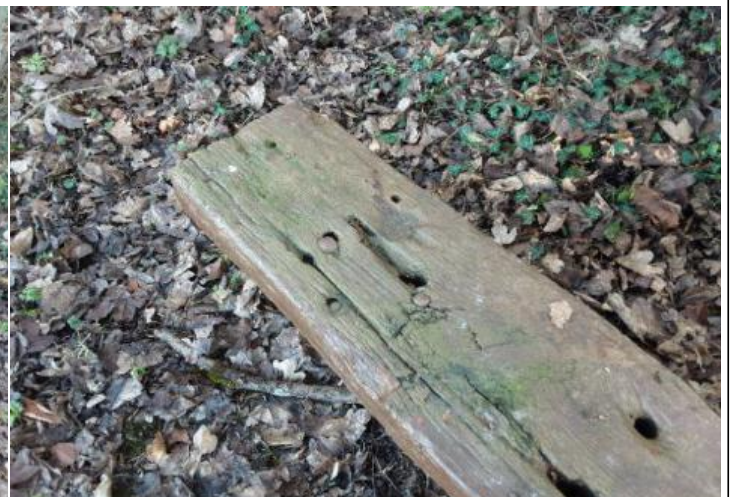
**Item:** Ancillary Items - Bench  
**Manufacturer:** Not Identified

**Risk Level:** L - Low Risk  
**Surface:** Concrete

**Finding:** There is some evidence of rot in the timber

**Action:** Monitor for any further deterioration and replace as required

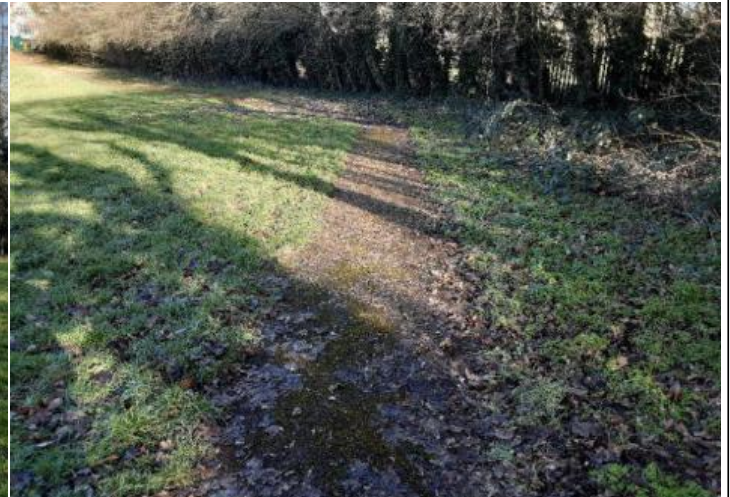
**Item:** Ancillary Items - Site General  
**Manufacturer:** Owner/Operator

**Risk Level:** L - Low Risk  
**Surface:** N/A

**Finding:** There is algae, silt or moss growth on the pathway surface resulting in slippery conditions

**Action:** Clean and treat appropriately

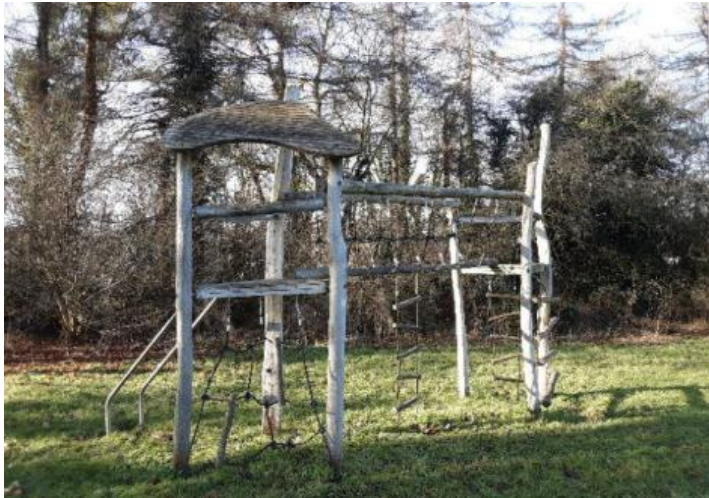
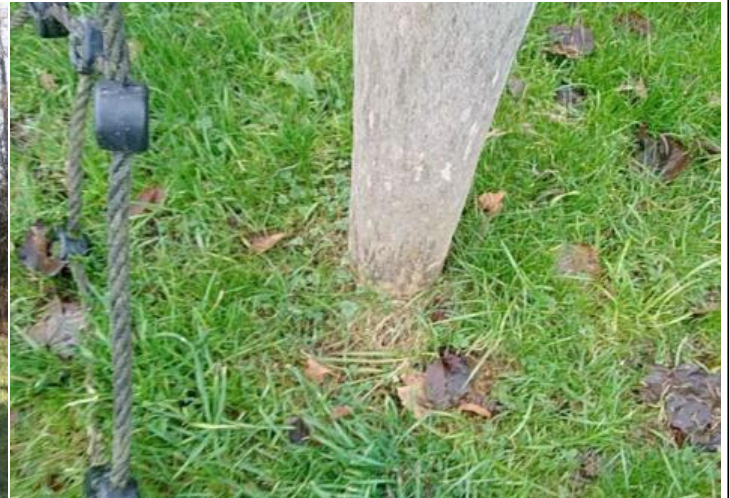
**Item:** Activity Equipment - Climbing Frame  
**Manufacturer:** Kompan Ltd

**Risk Level:** L - Low Risk  
**Surface:** Grass Matrix Tiles

**Finding:** There is some strimmer / machinery damage apparent on the posts, this can penetrate the preservative applied to the timber and accelerate the rotting process

**Action:** Monitor for any deterioration (rot) and replace as required

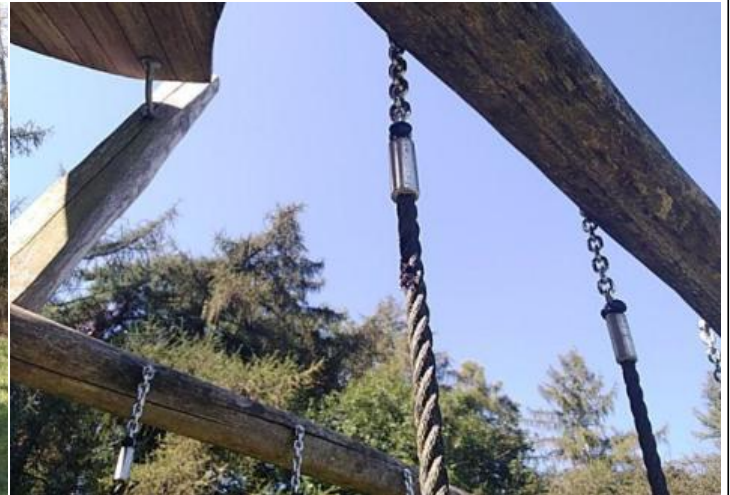
**Item:** Activity Equipment - Climbing Frame  
**Manufacturer:** Kompan Ltd

**Risk Level:** L - Low Risk  
**Surface:** Grass Matrix Tiles

**Finding:** The ropes/nets are worn/damaged in places

**Action:** Monitor for any further deterioration and repair or replace as required

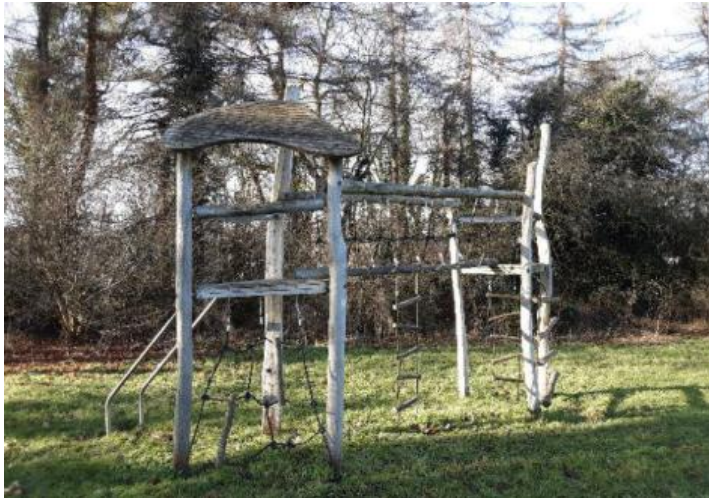
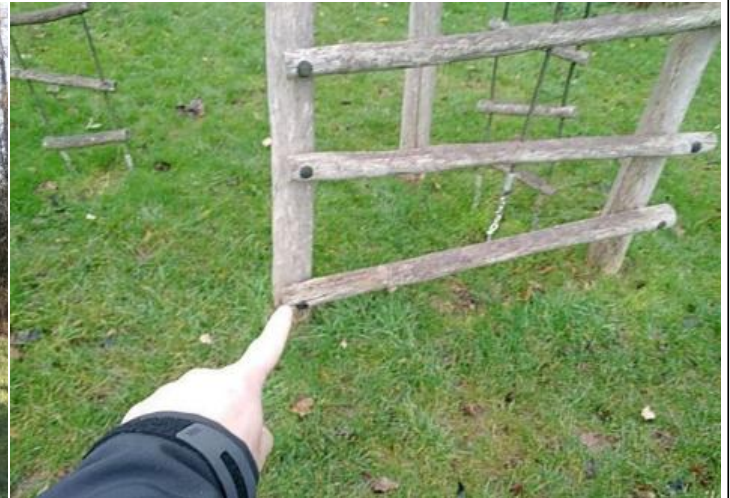
**Item:** Activity Equipment - Climbing Frame  
**Manufacturer:** Kompan Ltd

**Risk Level:** L - Low Risk  
**Surface:** Grass Matrix Tiles

**Finding:** A number of fixing(s) have worked loose

**Action:** Secure all loose fixings

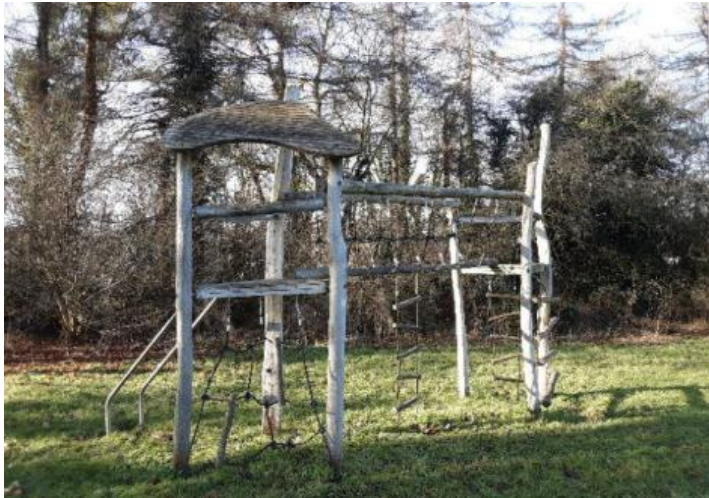
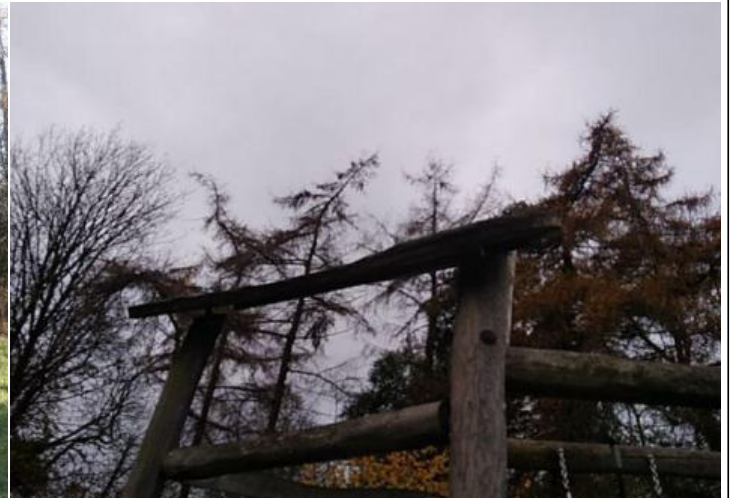
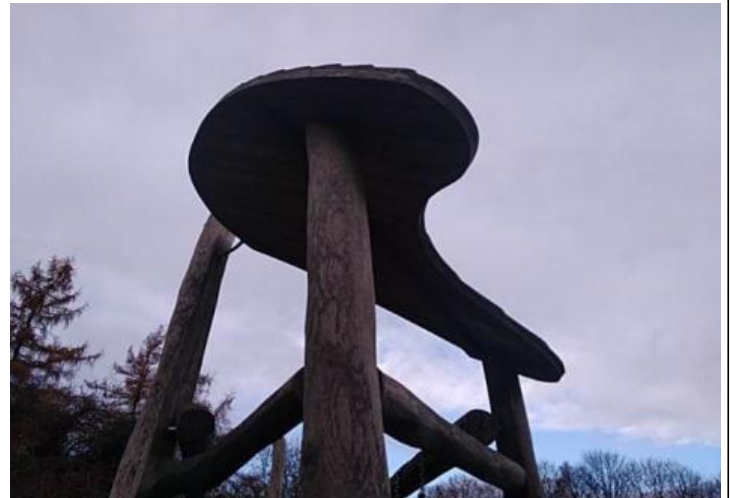
**Item:** Activity Equipment - Climbing Frame  
**Manufacturer:** Kompan Ltd

**Risk Level:** L - Low Risk  
**Surface:** Grass Matrix Tiles

**Finding:** The roof slats are lifting

**Action:** Monitor for any further deterioration and repair as required

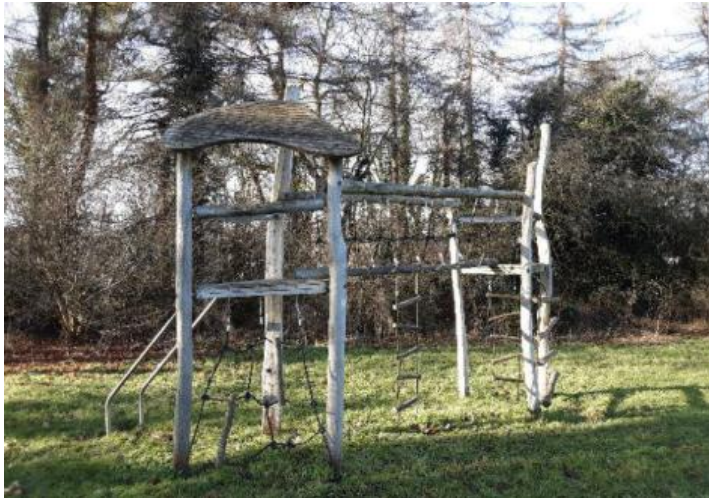
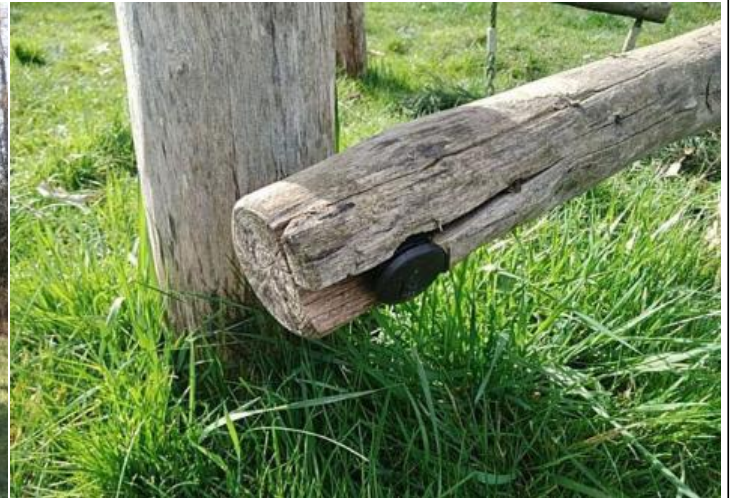
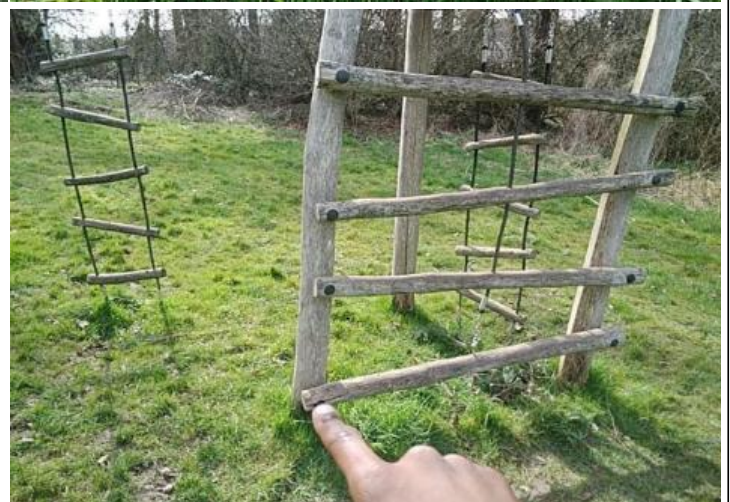
**Item:** Activity Equipment - Climbing Frame  
**Manufacturer:** Kompan Ltd

**Risk Level:** L - Low Risk  
**Surface:** Grass Matrix Tiles

**Finding:** There is some damage apparent on the posts, this can penetrate the preservative applied to the timber and accelerate the rotting process

**Action:** Monitor for any deterioration (rot) and replace as required

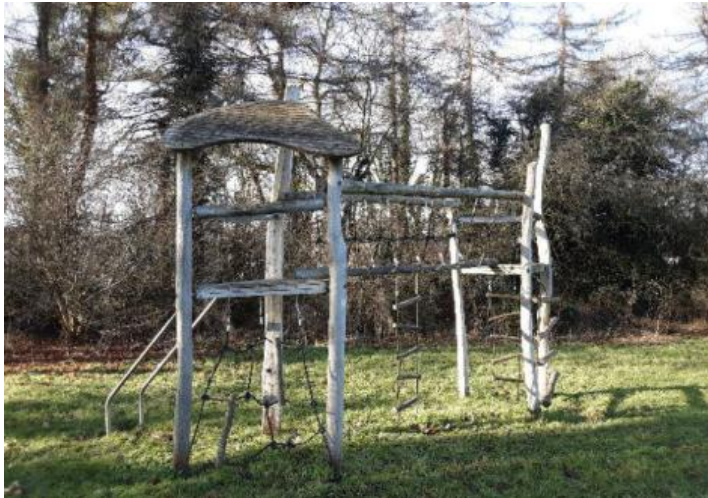
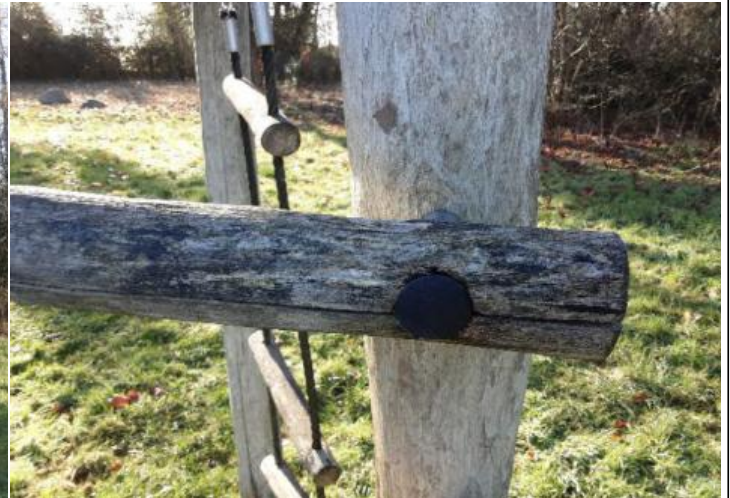
**Item:** Activity Equipment - Climbing Frame  
**Manufacturer:** Kompan Ltd

**Risk Level:** L - Low Risk  
**Surface:** Grass Matrix Tiles

**Finding:** There is some evidence of rot in the timber

**Action:** Monitor for any further deterioration and replace as required

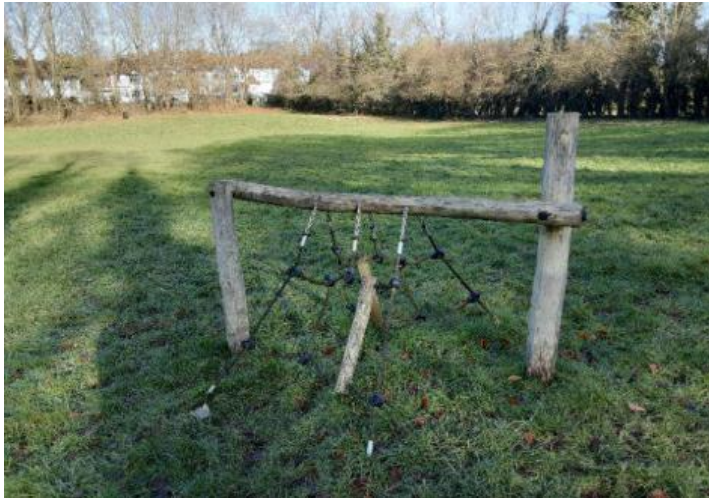
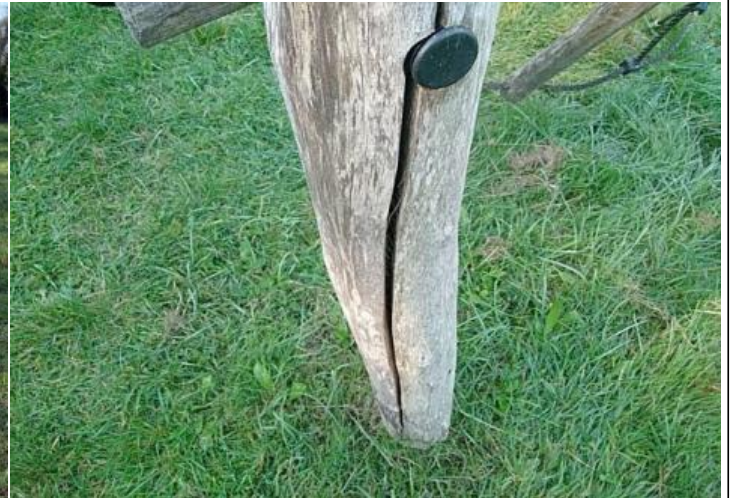
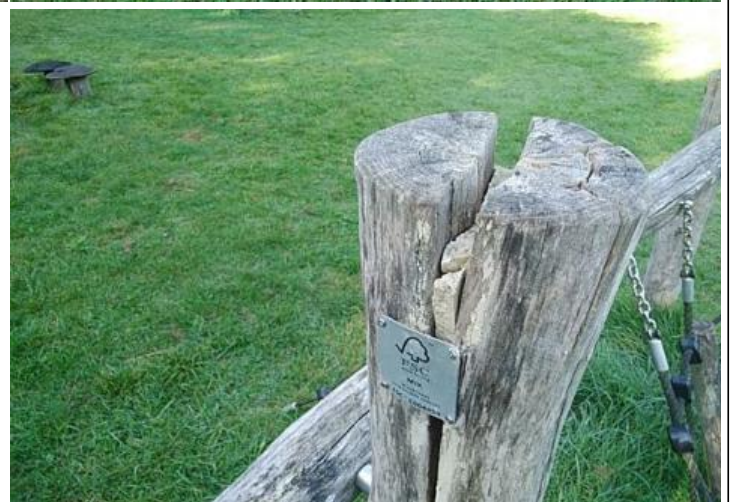
**Item:** Activity Equipment - A Frame Climber  
**Manufacturer:** Kompan Ltd

**Risk Level:** L - Low Risk  
**Surface:** Mixed Surface

**Finding:** The timber has a number of splits/shakes or air cracks and this may affect the stability or allow water ingress which will accelerate the rotting process

**Action:** Monitor to ensure the splits do not cross through fixing points of the structure and/or cause any instability

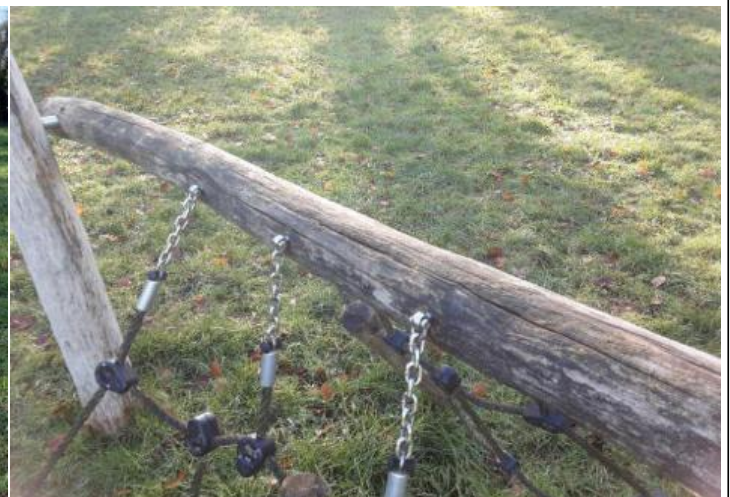
**Item:** Activity Equipment - A Frame Climber  
**Manufacturer:** Kompan Ltd

**Risk Level:** L - Low Risk  
**Surface:** Mixed Surface

**Finding:** There is some evidence of rot in the timber

**Action:** Monitor for any further deterioration and replace as required

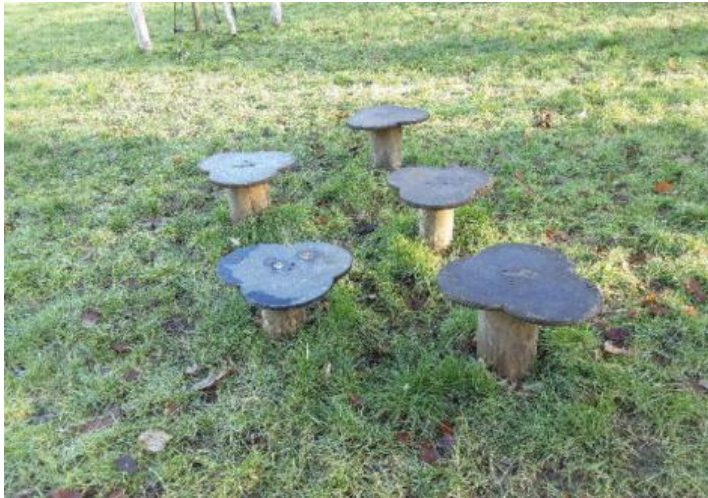
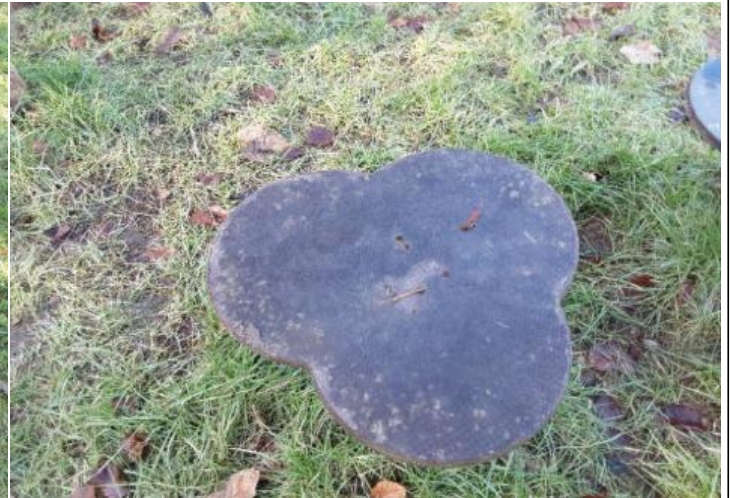
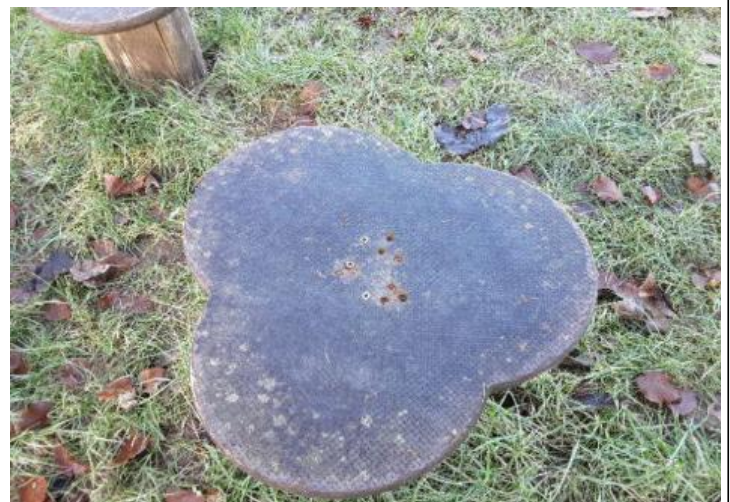
**Item:** Activity Equipment - Log Walk  
**Manufacturer:** Kompan Ltd

**Risk Level:** L - Low Risk  
**Surface:** Grass

**Finding:** The platforms are rotting and the fixings are pulling through  
**Action:** Replace all affected timber

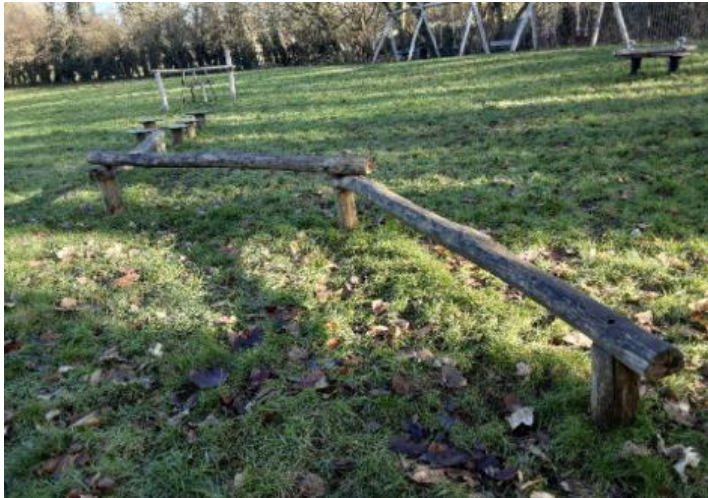
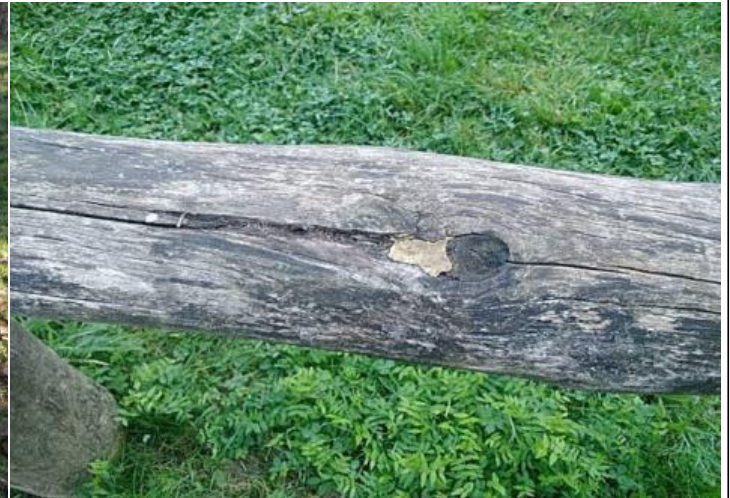
**Item:** Activity Equipment - Balance Beam  
**Manufacturer:** Kompan Ltd

**Risk Level:** L - Low Risk  
**Surface:** Grass

**Finding:** The use of synthetic fillers in timber is not recommended; timber being a natural material will expand and contract as the moisture content changes and the use of fillers can exacerbate the length and depth of these cracks or shakes in the timber. The only treatment that is normally required is the removal of any rough or sharp edges unless the structural integrity of the item is affected.

**Action:** Remove any rough or sharp edges and monitor timber for any further deterioration

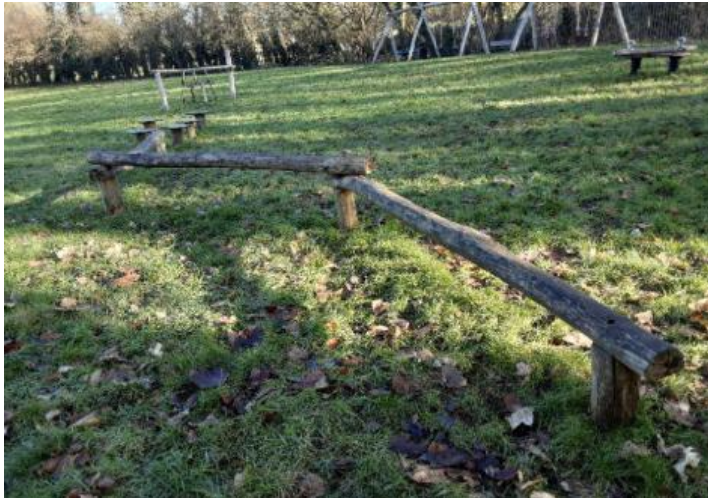
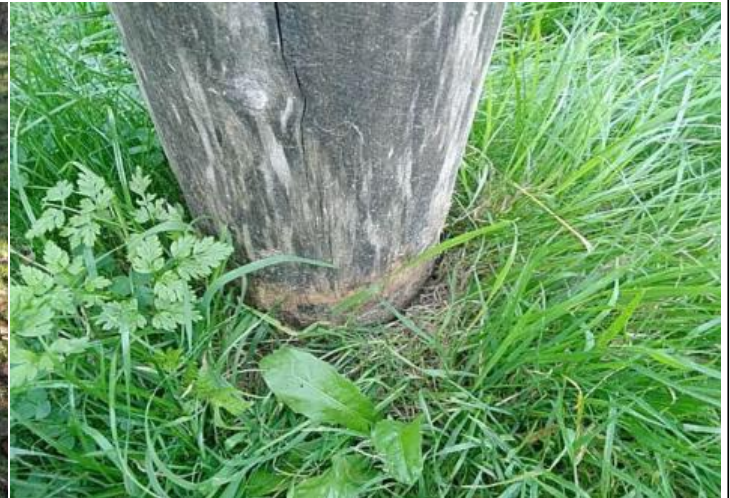
**Risk Level:** L - Low Risk  
**Surface:** Grass

**Finding:** There is some strimmer / machinery damage apparent on the posts, this can penetrate the preservative applied to the timber and accelerate the rotting process

**Action:** Monitor for any deterioration (rot) and replace as required

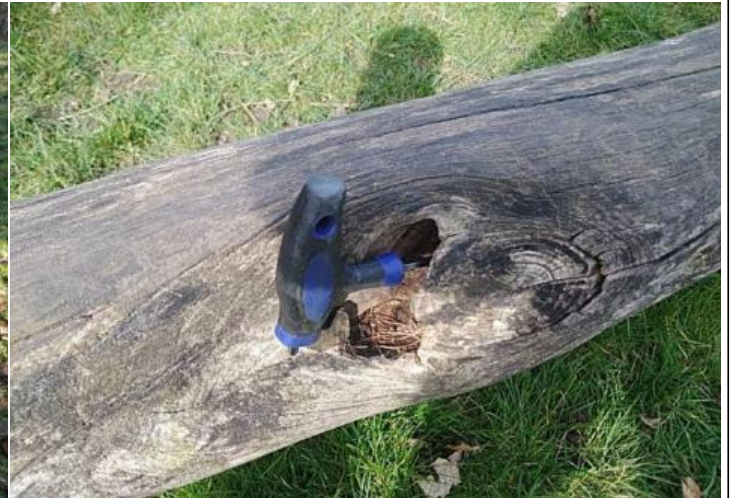
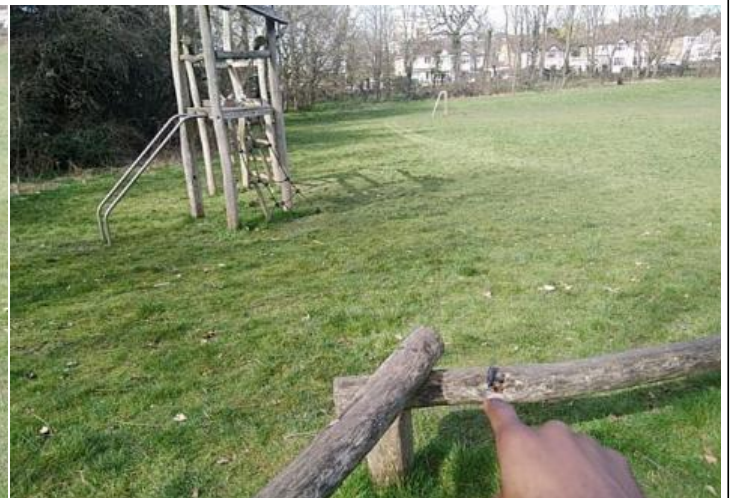
**Risk Level:** L - Low Risk  
**Surface:** Grass

**Finding:** There is some evidence of rot in the timber

**Action:** Monitor for any further deterioration and replace as required

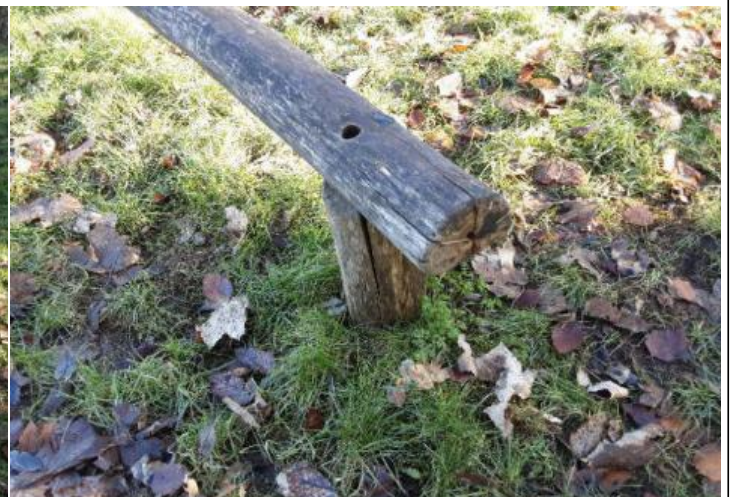
**Risk Level:** L - Low Risk  
**Surface:** Grass

**Finding:** The timber has a number of splits/shakes or air cracks and this may affect the stability or allow water ingress which will accelerate the rotting process

**Action:** Monitor to ensure the splits do not cross through fixing points of the structure and/or cause any instability

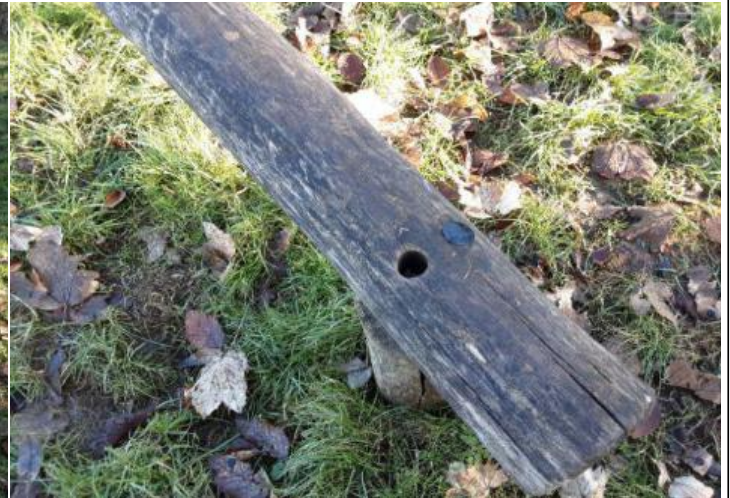
**Risk Level:** V - Very Low Risk  
**Surface:** Grass

**Finding:** There is/are bolt cap covers missing or damaged on the item

**Action:** Replace missing or damaged bolt cap covers

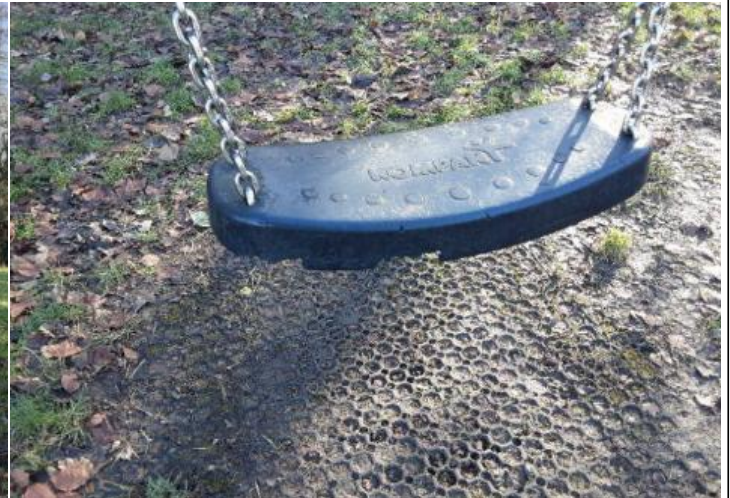
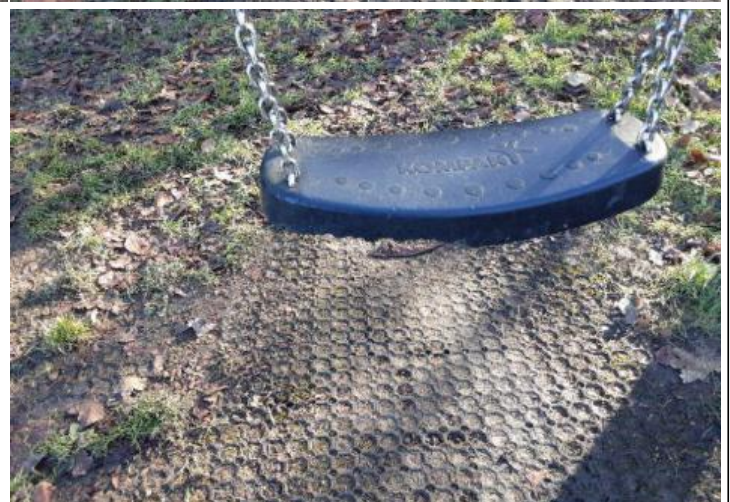
**Risk Level:** L - Low Risk  
**Surface:** Grass Matrix Tiles

**Finding:** The seat has minor damage or wear

**Action:** Monitor for any further deterioration and replace as required

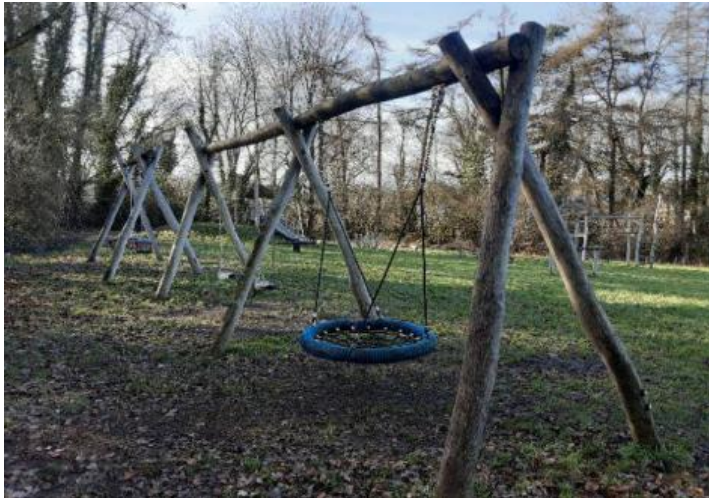
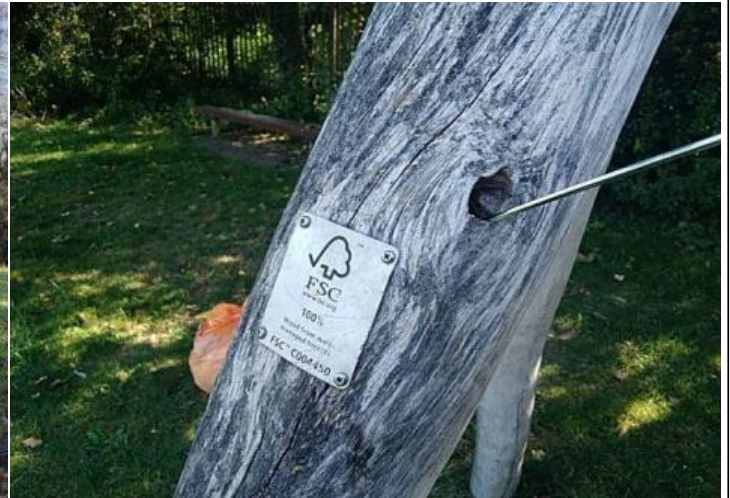
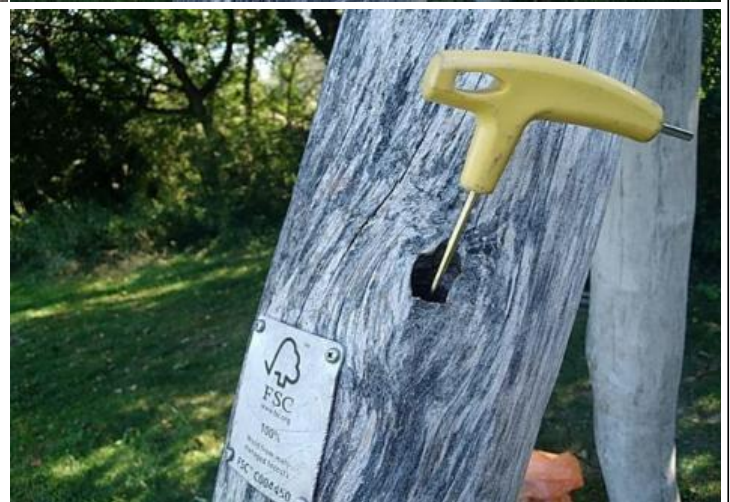
**Risk Level:** L - Low Risk  
**Surface:** Grass Matrix Tiles

**Finding:** There is a large cavity within the timber support and the inspector has some concerns about the internal condition of the timber and was unable to verify the structural integrity without further testing. We recommend a Resi-PD survey to establish the condition of the timber at it's core.

**Action:** Contact the Play Inspection Company office for further information

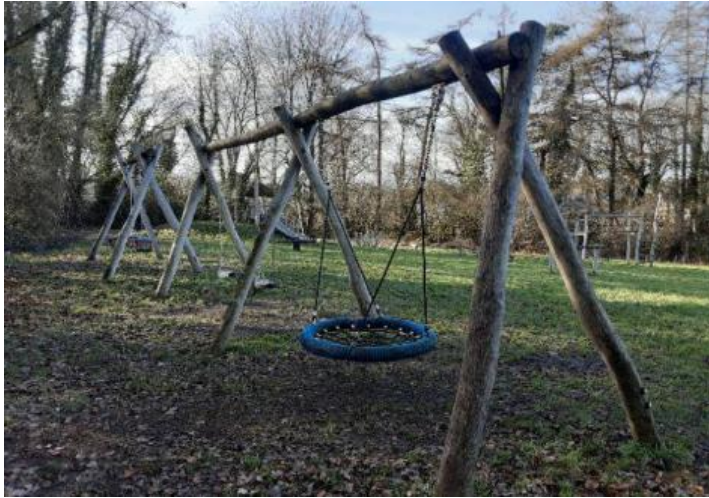
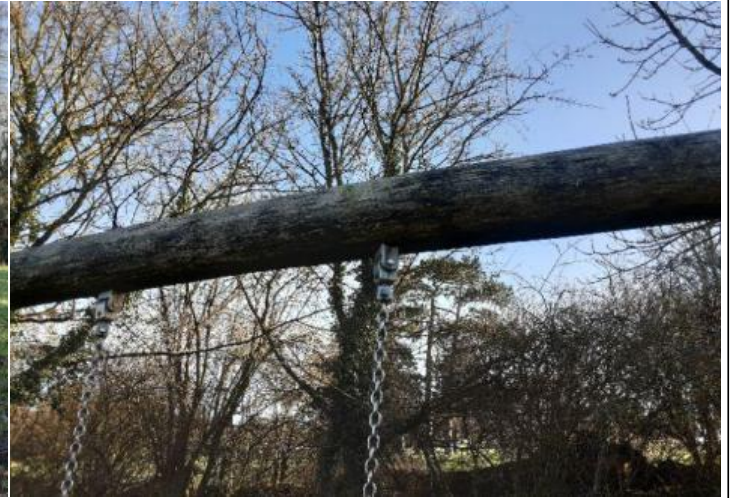
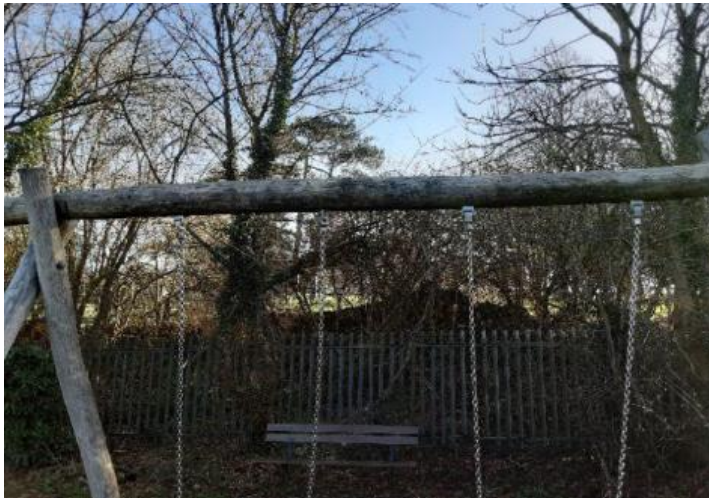
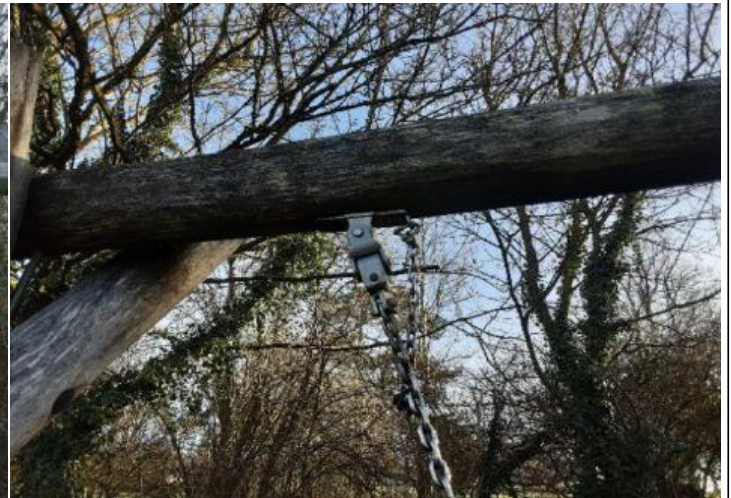
**Risk Level:** M - Moderate Risk  
**Surface:** Grass Matrix Tiles

**Finding:** A number of fixing(s) have worked loose on the suspension mounts

**Action:** Secure all loose fixings

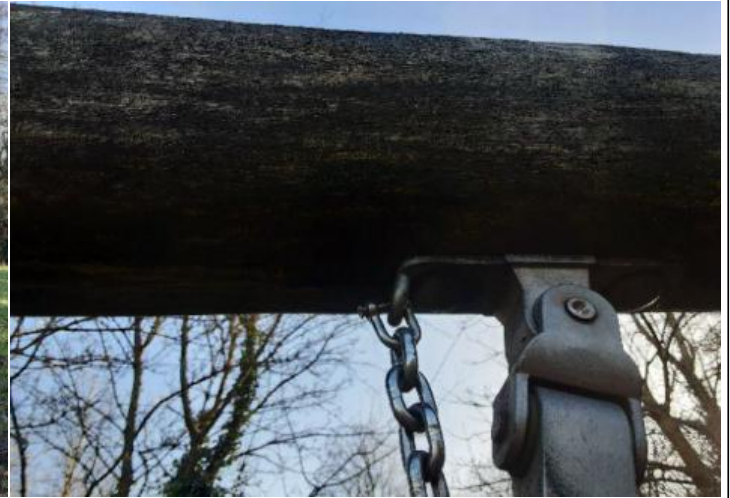
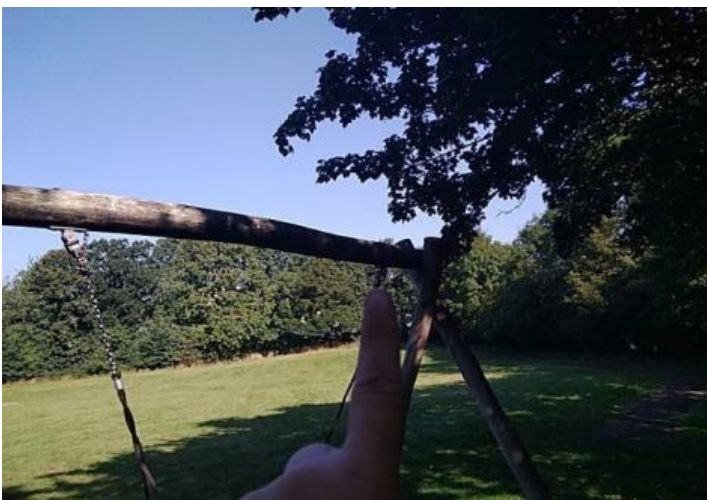
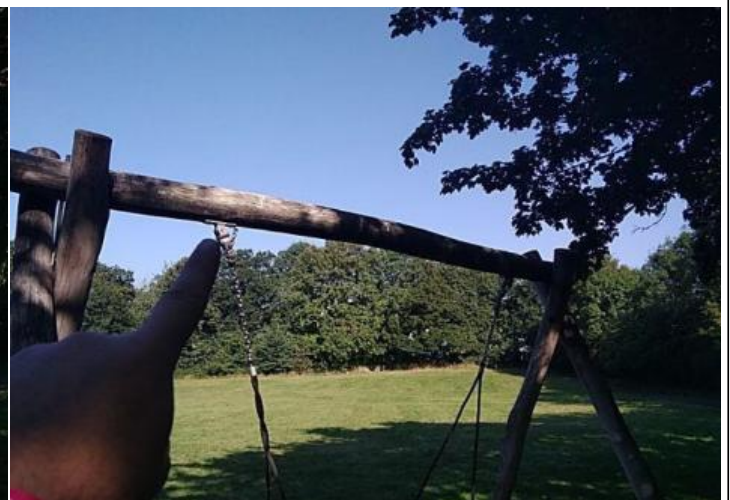
**Risk Level:** M - Moderate Risk  
**Surface:** Grass Matrix Tiles

**Finding:** A number of fixing(s) have worked loose on the secondary safety chain

**Action:** Secure all loose fixings

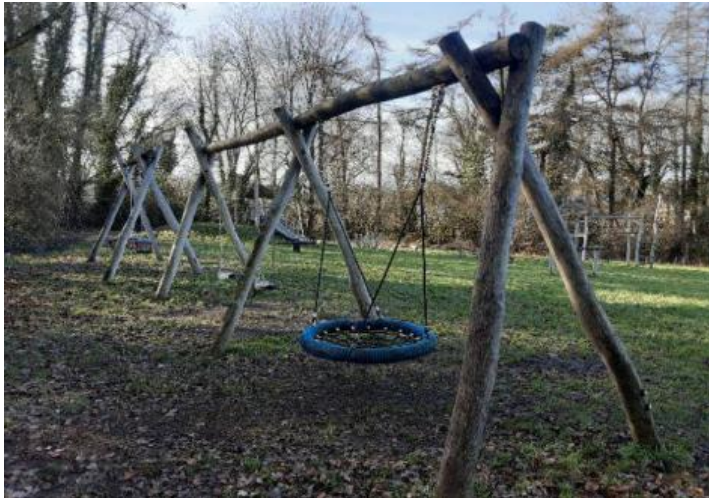
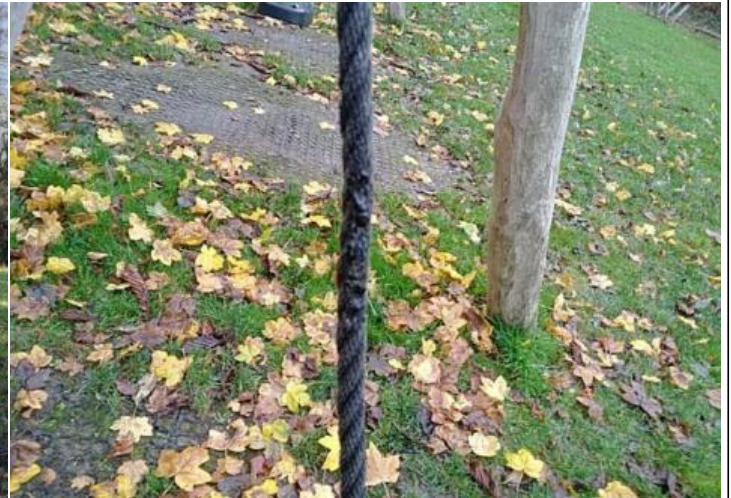
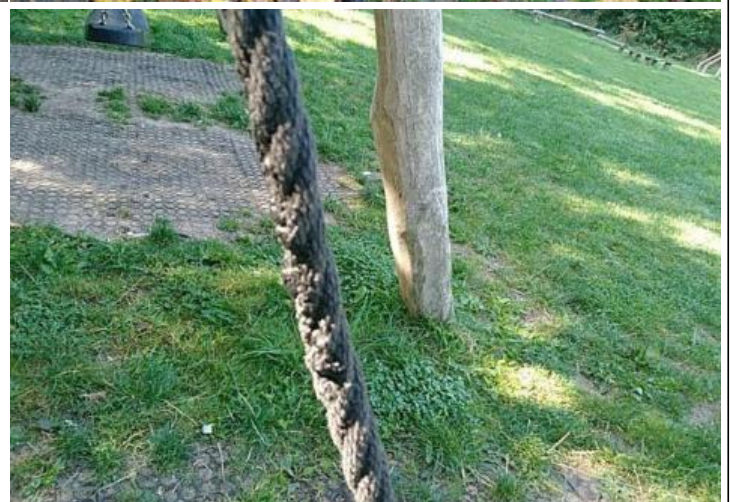
**Risk Level:** L - Low Risk  
**Surface:** Grass Matrix Tiles

**Finding:** There is some evidence of fire damage to the item **Action:** Monitor for any further deterioration and repair as required

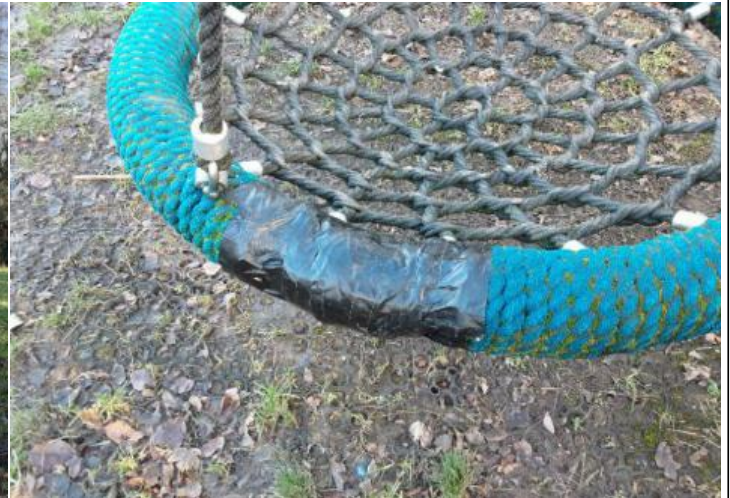
**Risk Level:** L - Low Risk  
**Surface:** Grass Matrix Tiles

**Finding:** The seat has minor damage or wear

**Action:** Monitor for any further deterioration and replace as required

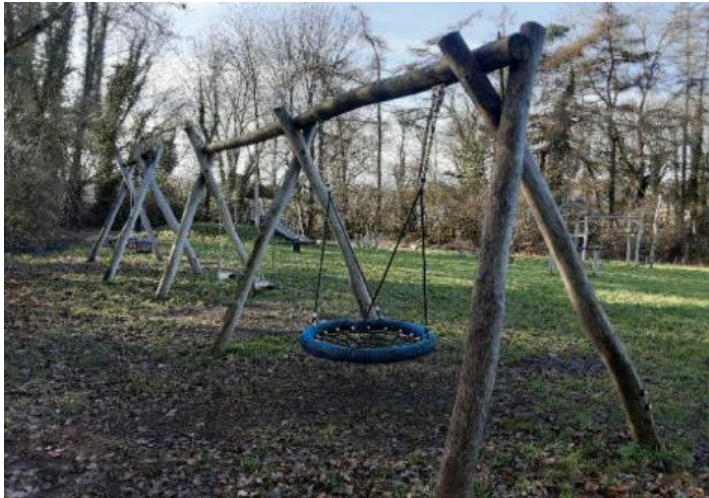
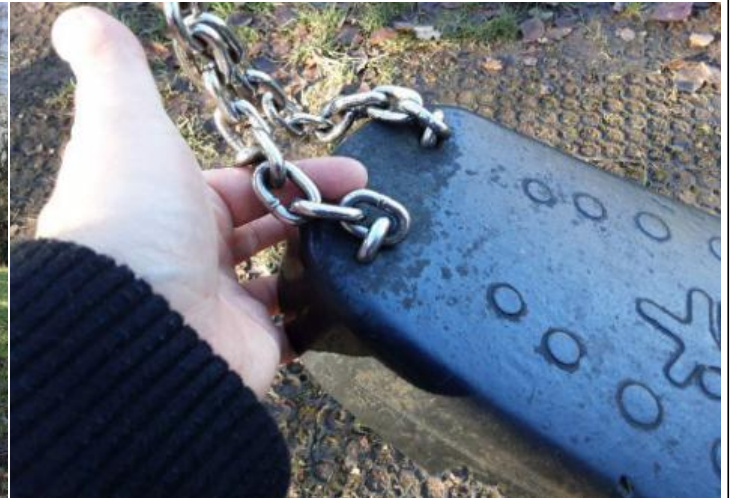
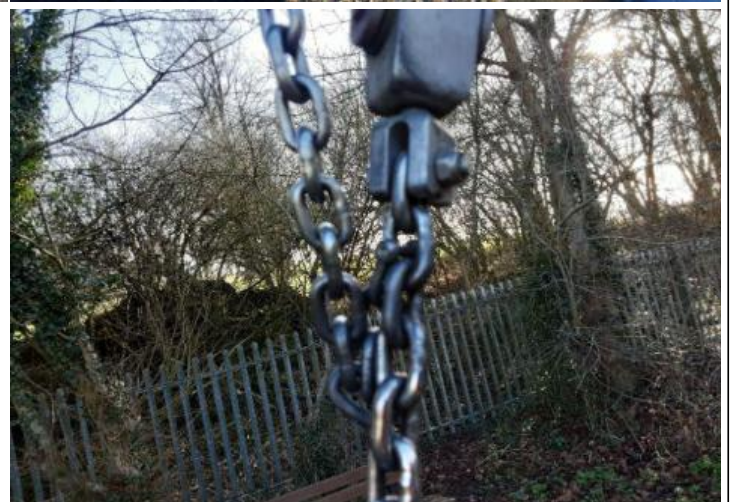
**Risk Level:** L - Low Risk  
**Surface:** Grass Matrix Tiles

**Finding:** There is some notable evidence of chain wear

**Action:** Monitor for any further deterioration and replace when 40% worn

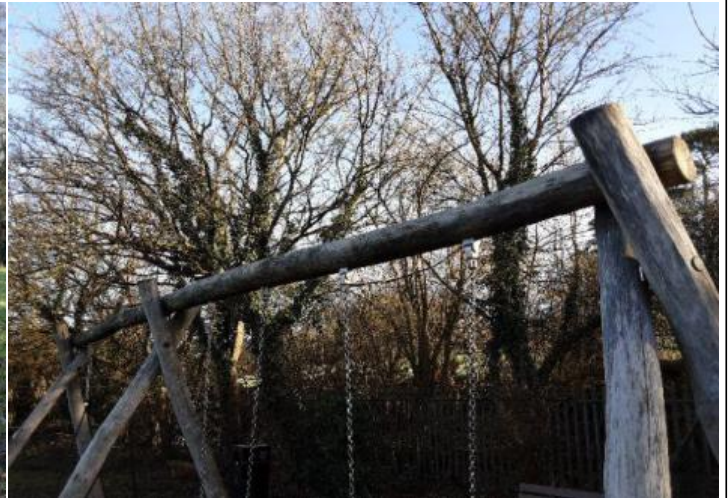
**Risk Level:** N - Risk Assessment not Undertaken  
**Surface:** Grass Matrix Tiles

**Finding:** This design of swing joint has been known to fail on the weld connecting the joint to the threaded stud

**Action:** We would recommend that the joint be dismantled and checked on a regular basis or consulting with manufacturer on whether a Secondary Safety Device can be fitted

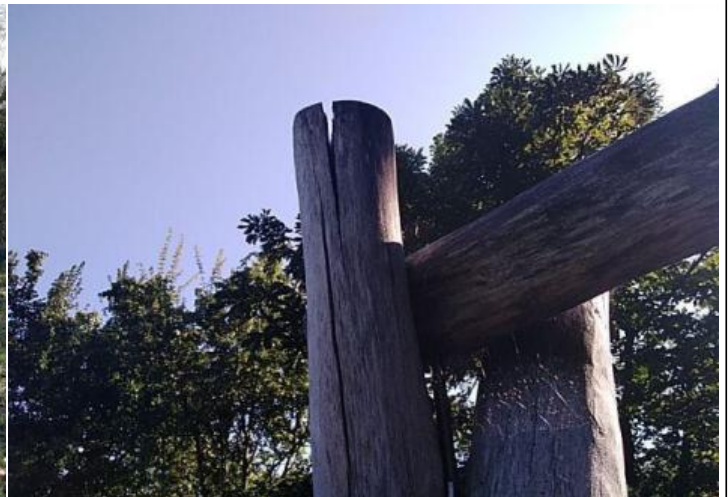
**Risk Level:** L - Low Risk  
**Surface:** Grass Matrix Tiles

**Finding:** The timber has a number of splits/shakes or air cracks and this may affect the stability or allow water ingress which will accelerate the rotting process

**Action:** Monitor to ensure the splits do not cross through fixing points of the structure and/or cause any instability

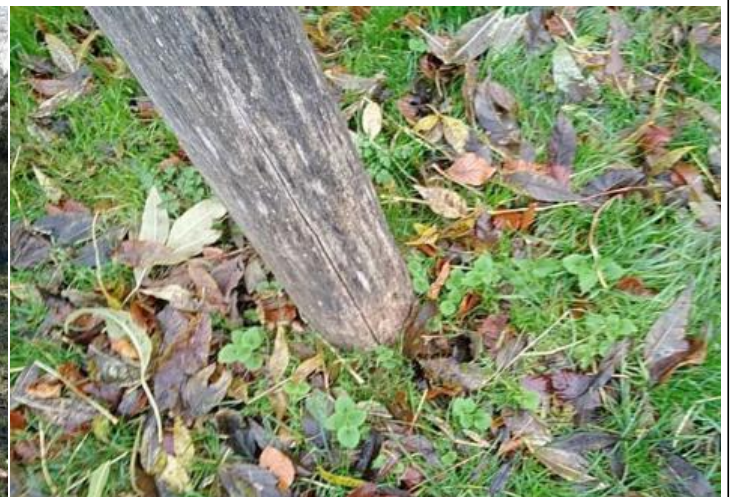
**Risk Level:** L - Low Risk  
**Surface:** Grass Matrix Tiles

**Finding:** There is some strimmer / machinery damage apparent on the posts, this can penetrate the preservative applied to the timber and accelerate the rotting process **Action:** Monitor for any deterioration (rot) and replace as required

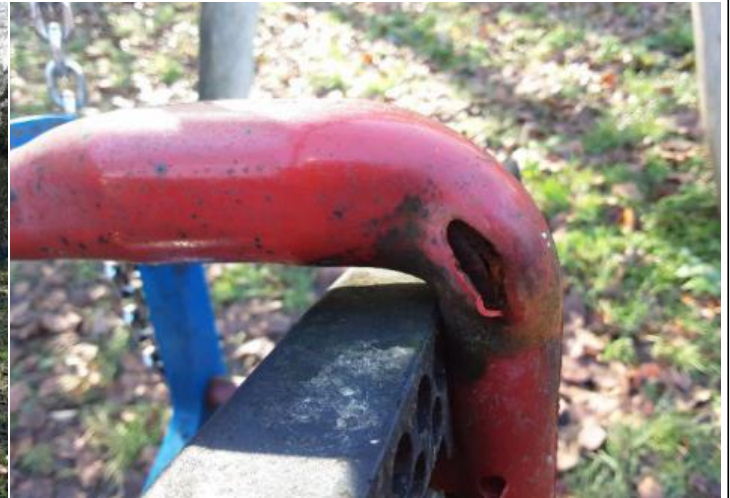
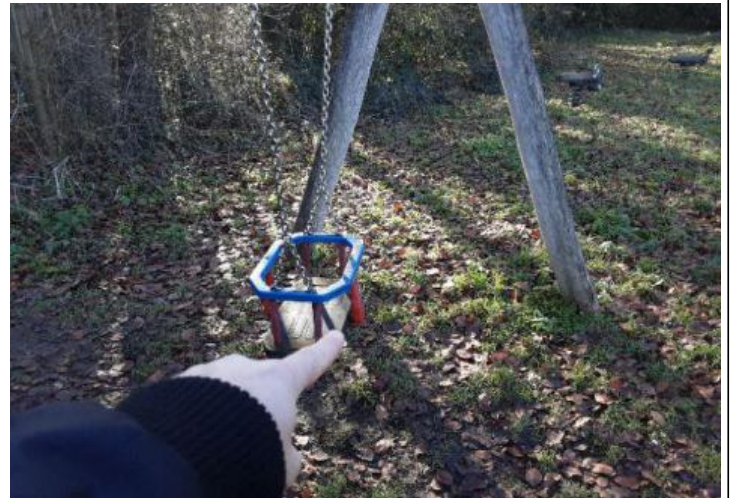
**Risk Level:** L - Low Risk  
**Surface:** Grass Matrix Tiles

**Finding:** The swing seat frame is severely corroded and requires replacement

**Action:** Replace seat

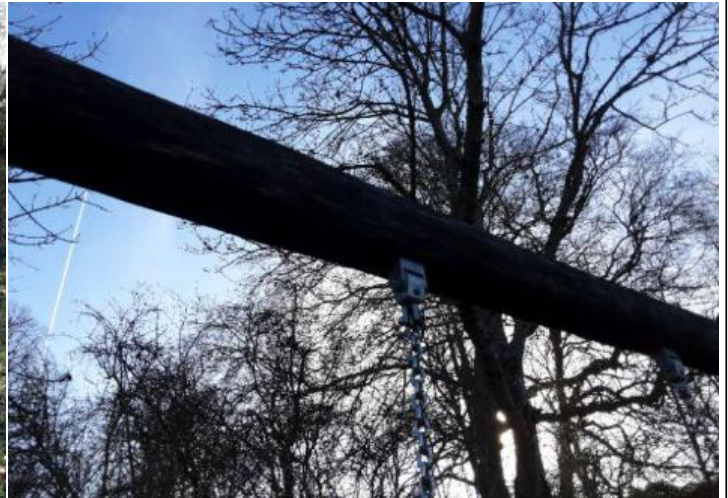
**Risk Level:** N - Risk Assessment not Undertaken  
**Surface:** Grass Matrix Tiles

**Finding:** This design of swing joint has been known to fail on the weld connecting the joint to the threaded stud

**Action:** We would recommend that the joint be dismantled and checked on a regular basis or consulting with manufacturer on whether a Secondary Safety Device can be fitted
