# NASH MILLS

## PARISH COUNCIL

### Clerk Report April 2023

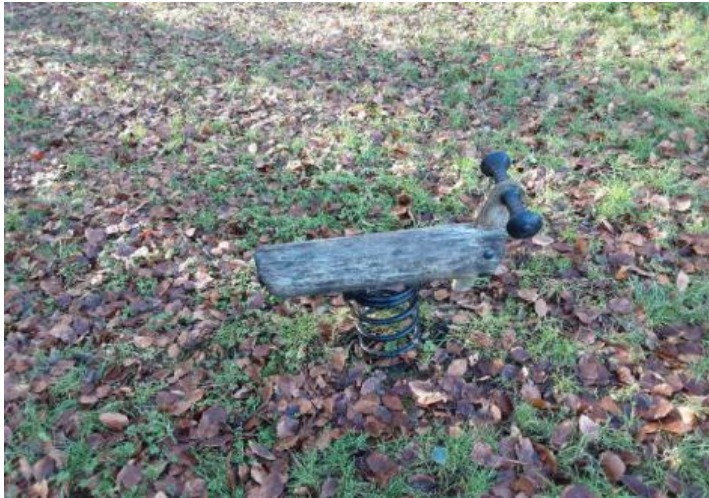
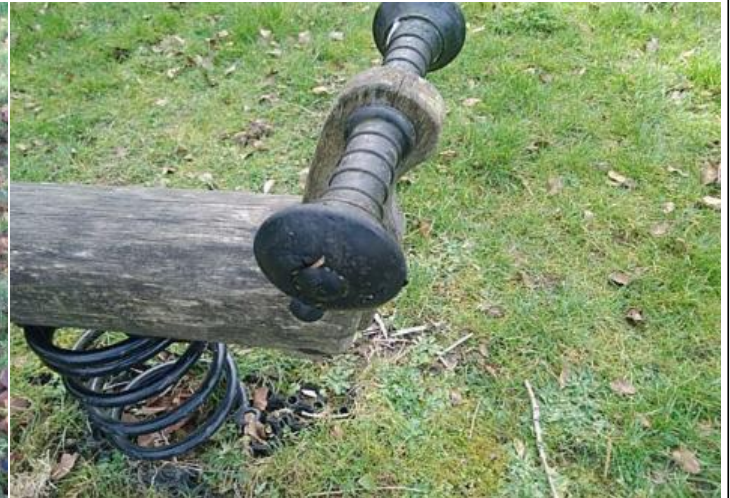
**Risk Level:** V - Very Low Risk  
**Surface:** Grass Matrix Tiles

**Finding:** There is some minor damage to the hand grips

**Action:** Monitor for any further deterioration and replace as required

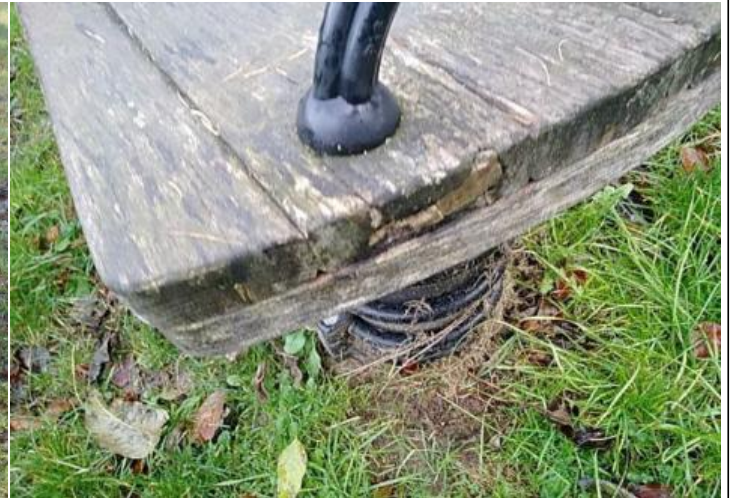
**Risk Level:** L - Low Risk  
**Surface:** Grass Matrix Tiles

**Finding:** The use of synthetic fillers in timber is not recommended; timber being a natural material will expand and contract as the moisture content changes and the use of fillers can exacerbate the length and depth of these cracks or shakes in the timber. The only treatment that is normally required is the removal of any rough or sharp edges unless the structural integrity of the item is affected.

**Action:** Remove any rough or sharp edges and monitor timber for any further deterioration

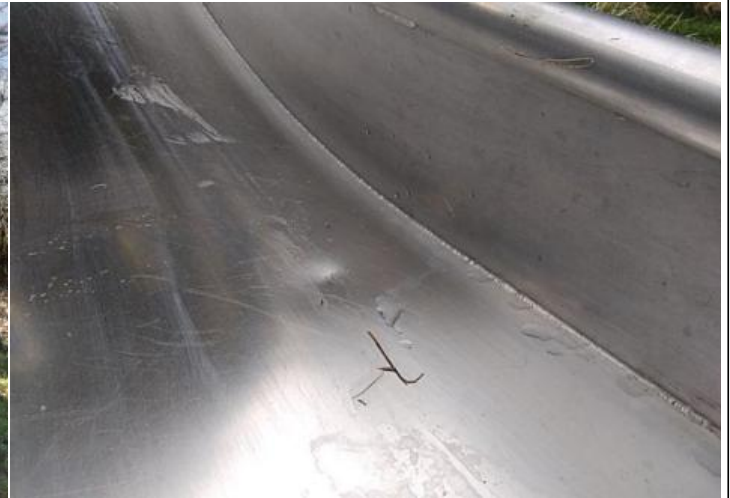
**Risk Level:** V - Very Low Risk  
**Surface:** Grass Matrix Tiles

**Finding:** There are a number of dents in the slide surface

**Action:** Monitor for any further deterioration and repair as required

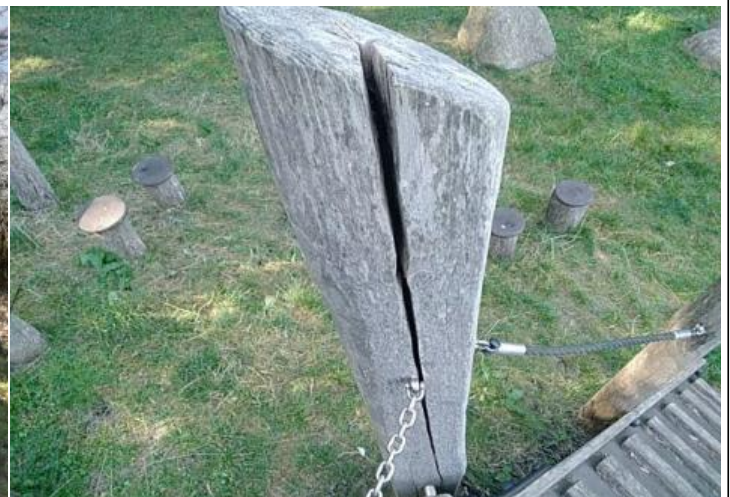
**Risk Level:** L - Low Risk  
**Surface:** Grass Matrix Tiles

**Finding:** The timber has a number of splits/shakes or air cracks and this may affect the stability or allow water ingress which will accelerate the rotting process

**Action:** Monitor to ensure the splits do not cross through fixing points of the structure and/or cause any instability

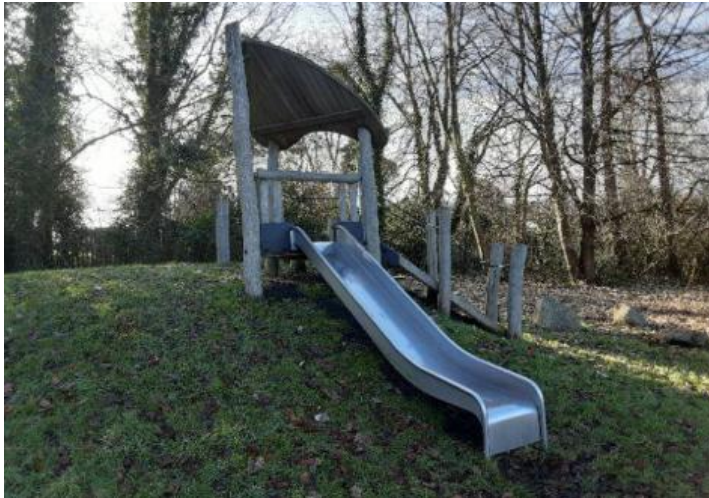
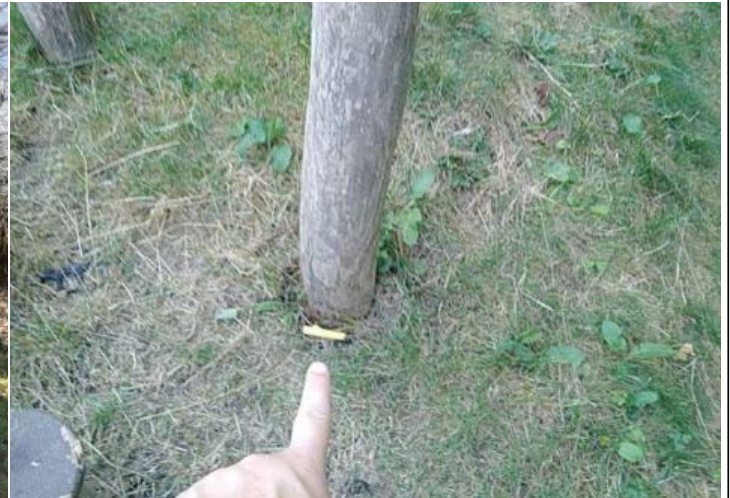
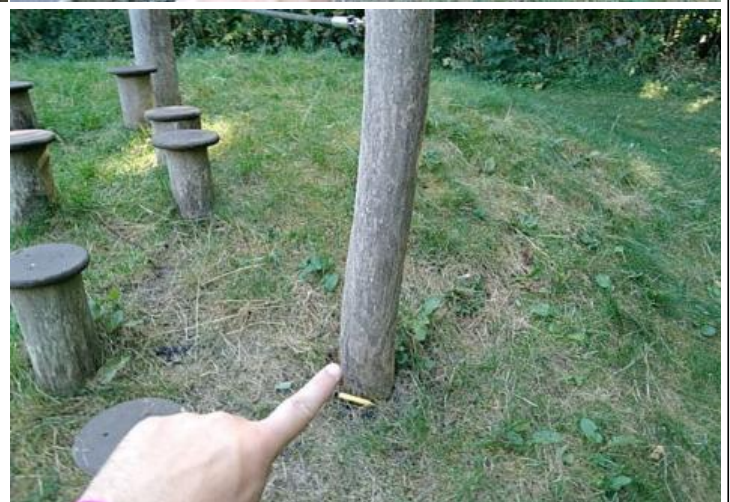
**Risk Level:** L - Low Risk  
**Surface:** Grass Matrix Tiles

**Finding:** There is some evidence of rot in the timber

**Action:** Monitor for any further deterioration and replace as required

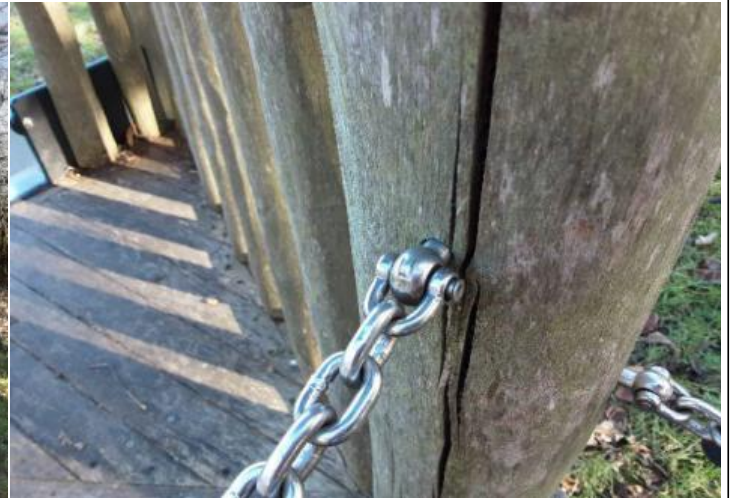
**Risk Level:** L - Low Risk  
**Surface:** Grass Matrix Tiles

**Finding:** A number of fixing(s) have worked loose

**Action:** Secure all loose fixings

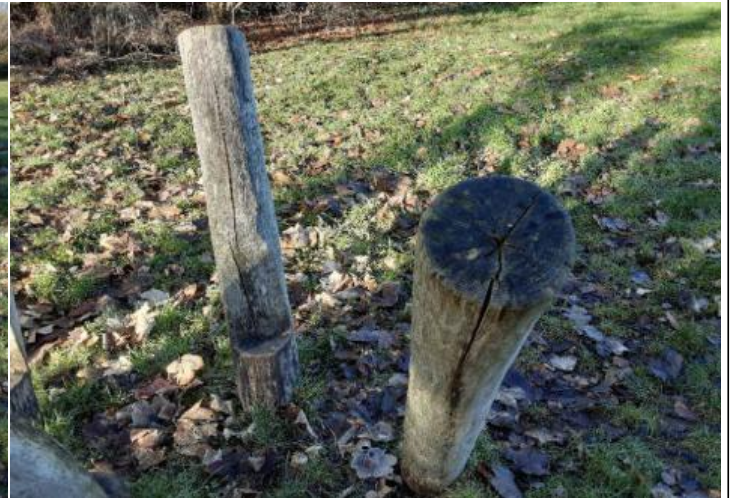
**Risk Level:** L - Low Risk  
**Surface:** Grass

**Finding:** The timber has a number of splits/shakes or air cracks and this may affect the stability or allow water ingress which will accelerate the rotting process

**Action:** Monitor to ensure the splits do not cross through fixing points of the structure and/or cause any instability

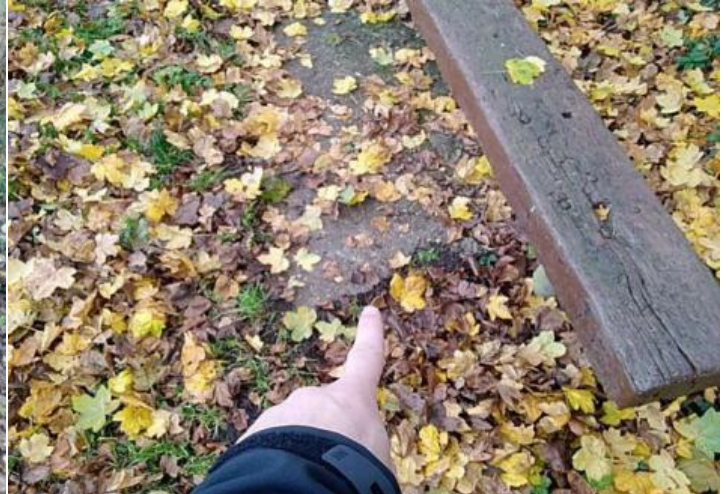
**Risk Level:** L - Low Risk  
**Surface:** Concrete

**Finding:** There are trip hazards at the edges of the surface

**Action:** Reinstate surrounding surface levels to remove the trip points

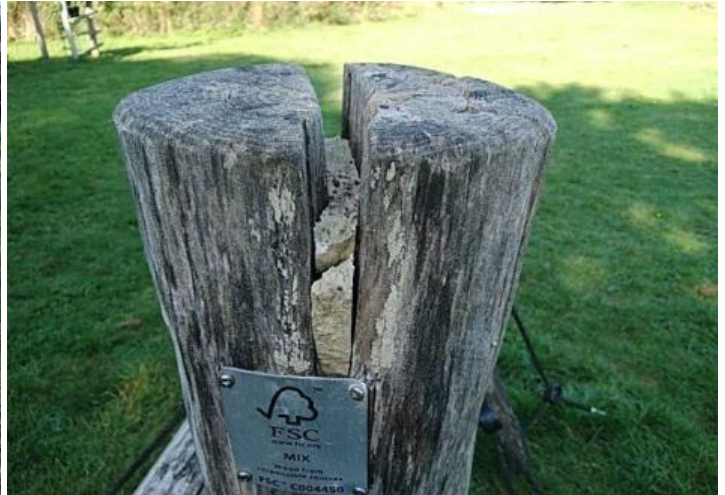
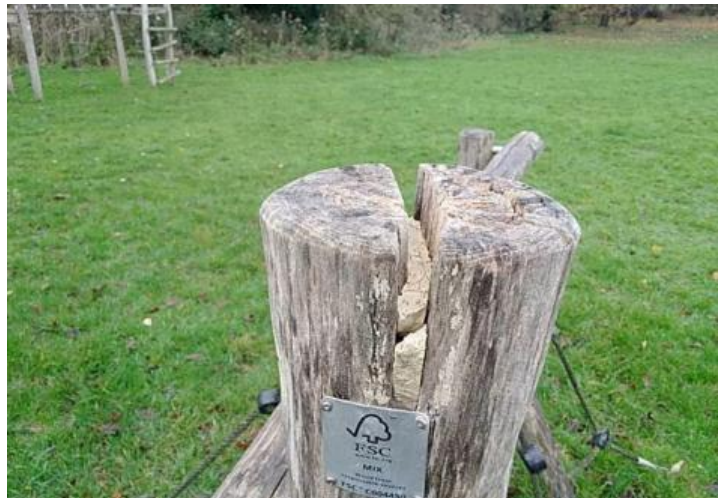
**Risk Level:** L - Low Risk  
**Surface:** Mixed Surface

**Finding:** The use of synthetic fillers in timber is not recommended; timber being a natural material will expand and contract as the moisture content changes and the use of fillers can exacerbate the length and depth of these cracks or shakes in the timber. The only treatment that is normally required is the removal of any rough or sharp edges unless the structural integrity of the item is affected.

**Action:** Remove any rough or sharp edges and monitor timber for any further deterioration
