Clerk Report – Swing Repairs July 2023

Play Inspection Report March 2023

Project Name EN347302 Nash Mills Play Area

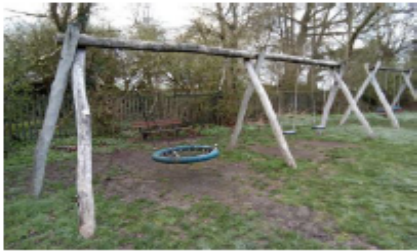
12 - Moderate Risk </div>	
Item: 2 Bay 2 Flat 1 Basket Seat Manufacturer: Kompan Ltd Surface Type: Grass Matrix Tiles Item Quantity: 1 Equipment Compliance: No Surface Area Compliance: Yes

12 - Moderate Risk (Finding 3)			
Item:	Swings - 2 Bay 2 Flat 1 Basket Seat	Risk Level:	M - Moderate Risk
Manufacturer:	Kompan Ltd	Surface:	Grass Matrix Tiles

Finding: A number of fixing(s) have worked loose on the suspension mounts		Action: Secure all loose fixings

Swing fixing finding, 3,4,9 – the bolt cannot be tightened further as it is embedded into the wood so I would suggest that we perhaps need new fixings and the old ones dug out or an additional safety device fitted.

I cannot obtain 3 quotes. As the equipment is Kompan equipment the other 2 suppliers that I have approached will not repair it. The quote is for complete dig out of old brackets and replacement.
