the **play** inspection company

Operational Inspection

Nashmills Parish Council

Bunkers Lane Play Area

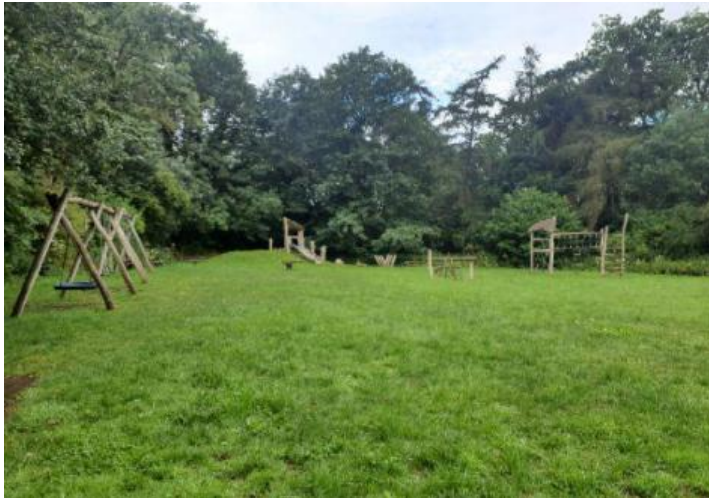
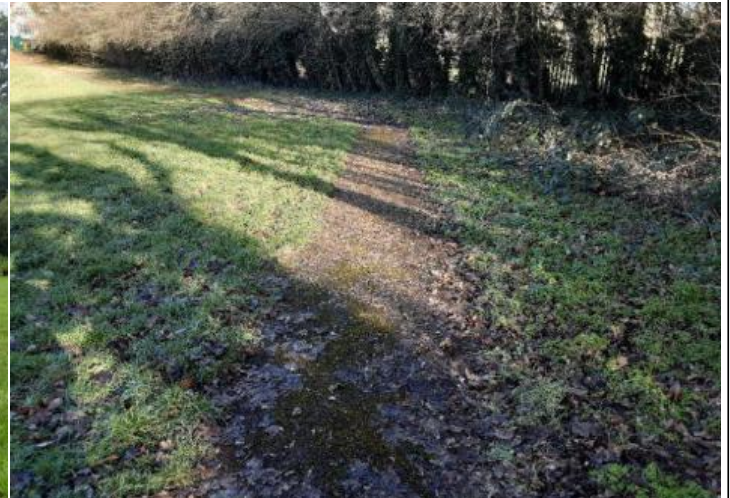
Finding: There is algae, silt or moss growth on the pathway surface resulting in slippery conditions
Action: Clean and treat appropriately

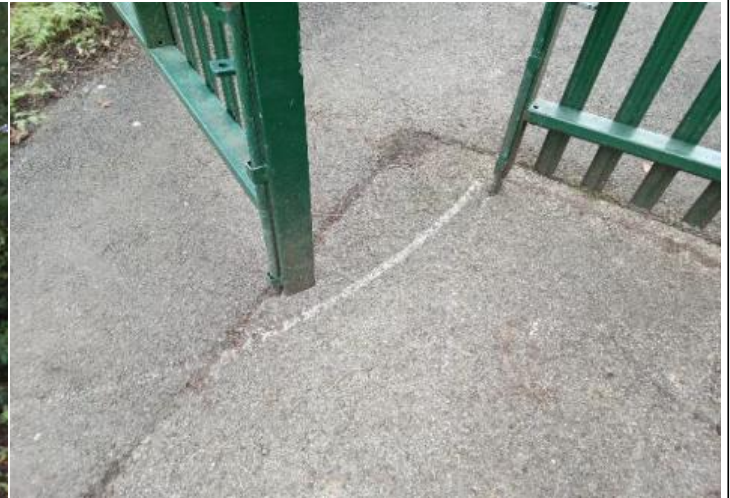
Finding: The bitumen surface is worn or damaged

Action: Repair the bitumen to provide a uniform surface

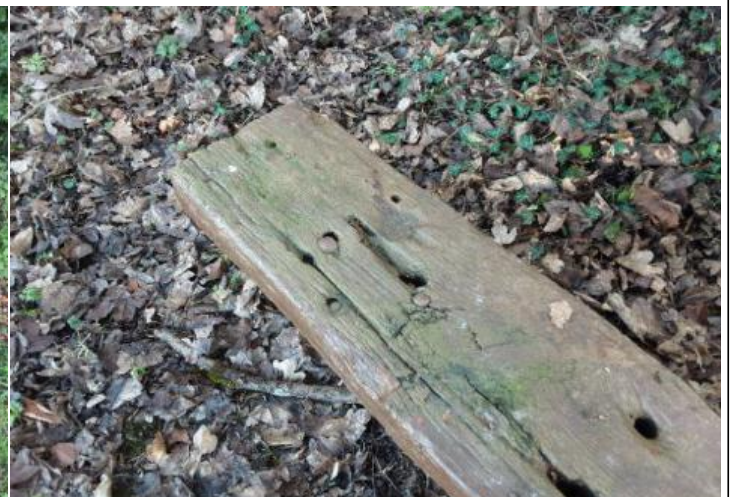
Finding: There is some evidence of rot in the timber

Action: Monitor for any further deterioration and replace as required

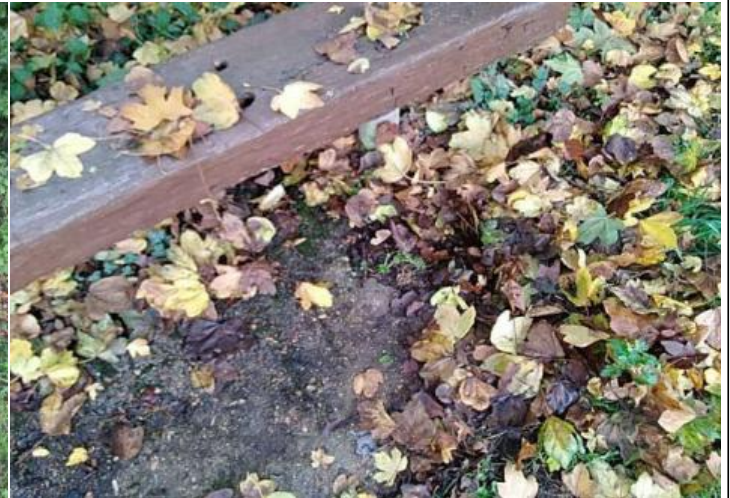
Finding: The concrete base has been damaged

Action: Monitor for any further deterioration and replace as required

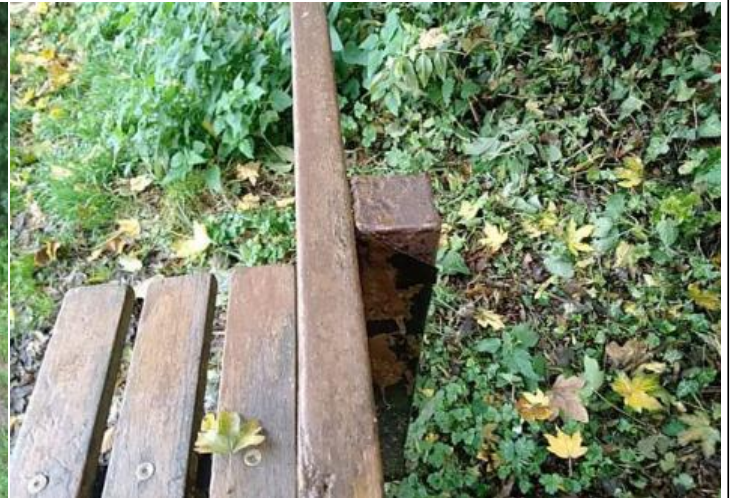
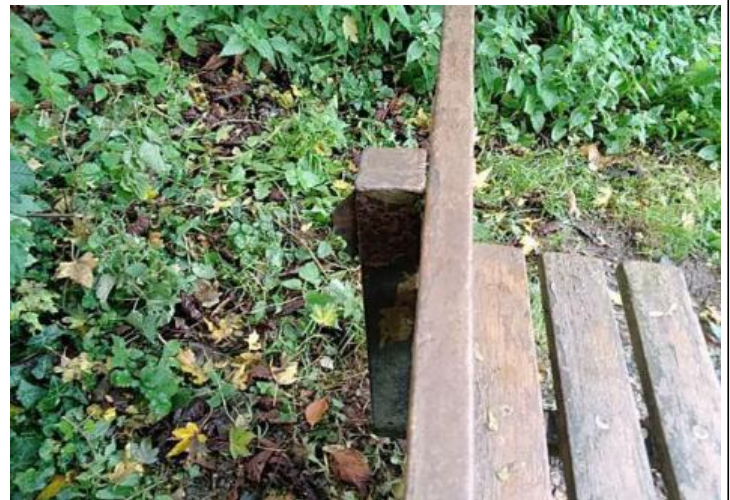
Finding: The paintwork on this item has been damaged or worn exposing the metal underneath which is rusting

Action: Treat any rusting components and repaint

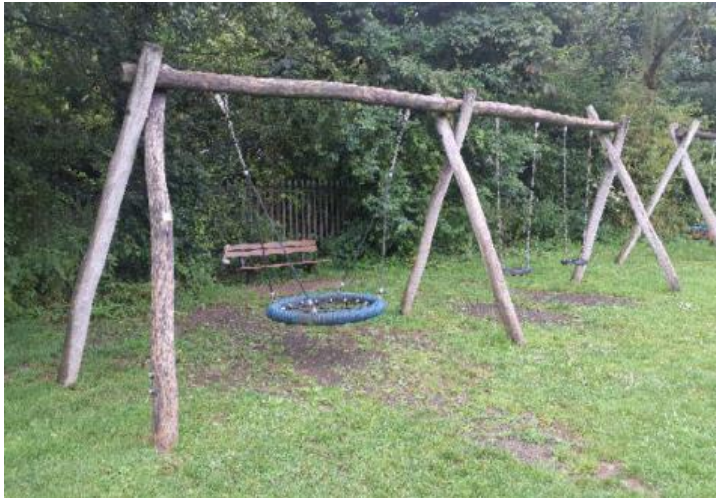
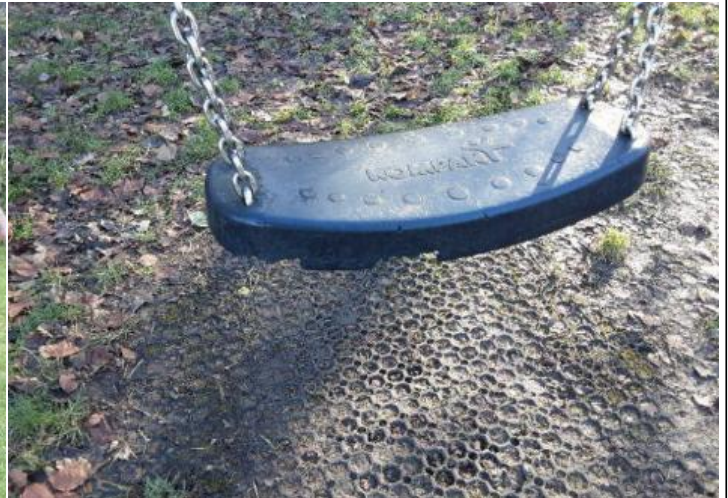
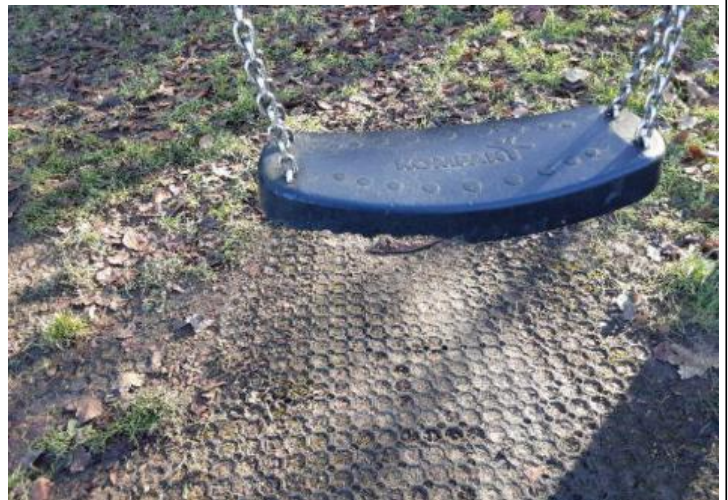
Finding: The seat has minor damage or wear

Action: Monitor for any further deterioration and replace as required

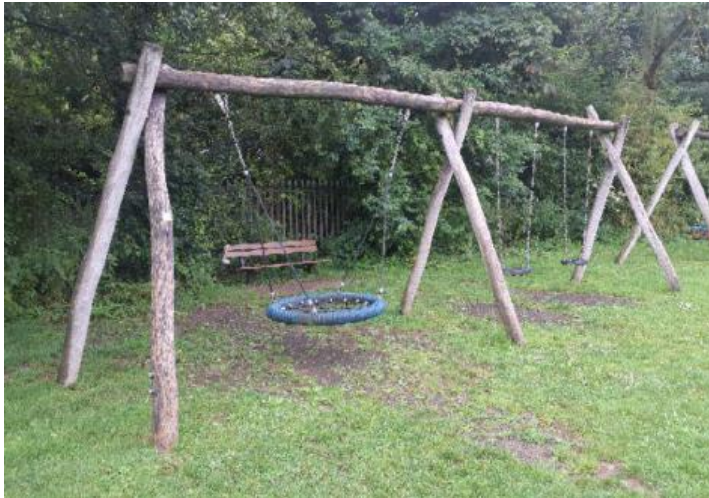
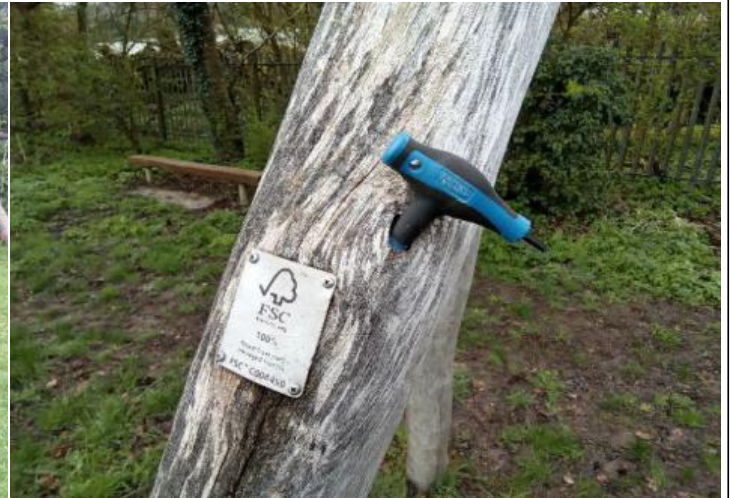
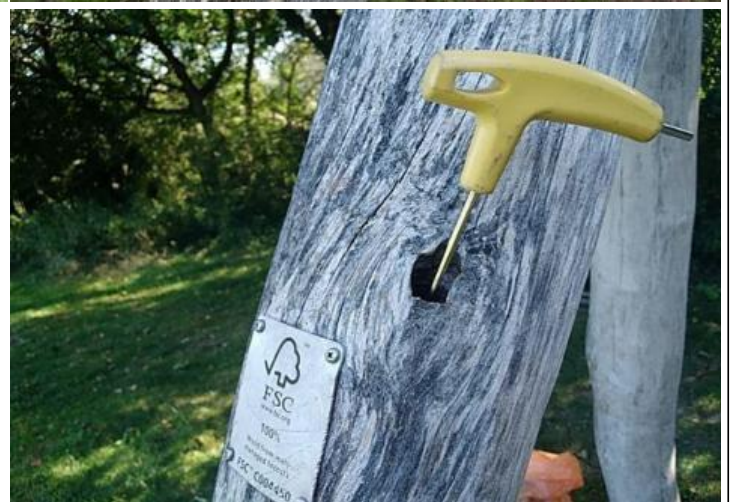
Finding: There is a large cavity within the timber support and the inspector has some concerns about the internal condition of the timber and was unable to verify the structural integrity without further testing. We recommend a Resi-PD survey to establish the condition of the timber at it's core.

Action: Contact the Play Inspection Company office for further information

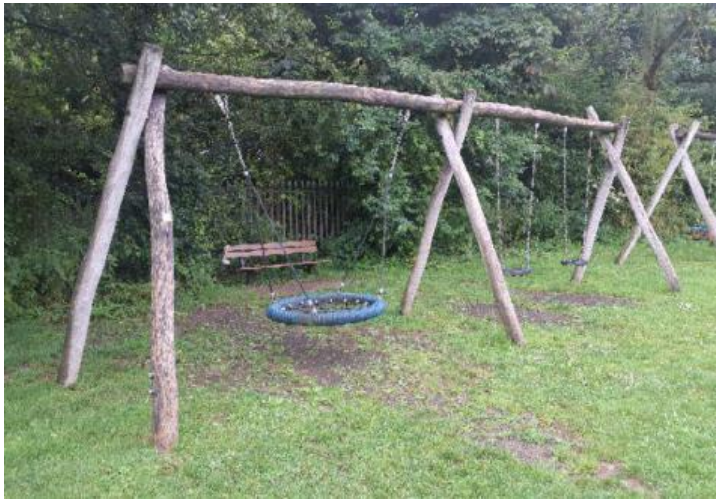
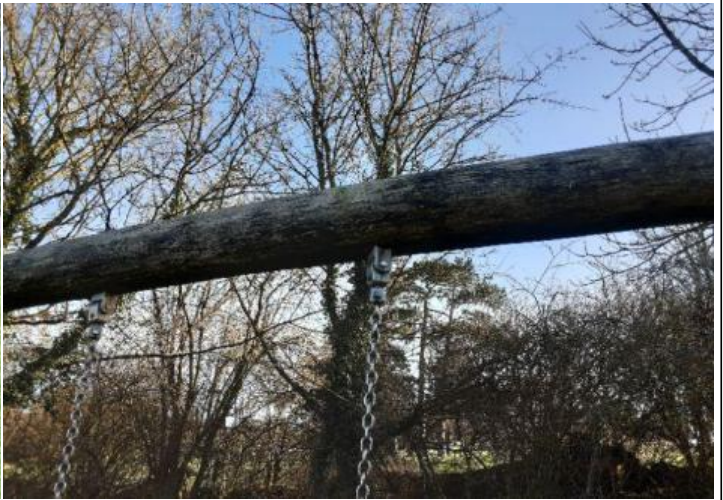
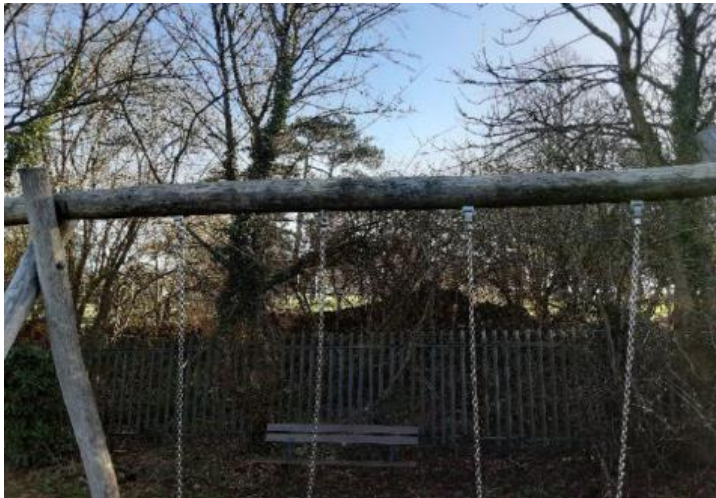
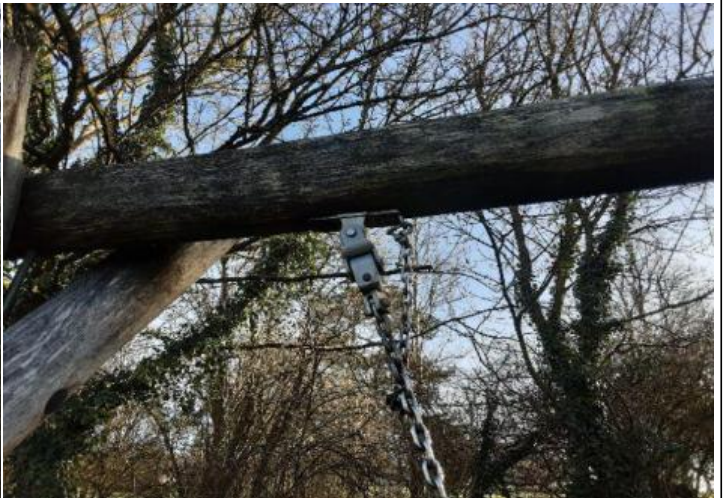
Finding: A number of fixing(s) have worked loose on the suspension mounts. The office and client have been notified of this

Action: Secure all loose fixings

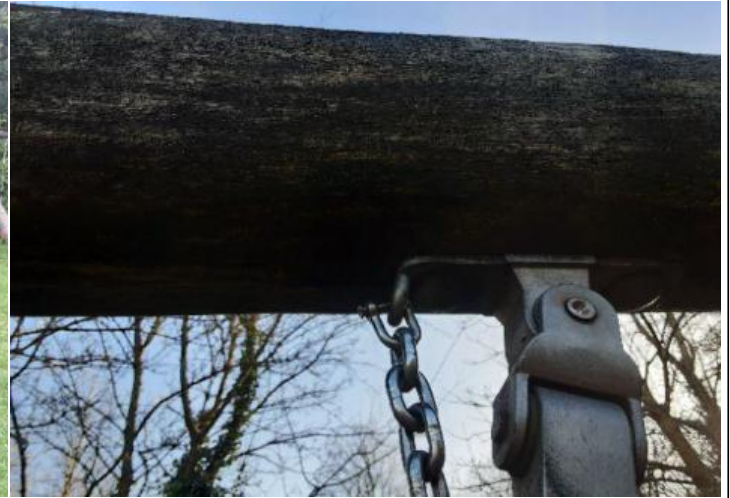
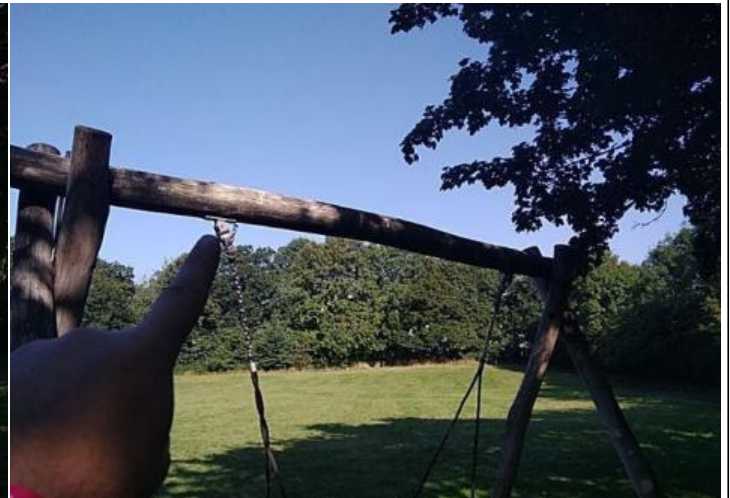
Finding: A number of fixing(s) have worked loose on the secondary safety chain

Action: Secure all loose fixings

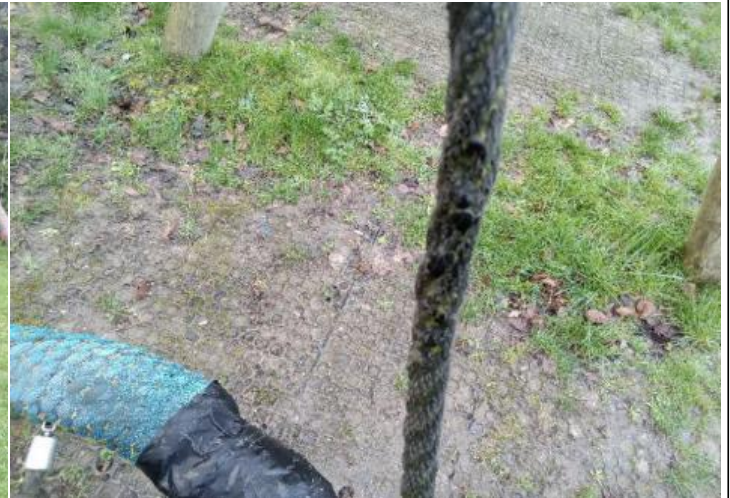
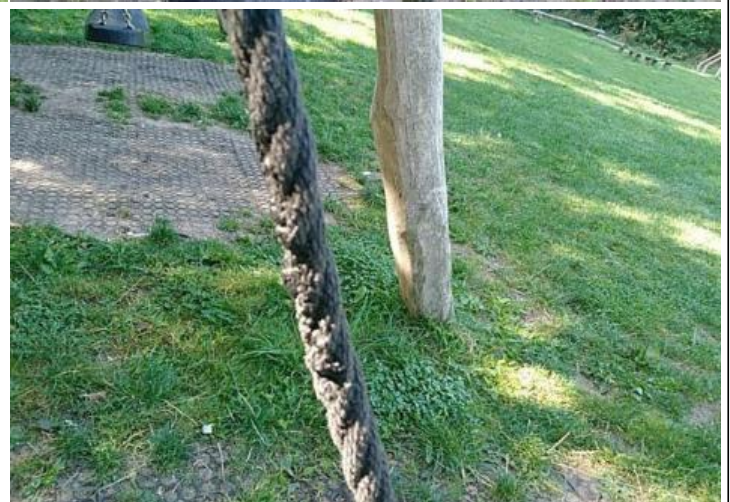
Finding: There is some evidence of fire damage to the item **Action:** Monitor for any further deterioration and repair as required

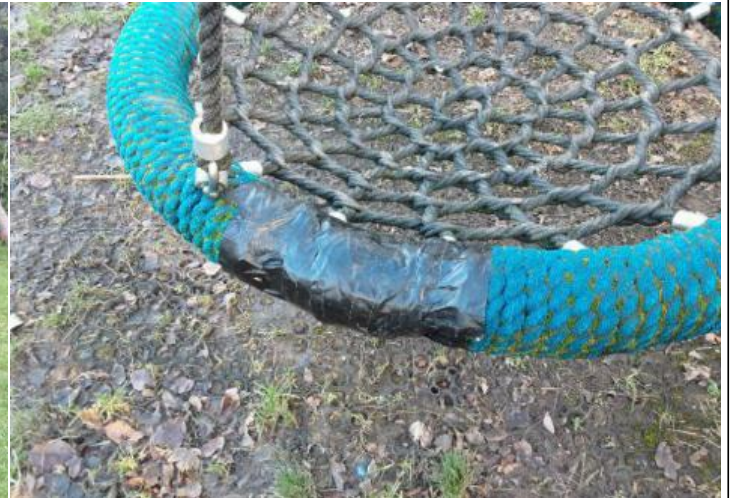
Finding: The seat has minor damage or wear

Action: Monitor for any further deterioration and replace as required

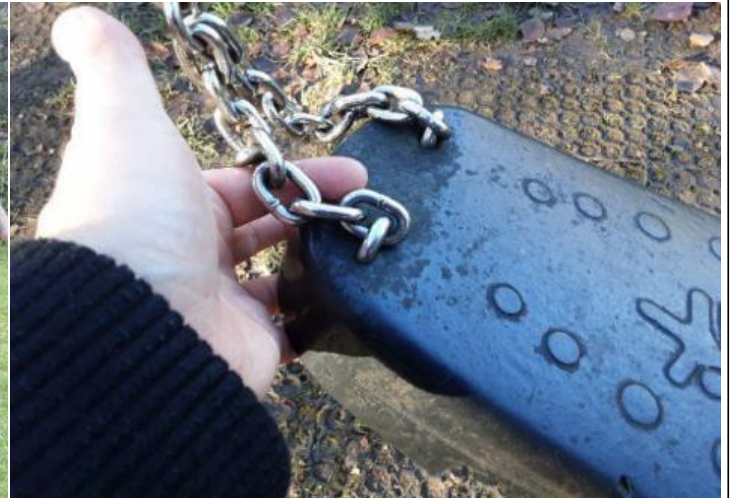
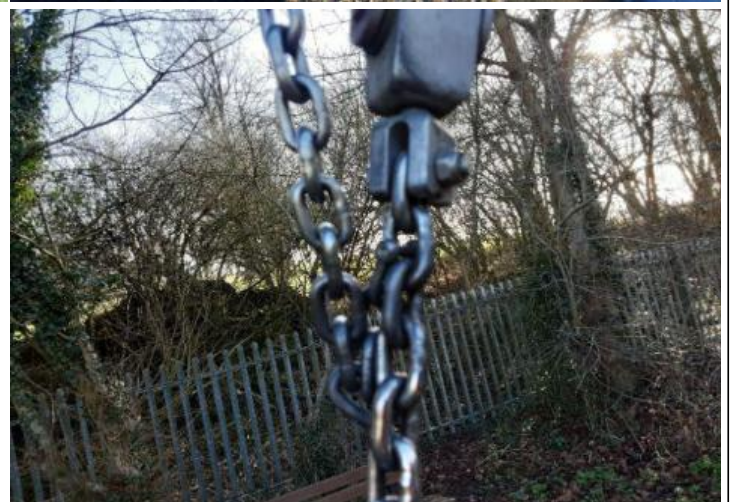
Finding: There is some notable evidence of chain wear

Action: Monitor for any further deterioration and replace when 40% worn

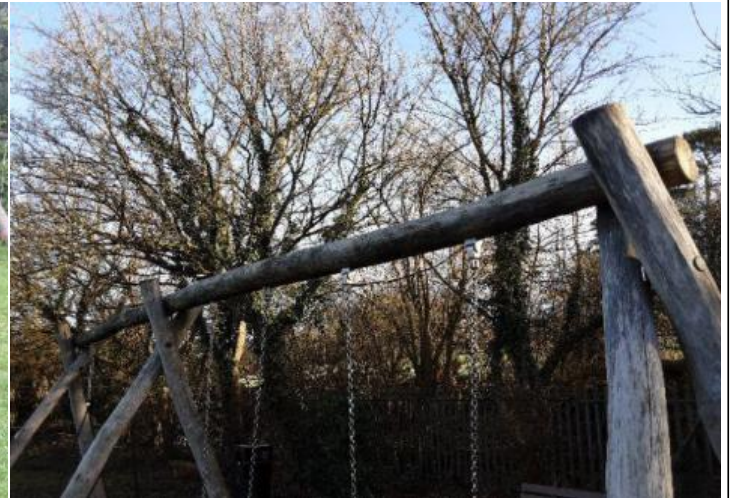
Finding: This design of swing joint has been known to fail on the weld connecting the joint to the threaded stud

Action: We would recommend that the joint be dismantled and checked on a regular basis or consulting with manufacturer on whether a Secondary Safety Device can be fitted

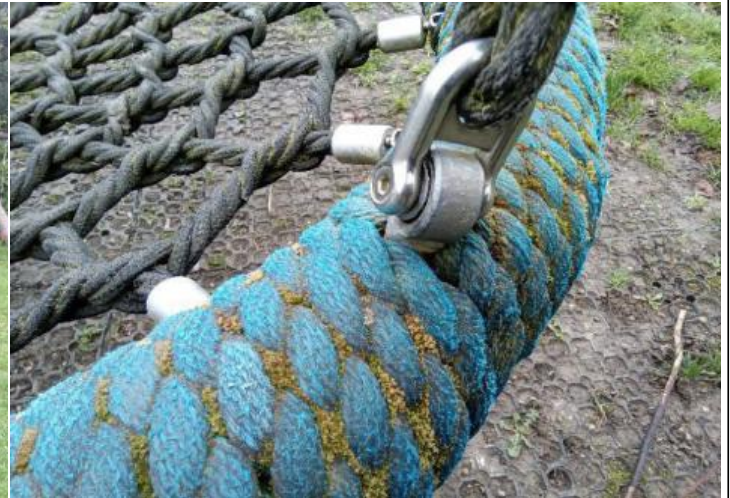
Finding: The bushes are showing signs of wear

Action: Monitor for any further deterioration and replace as required

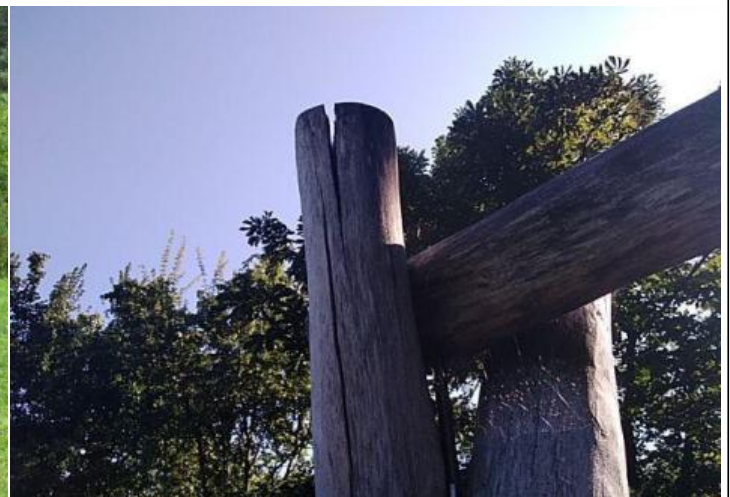
Finding: The timber has a number of splits/shakes or air cracks and this may affect the stability or allow water ingress which will accelerate the rotting process

Action: Monitor to ensure the splits do not cross through fixing points of the structure and/or cause any instability

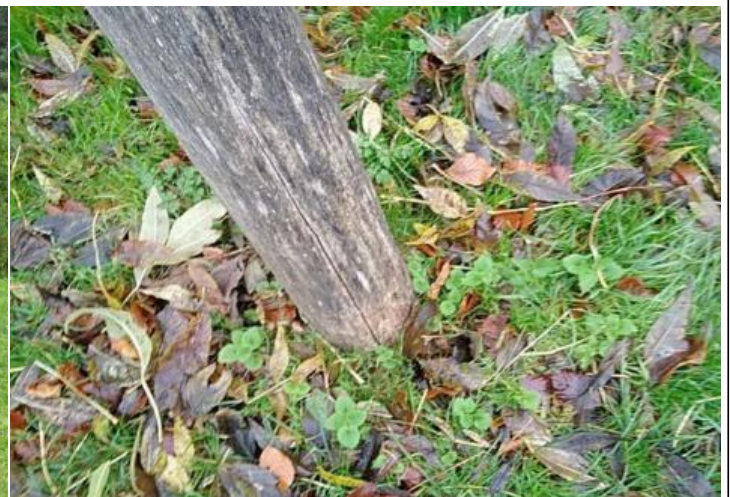
Finding: There is some strimmer / machinery damage apparent on the posts, this can penetrate the preservative applied to the timber and accelerate the rotting process **Action:** Monitor for any deterioration (rot) and replace as required

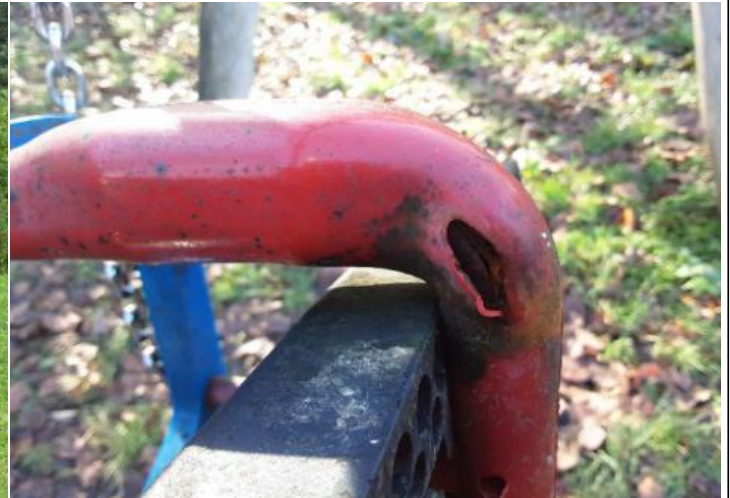
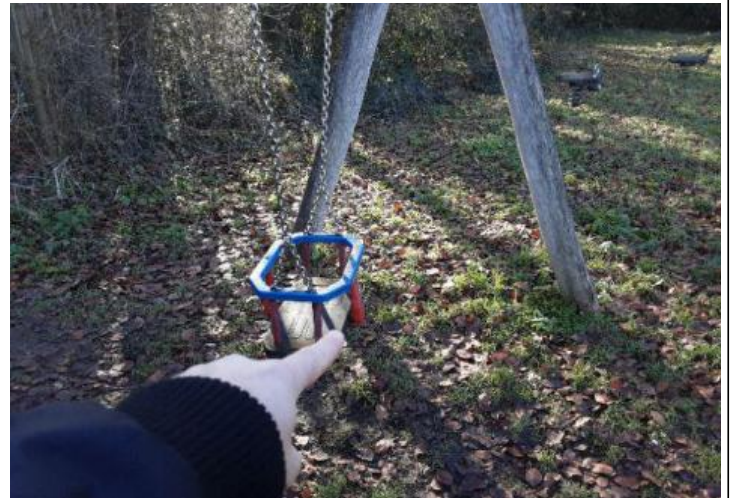
Finding: The swing seat frame is severely corroded and requires replacement

Action: Replace seat

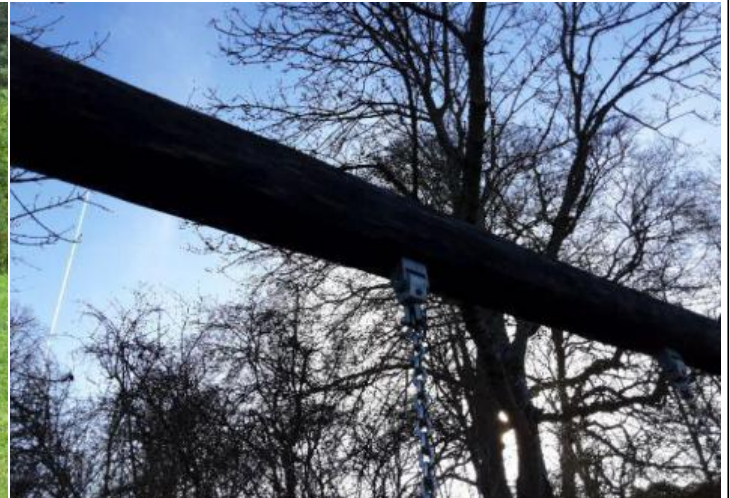
Finding: This design of swing joint has been known to fail on the weld connecting the joint to the threaded stud

Action: We would recommend that the joint be dismantled and checked on a regular basis or consulting with manufacturer on whether a Secondary Safety Device can be fitted

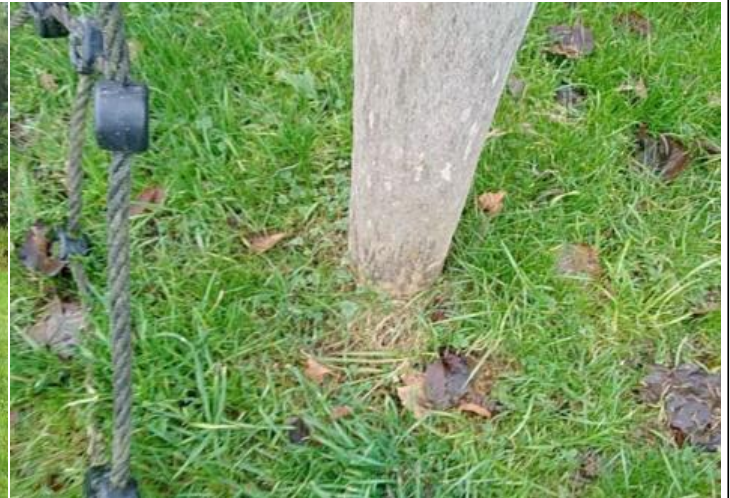
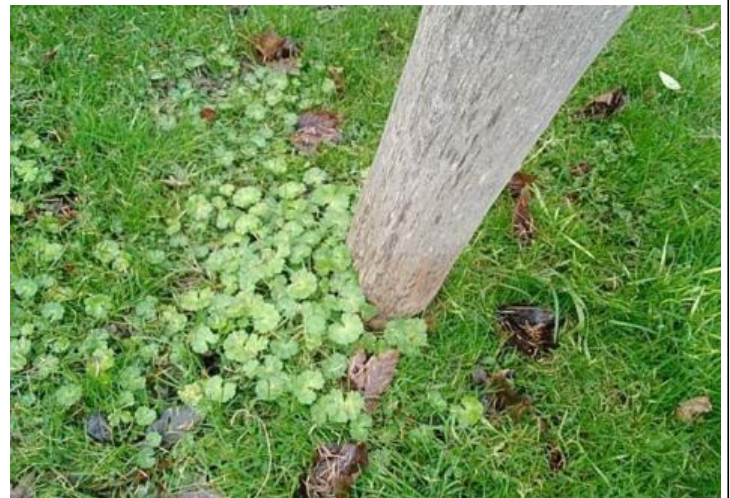
Finding: There is some strimmer / machinery damage apparent on the posts, this can penetrate the preservative applied to the timber and accelerate the rotting process

Action: Monitor for any deterioration (rot) and replace as required

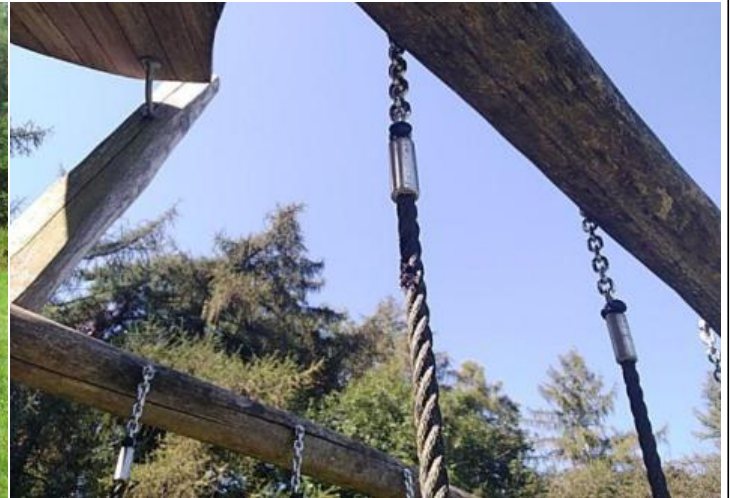
Finding: The ropes/nets are worn/damaged in places

Action: Monitor for any further deterioration and repair or replace as required

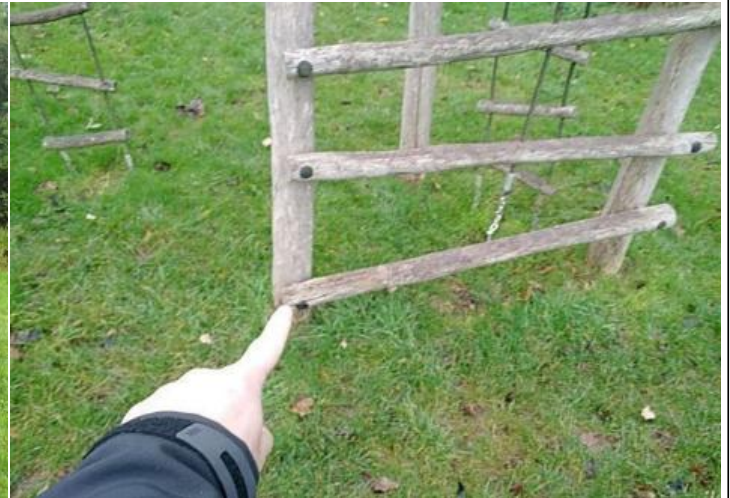
Finding: A number of fixing(s) have worked loose

Action: Secure all loose fixings

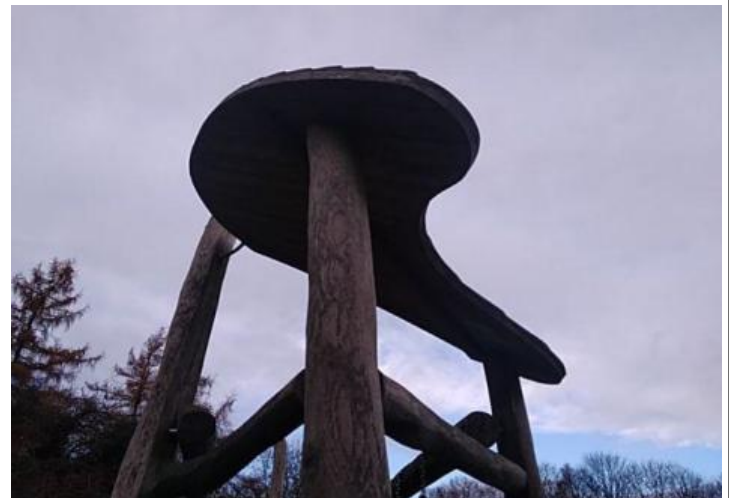
Finding: The roof slats are lifting

Action: Monitor for any further deterioration and repair as required

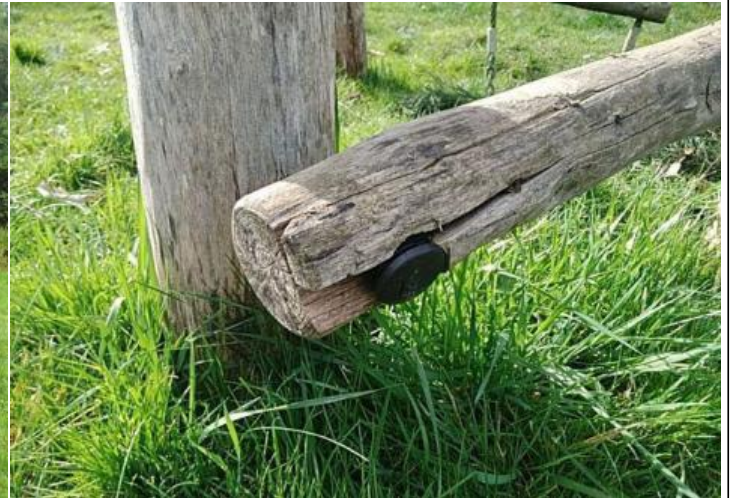
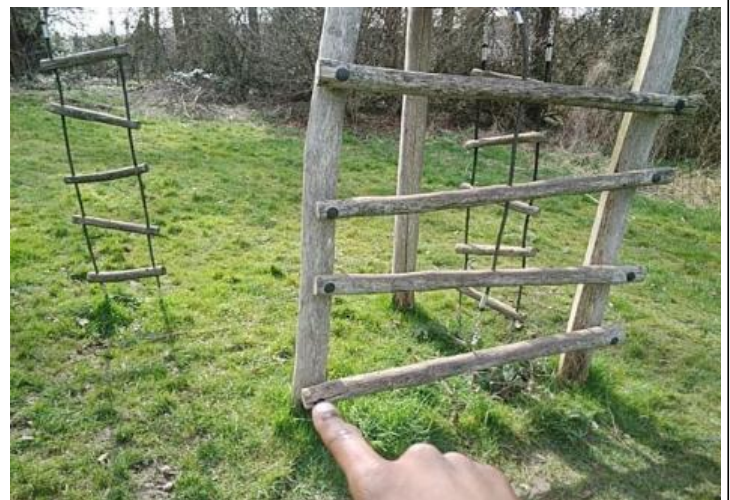
Finding: There is some damage apparent on the posts, this can penetrate the preservative applied to the timber and accelerate the rotting process

Action: Monitor for any deterioration (rot) and replace as required

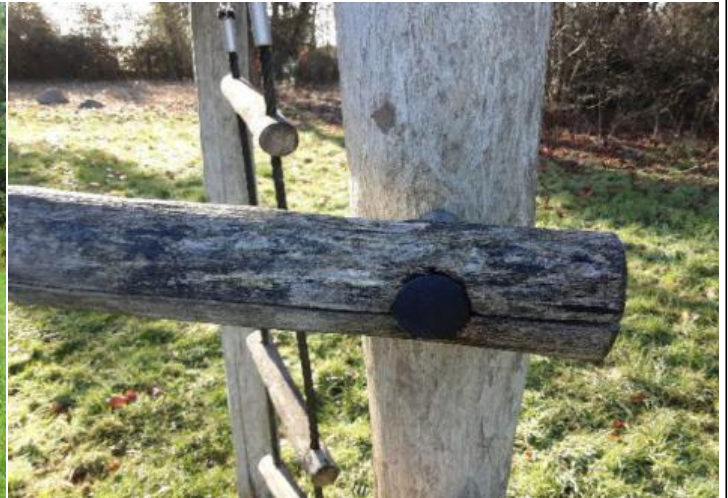
Finding: There is some evidence of rot in the timber

Action: Monitor for any further deterioration and replace as required

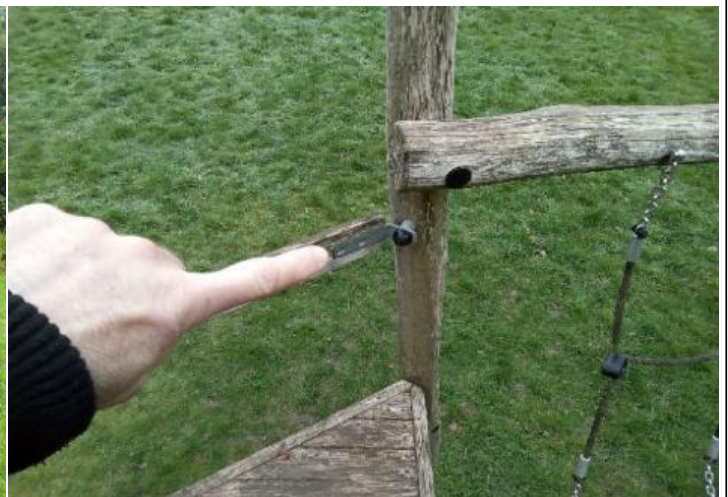
Finding: A number of fixing(s) have worked loose

Action: Secure all loose fixings

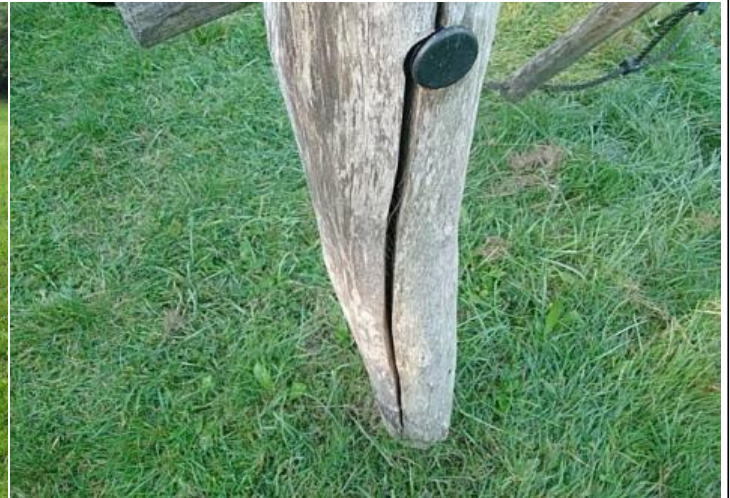
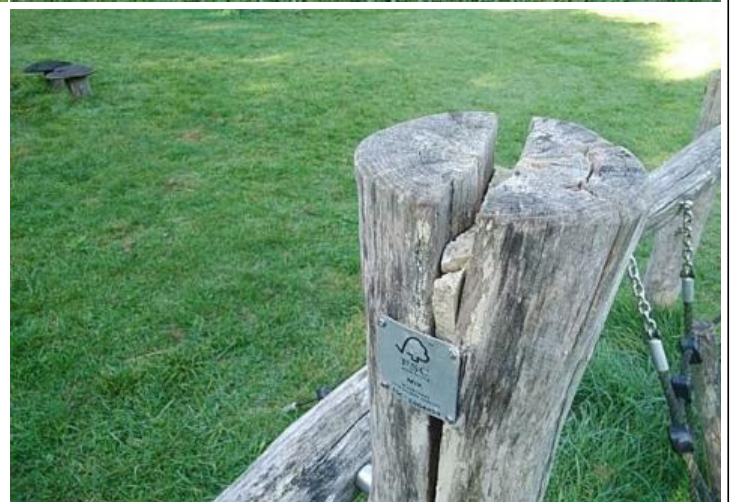
Finding: The timber has a number of splits/shakes or air cracks and this may affect the stability or allow water ingress which will accelerate the rotting process

Action: Monitor to ensure the splits do not cross through fixing points of the structure and/or cause any instability

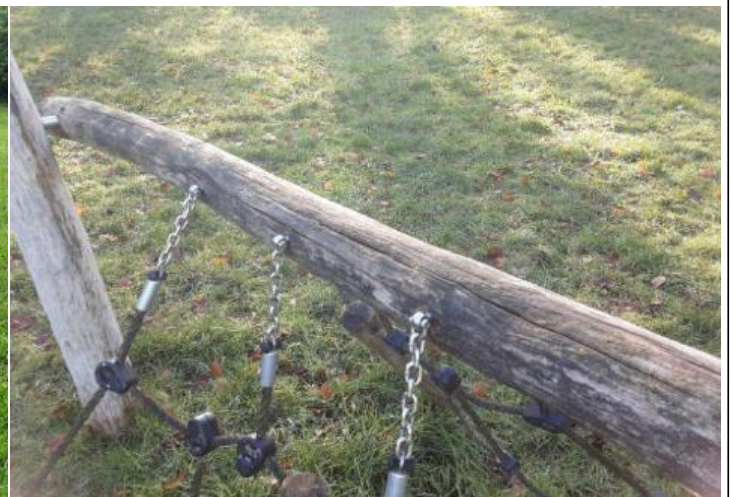
Finding: There is some evidence of rot in the timber

Action: Monitor for any further deterioration and replace as required

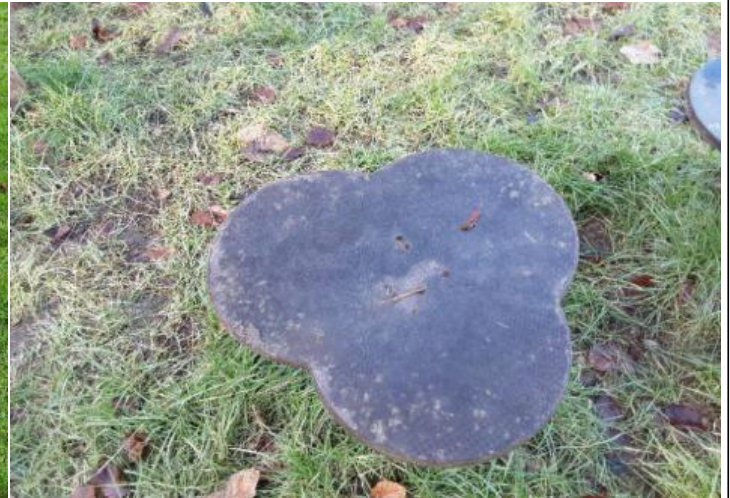
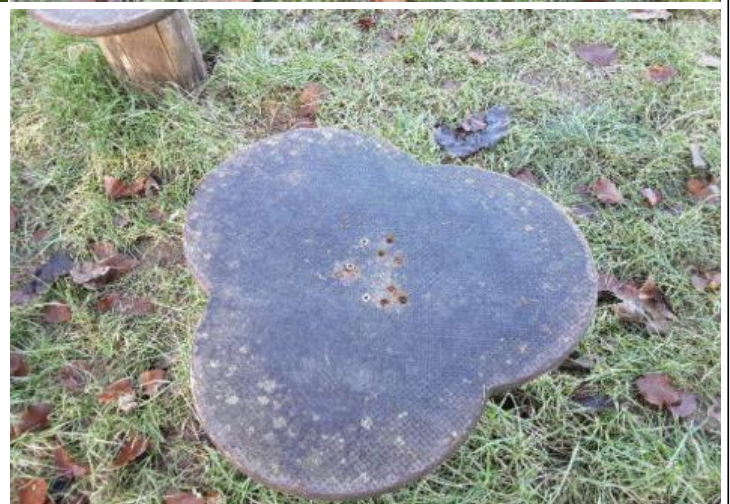
Finding: The platforms are rotting and the fixings are pulling through
Action: Replace all affected timber

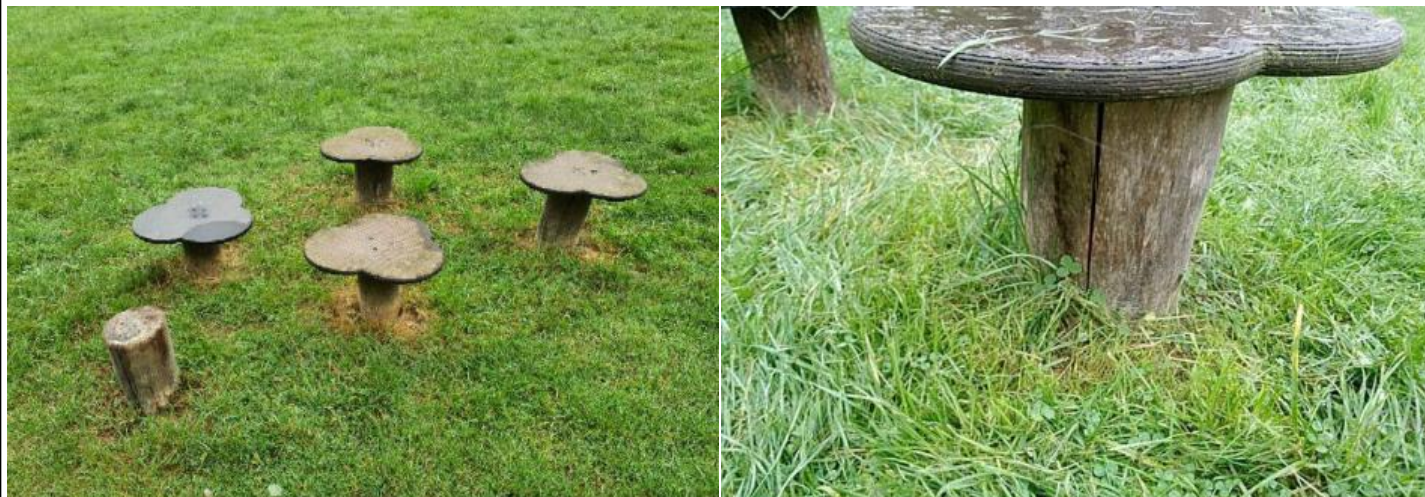
Finding: The timber has a number of splits/shakes or air cracks and this may affect the stability or allow water ingress fixing points of the structure and/or cause any instability which will accelerate the rotting process

Action: Monitor to ensure the splits do not cross through

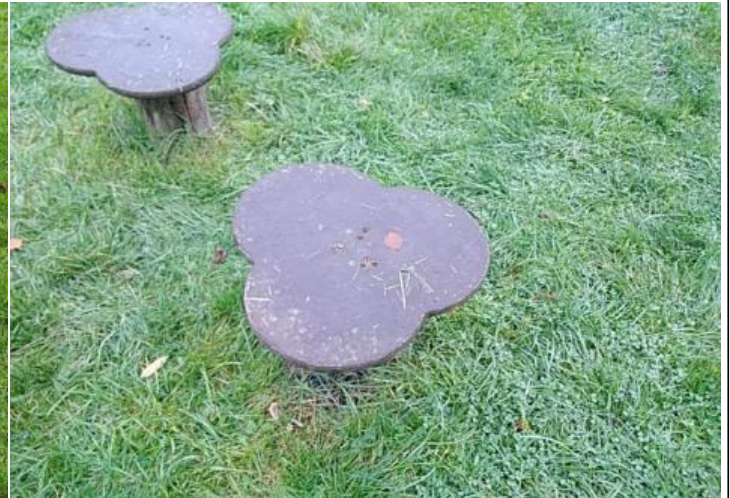
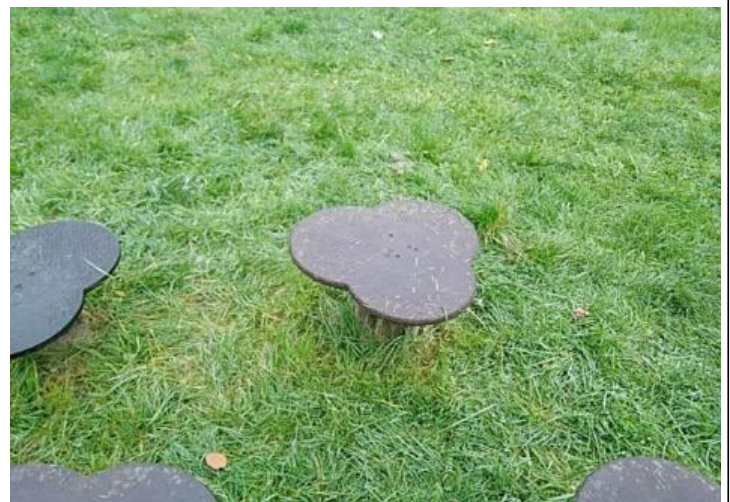
Finding: A number of fixing(s) have worked loose tops

Action: Secure all loose fixings

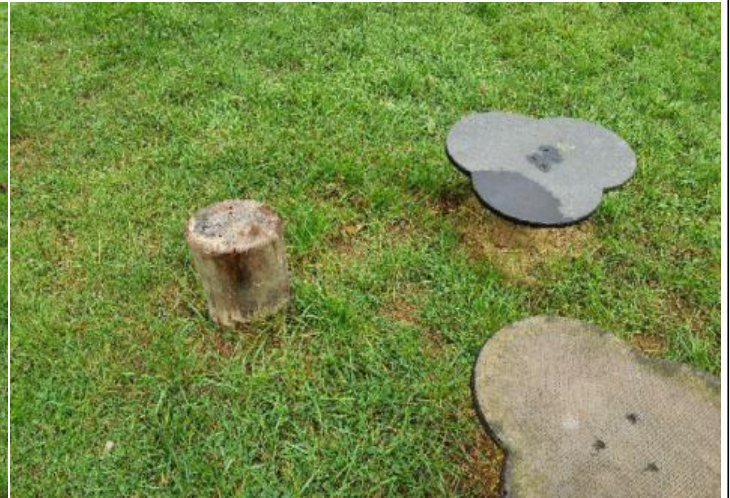
Finding: The item has missing component(s) (step top)

Action: Consider replacing missing components

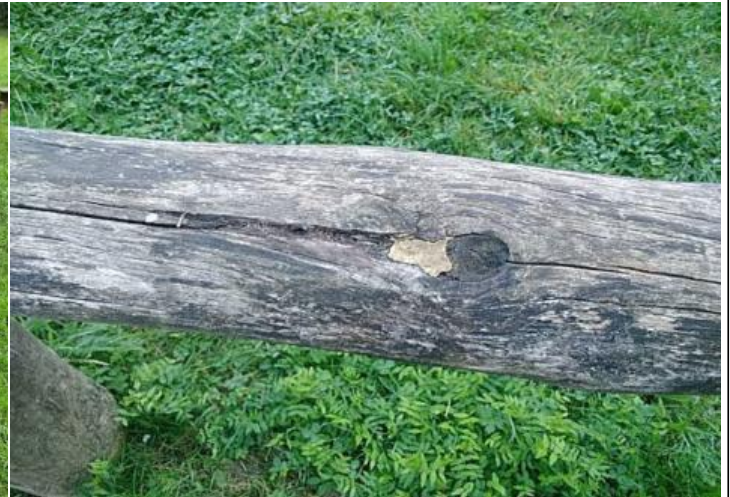
Finding: The use of synthetic fillers in timber is not recommended; timber being a natural material will expand and contract as the moisture content changes and the use of fillers can exacerbate the length and depth of these cracks or shakes in the timber. The only treatment that is normally required is the removal of any rough or sharp edges unless the structural integrity of the item is affected.

Action: Remove any rough or sharp edges and monitor timber for any further deterioration

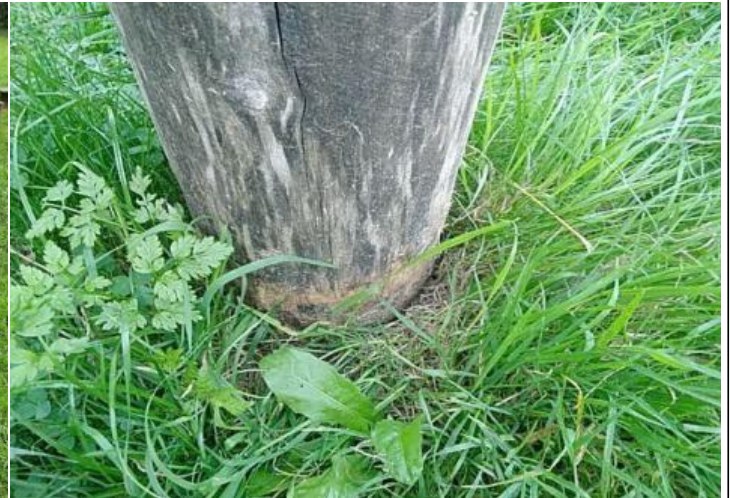
Finding: There is some strimmer / machinery damage apparent on the posts, this can penetrate the preservative applied to the timber and accelerate the rotting process

Action: Monitor for any deterioration (rot) and replace as required

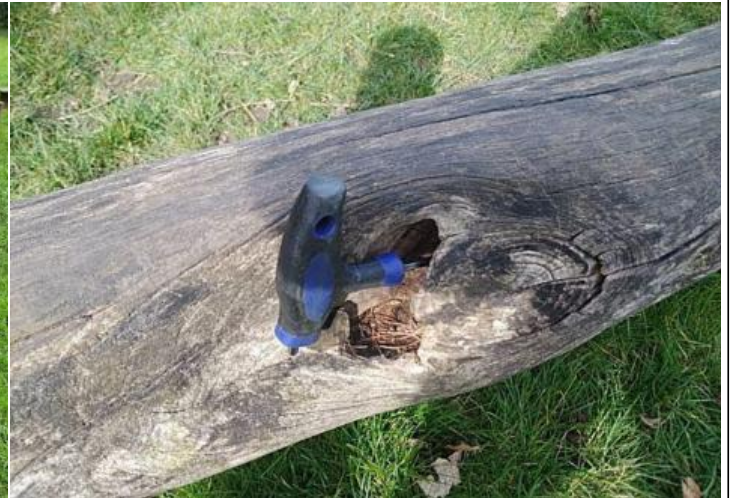
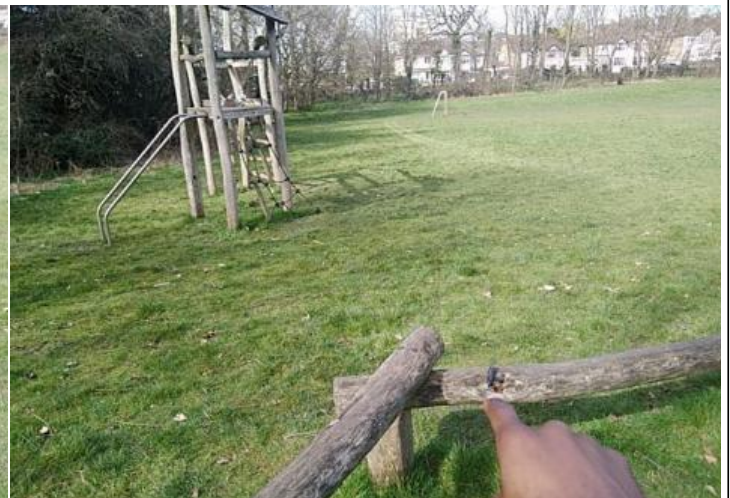
Finding: There is some evidence of rot in the timber

Action: Monitor for any further deterioration and replace as required

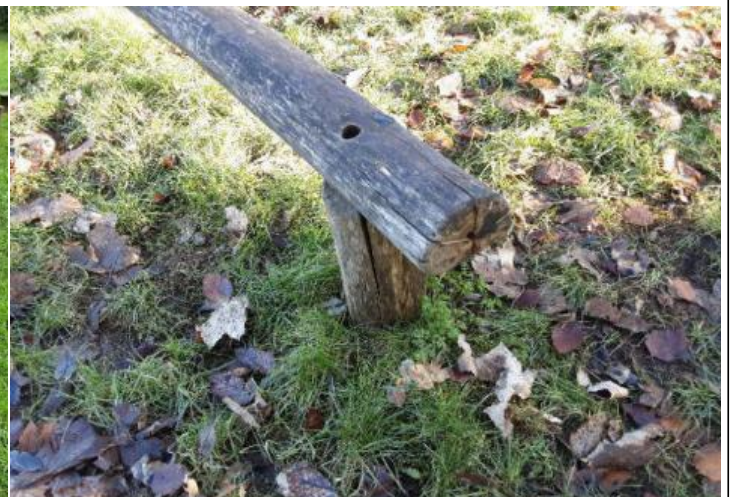
Finding: The timber has a number of splits/shakes or air cracks and this may affect the stability or allow water ingress which will accelerate the rotting process

Action: Monitor to ensure the splits do not cross through fixing points of the structure and/or cause any instability

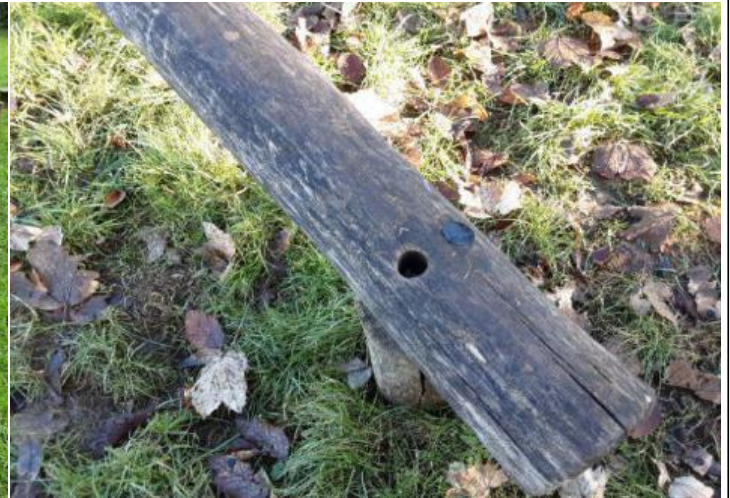
Finding: There is/are bolt cap covers missing or damaged on the item

Action: Replace missing or damaged bolt cap covers

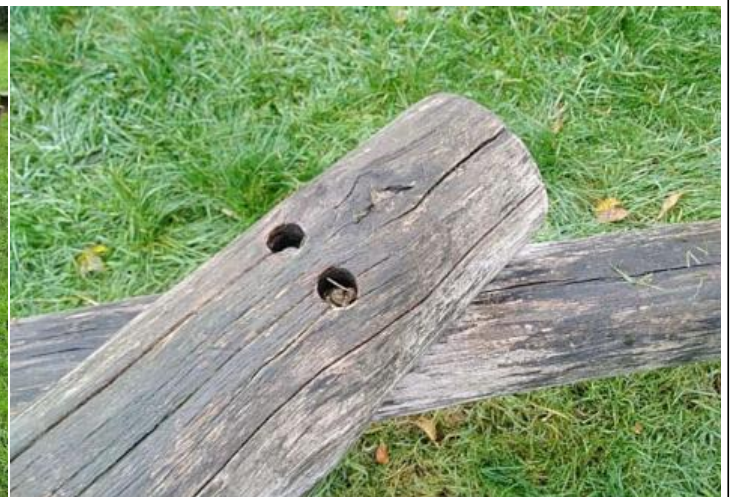
Finding: There is/are several inserts missing

Action: Replace missing inserts

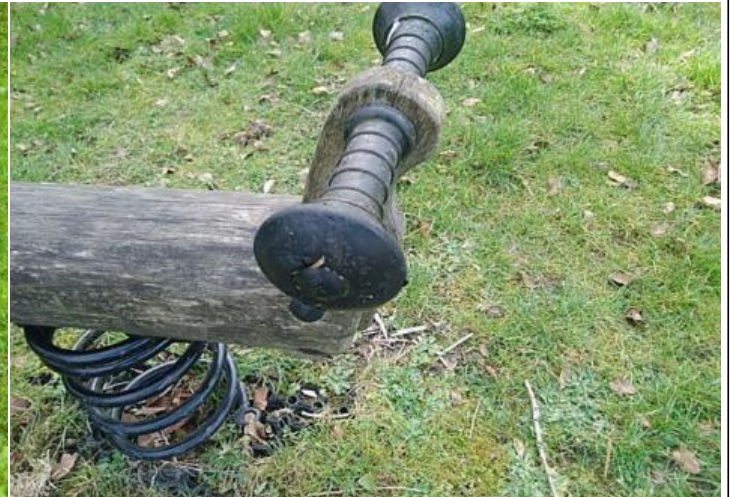
Finding: There is some minor damage to the hand grips

Action: Monitor for any further deterioration and replace as required

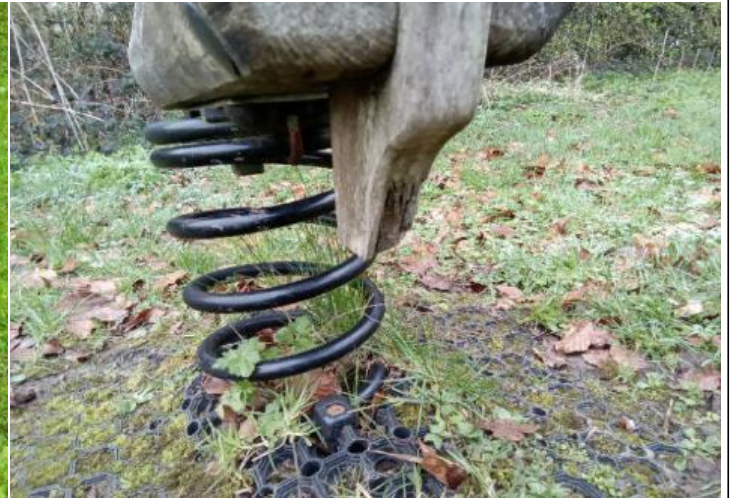
Finding: The item has been damaged

Action: Monitor for any further deterioration and replace as required
