the **play** inspection company

Operational Inspection

Nashmills Parish Council

Bunkers Lane Play Area

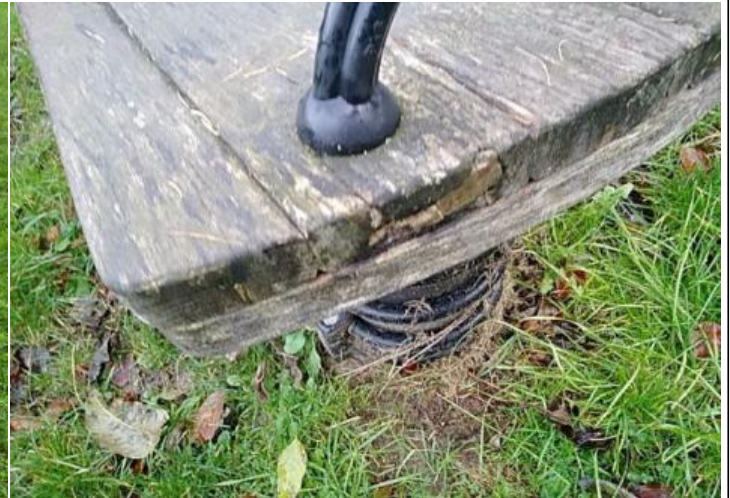
Finding: The use of synthetic fillers in timber is not recommended; timber being a natural material will expand and contract as the moisture content changes and the use of fillers can exacerbate the length and depth of these cracks or shakes in the timber. The only treatment that is normally required is the removal of any rough or sharp edges unless the structural integrity of the item is affected.

Action: Remove any rough or sharp edges and monitor timber for any further deterioration

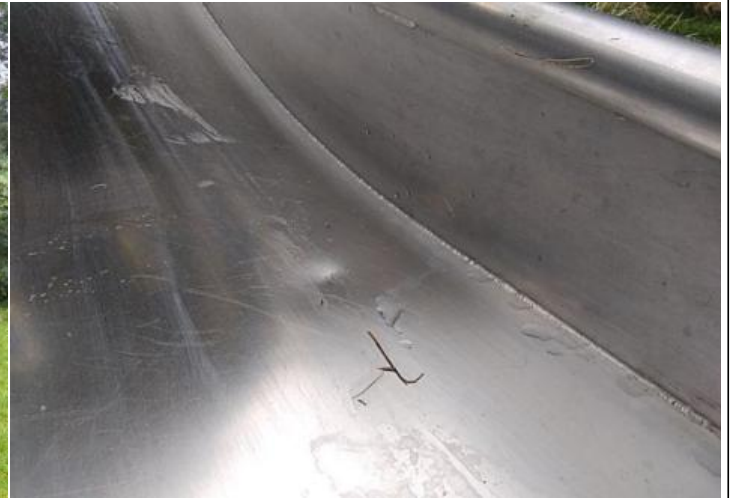
Finding: There are a number of dents in the slide surface

Action: Monitor for any further deterioration and repair as required

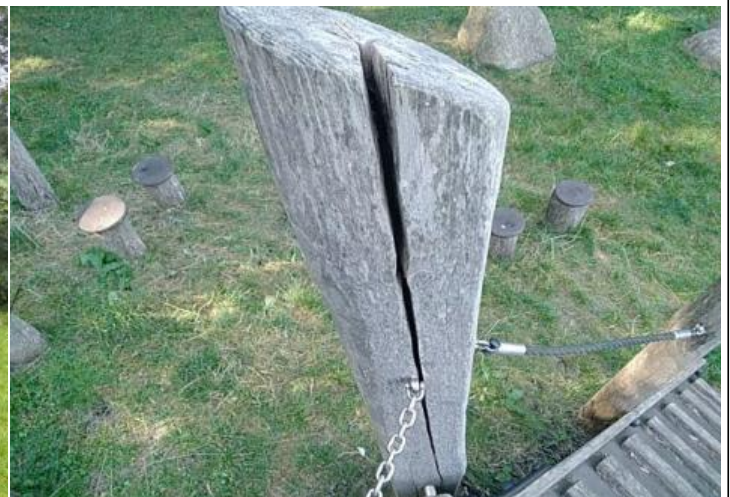
Finding: The timber has a number of splits/shakes or air cracks and this may affect the stability or allow water ingress which will accelerate the rotting process

Action: Monitor to ensure the splits do not cross through fixing points of the structure and/or cause any instability

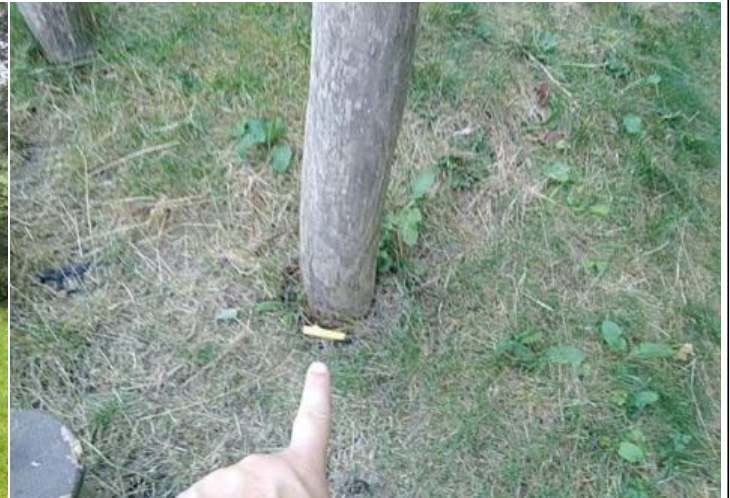
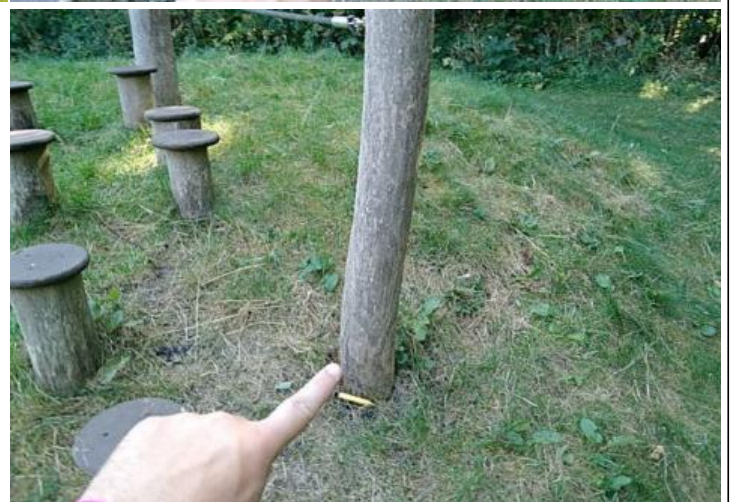
Finding: There is some evidence of rot in the timber

Action: Monitor for any further deterioration and replace as required

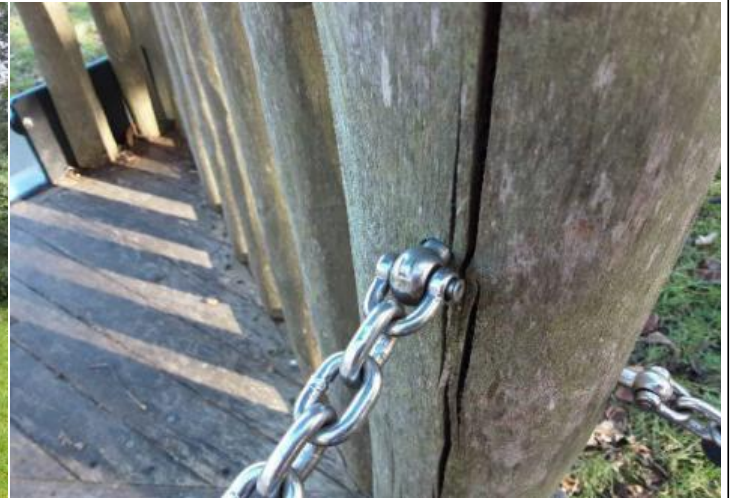
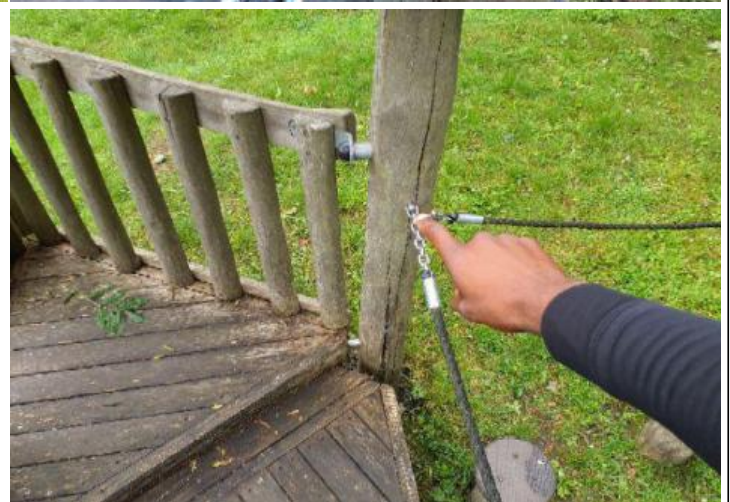
Finding: A number of fixing(s) have worked loose

Action: Secure all loose fixings

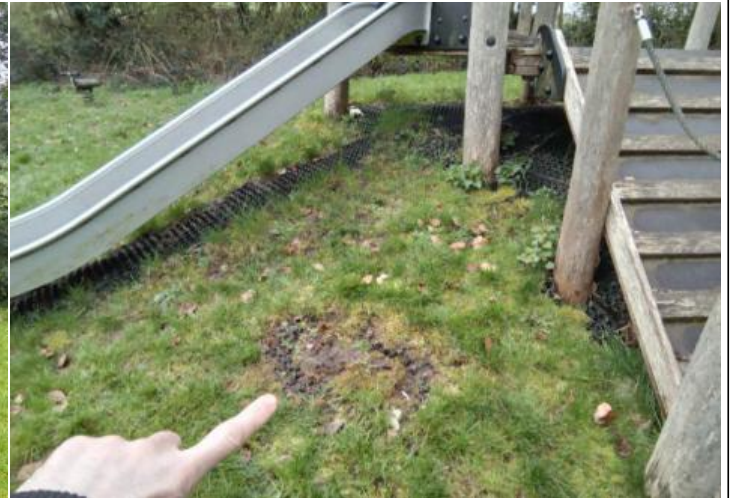
Finding: There is moderate damage to the surface

Action: Replace the damaged areas of surfacing

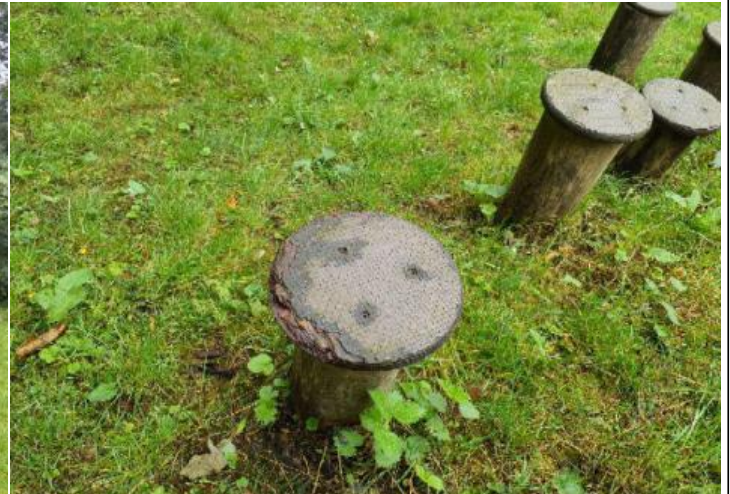
Finding: There are areas or parts of the timber on the structure that have rotted

Action: Replace all affected timbers

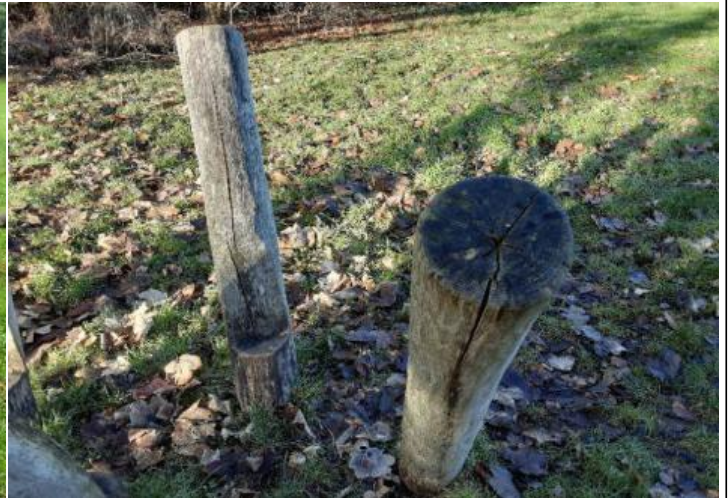
Finding: The timber has a number of splits/shakes or air cracks and this may affect the stability or allow water ingress fixing points of the structure and/or cause any instability which will accelerate the rotting process

Action: Monitor to ensure the splits do not cross through

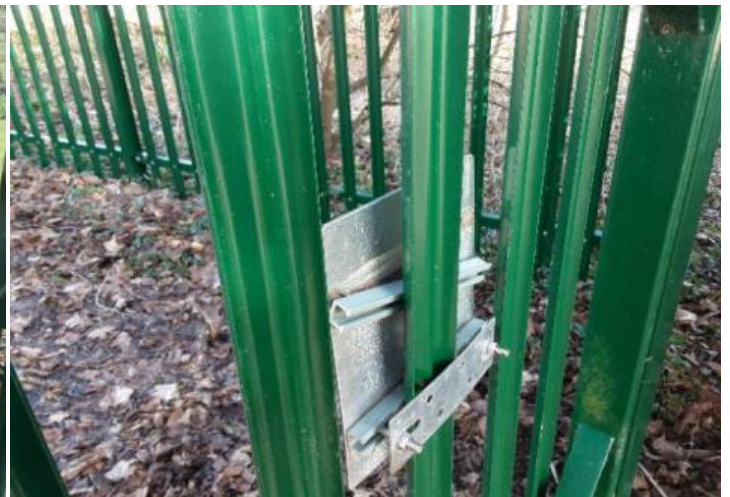
Finding: There is or are fixings missing on the item

Action: Replace all missing fixings

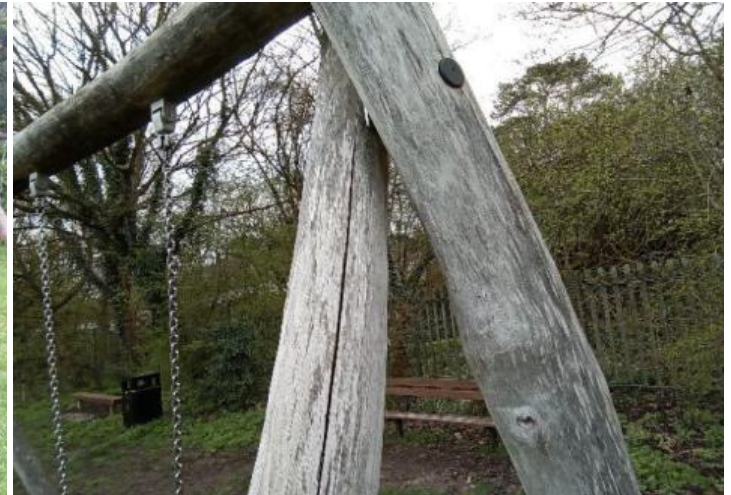
Finding: The timber has a number of splits/shakes or air cracks and this may affect the stability or allow water ingress which will accelerate the rotting process
