Operational Inspection

Nashmills Parish Council

Bunkers Lane Play Area

Bunkers Lane, Hemel Hempstead, Hertfordshire, HP3

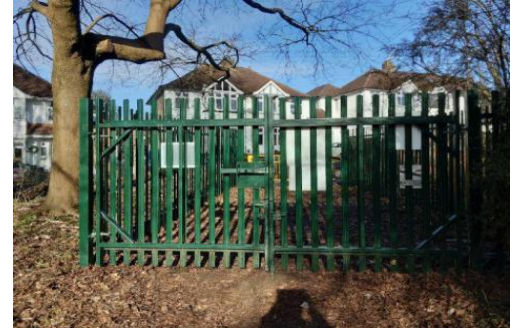
Item: Maintenance Gate
Manufacturer: Not Identified
Surface Type: Bitmac
Item Quantity: 1
Equipment Compliance: N/A
Surface Area Compliance: N/A

The bitumen surface is worn or damaged - Repair the bitumen to provide a uniform surface

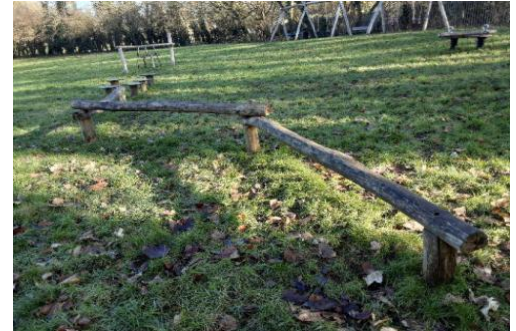
Item: Balance Beam
Manufacturer: Kompan Ltd
Surface Type: Grass
Item Quantity: 1
Equipment Compliance: Yes
Surface Area Compliance: Yes

The use of synthetic fillers in timber is not recommended; timber being a natural material will expand and contract as the moisture content changes and the use of fillers can exacerbate the length and depth of these cracks or shakes in the timber. The only treatment that is normally required is the removal of any rough or sharp edges unless the structural integrity of the item is affected. - Remove any rough or sharp edges and monitor timber for any further deterioration

There is some evidence of rot in the timber - Monitor for any further deterioration and replace as required

The timber has a number of splits/shakes or air cracks and this may affect the stability or allow water ingress which will accelerate the rotting process - Monitor to ensure the splits do not cross through fixing points of the structure and/or cause any instability

There is some strimmer / machinery damage apparent on the posts, this can penetrate the preservative applied to the timber and accelerate the rotting process - Monitor for any deterioration (rot) and replace as required

There is/are bolt cap covers missing or damaged on the item - Replace missing or damaged bolt cap covers

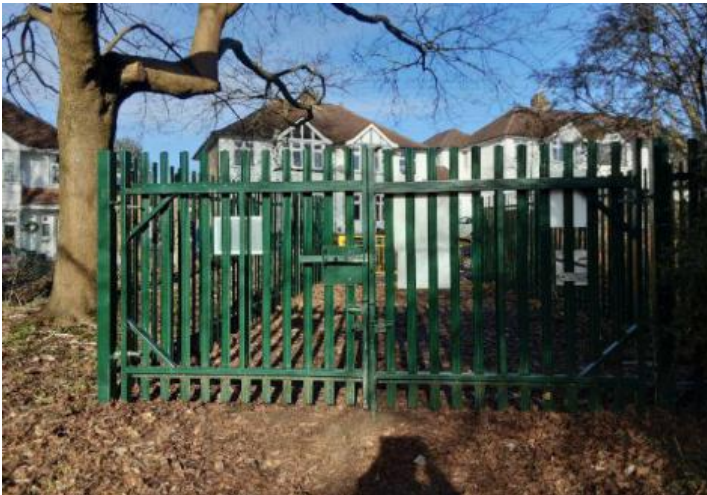
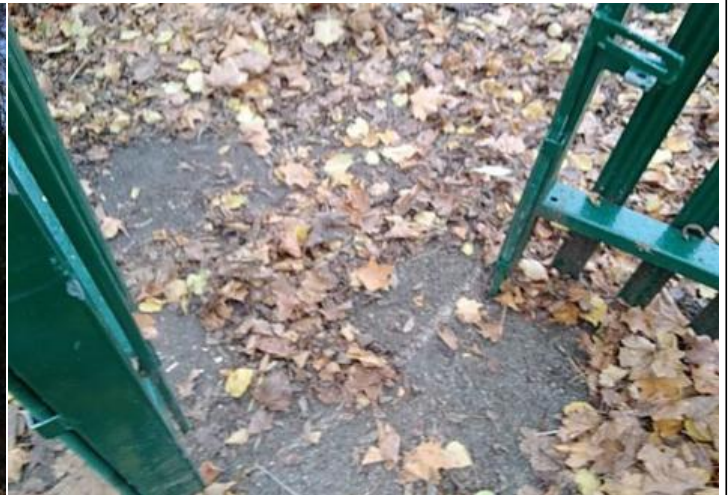
Item: Gates - Maintenance Gate
Manufacturer: Not Identified

Finding: The gate has no drop bolt sleeves and/or drop bolts fitted

Action: Provide drop bolt sleeves and/or drop bolts

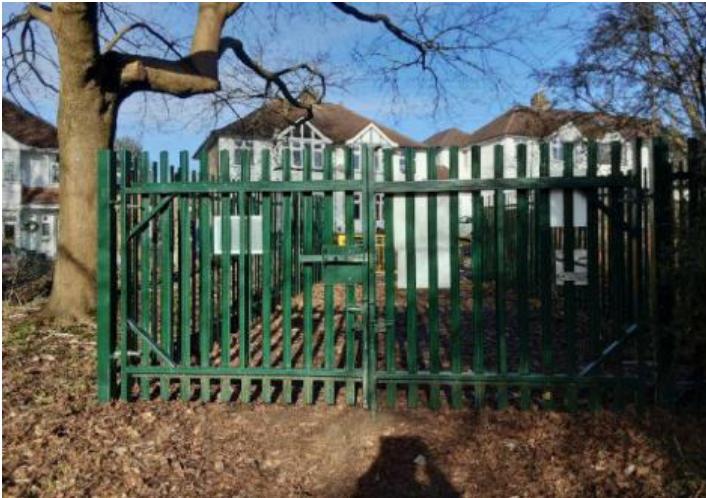
Item: Gates - Maintenance Gate
Manufacturer: Not Identified

Finding: There is no padlock on the maintenance gate

Action: Provide a padlock to secure the gate

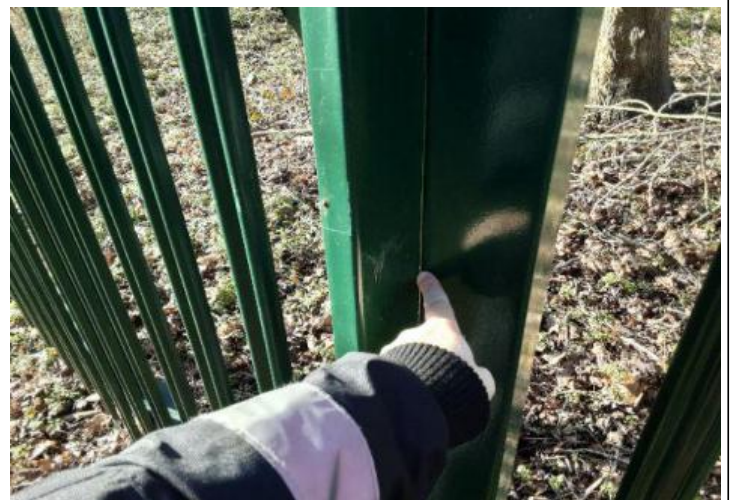
Item: Gates - Maintenance Gate
Manufacturer: Not Identified

Finding: There are openings that are less than 12mm that could trap or crush fingers

Action: Provide a 12mm gap throughout full range of motion at both sides of gate

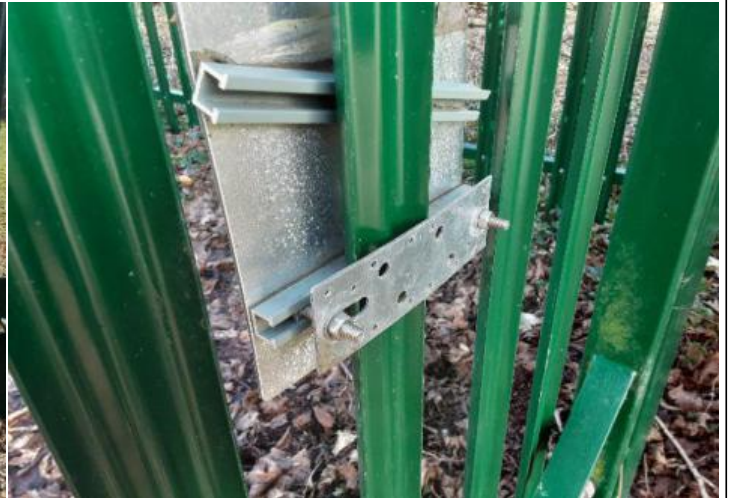
Item: Ancillary Items - Sign
Manufacturer: Owner/Operator

Finding: There are projecting bolt thread(s) present

Action: Remove excess thread length and deburr or provide cap

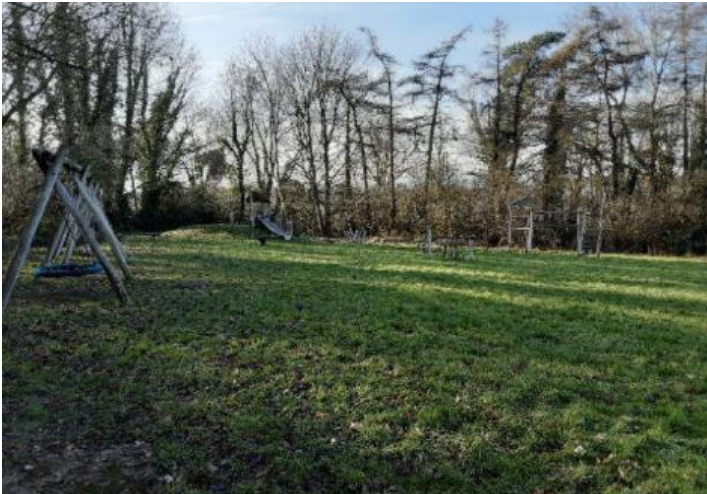
Item: Ancillary Items - Site General
Manufacturer: Owner/Operator

Finding: There is algae, silt or moss growth on the pathway surface resulting in slippery conditions

Action: Clean and treat appropriately

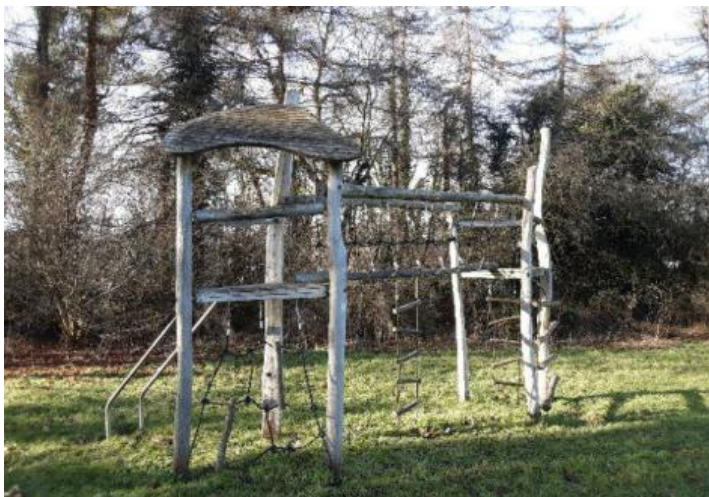
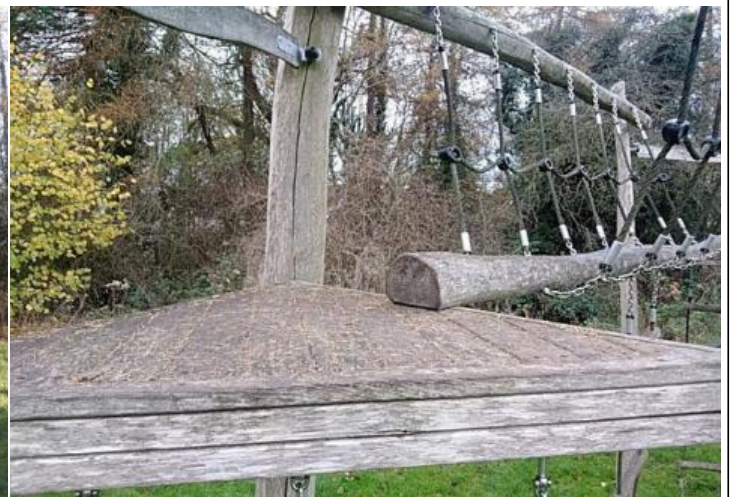
Item: Activity Equipment - Climbing Frame
Manufacturer: Kompan Ltd

Finding: There is algae or moss on the surface of the equipment

Action: Clean and treat appropriately

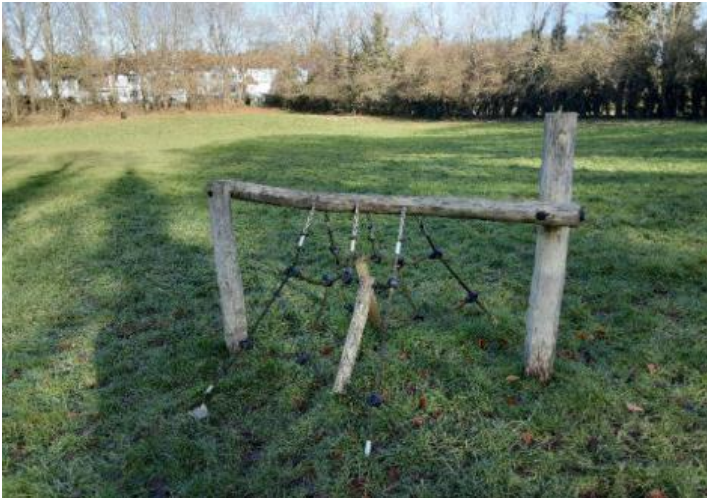
Item: Activity Equipment - A Frame Climber
Manufacturer: Kompan Ltd

Finding: The timber has a number of splits/shakes or air cracks and this may affect the stability or allow water ingress which will accelerate the rotting process

Action: Monitor to ensure the splits do not cross through fixing points of the structure and/or cause any instability

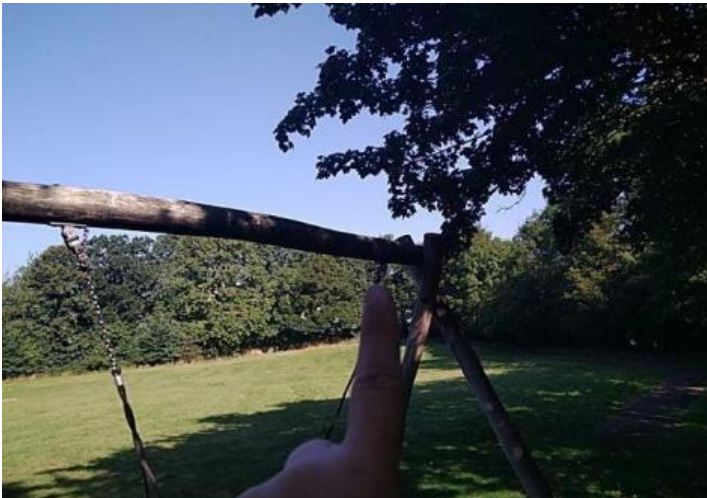
Item: Swings - 2 Bay 2 Flat 1 Basket Seat
Manufacturer: Kompan Ltd

Finding: A number of fixing(s) have worked loose on the secondary safety chain

Action: Secure all loose fixings

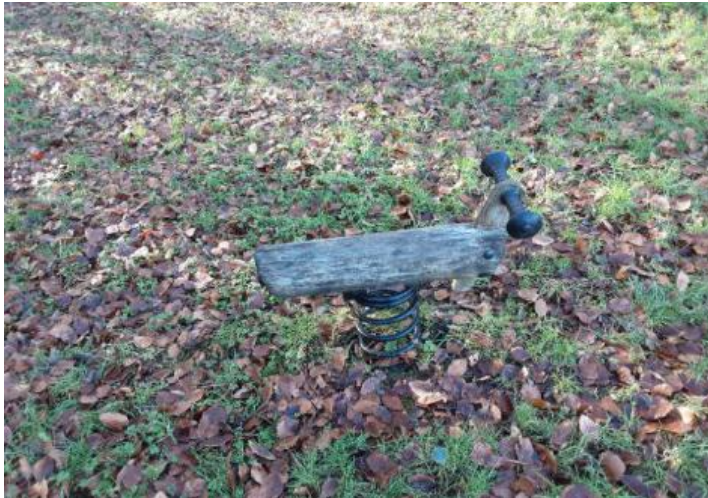
Item: Rocking Equipment - Misc Springer
Manufacturer: Kompan Ltd

There is some minor damage to the hand grips - Monitor for any further deterioration and replace as required

Finding: There is some minor damage to the hand grips

Action: Monitor for any further deterioration and replace as required

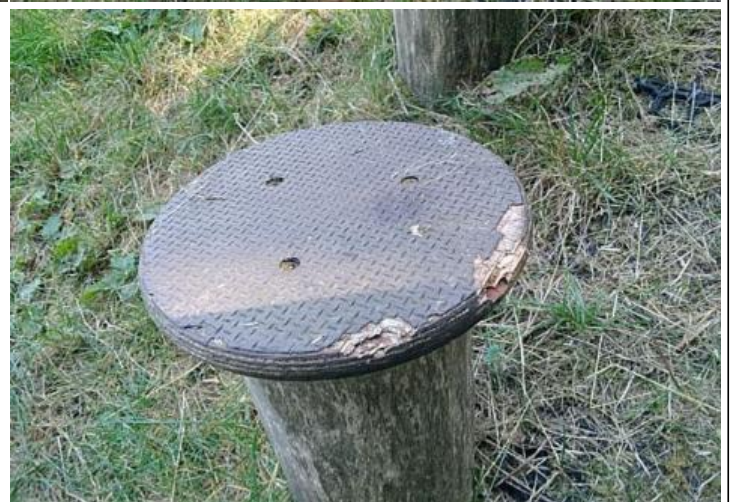
Item: Activity Equipment - Multi Play (Toddler)
Manufacturer: Kompan Ltd

Finding: Parts of the timber are rough or splintered

Action: Remove all rough or sharp edges

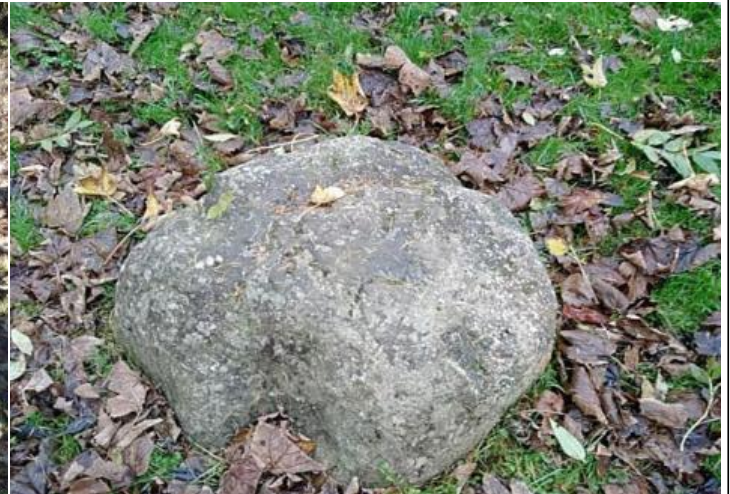
Item: Ancillary Items - Boulders
Manufacturer: Natural Feature

Finding: The rocks and/or boulders have moss/algae growth apparent

Action: Clean and maintain

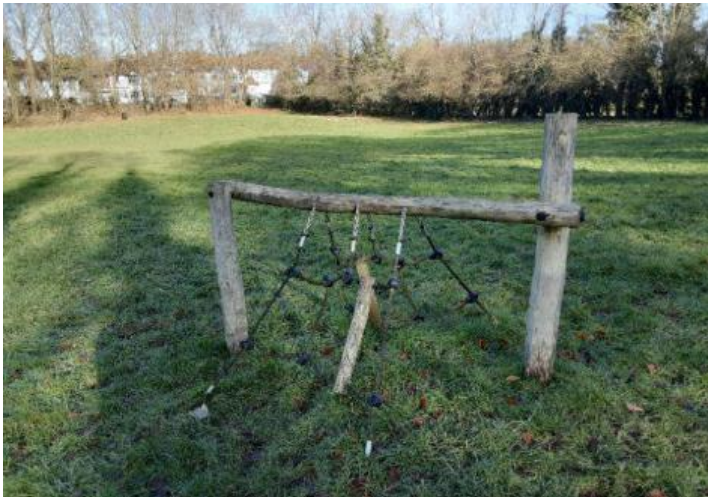
Item: Activity Equipment - A Frame Climber
Manufacturer: Kompan Ltd

Finding: The use of synthetic fillers in timber is not recommended; timber being a natural material will expand and contract as the moisture content changes and the use of fillers can exacerbate the length and depth of these cracks or shakes in the timber. The only treatment that is normally required is the removal of any rough or sharp edges unless the structural integrity of the item is affected.

Action: Remove any rough or sharp edges and monitor timber for any further deterioration

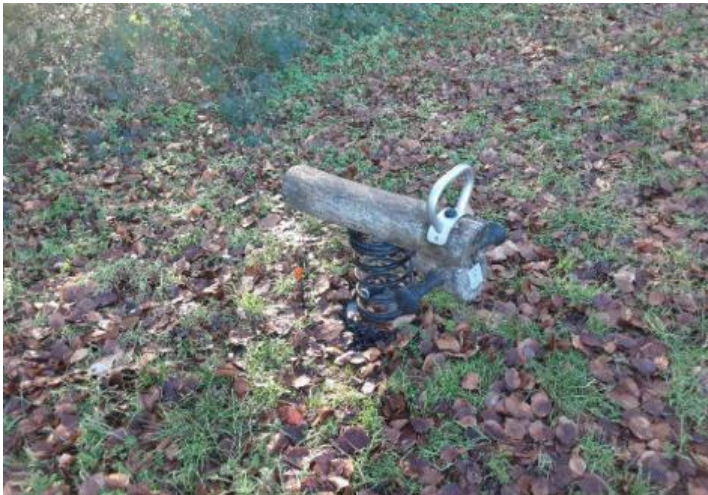
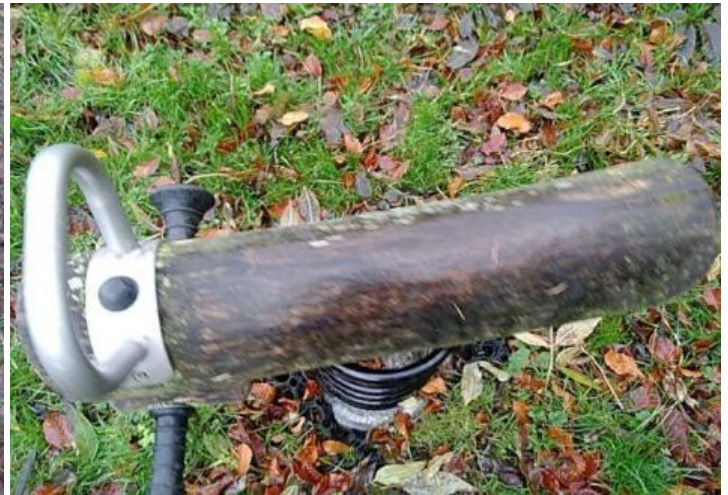
Item: Rocking Equipment - Misc Springer
Manufacturer: Kompan Ltd

Finding: There is algae or moss on the surface of the equipment

Action: Clean and treat appropriately

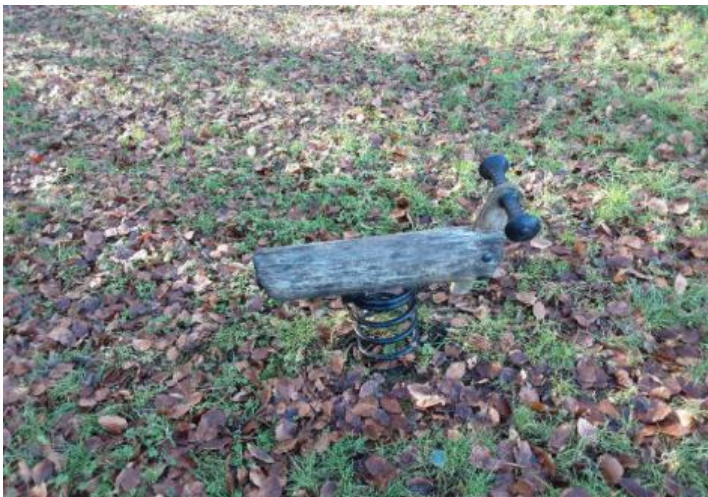
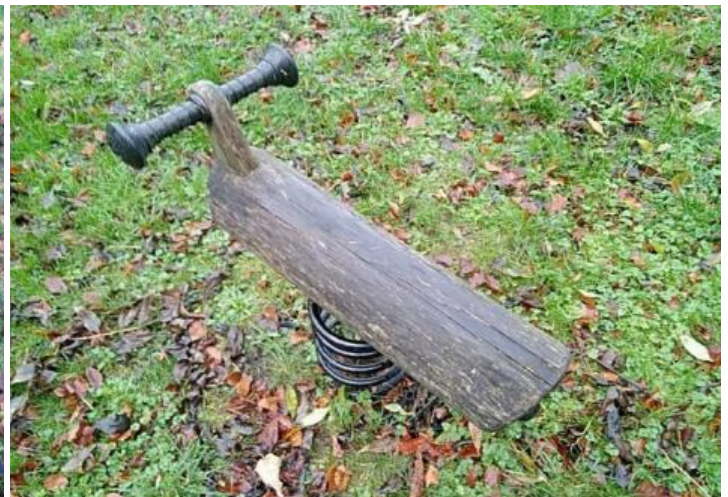
Item: Rocking Equipment - Misc Springer
Manufacturer: Kompan Ltd

Finding: There is algae or moss on the surface of the equipment

Action: Clean and treat appropriately

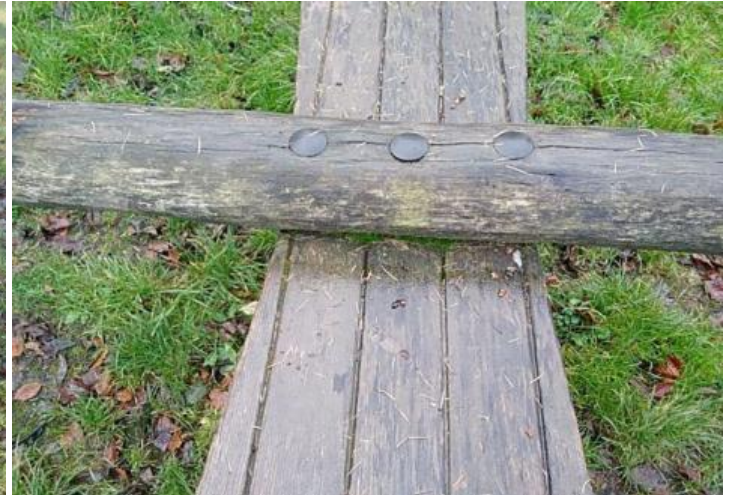
Item: Rocking Equipment - Spring See-Saw
Manufacturer: Kompan Ltd

Finding: There is algae or moss on the surface of the equipment

Action: Clean and treat appropriately

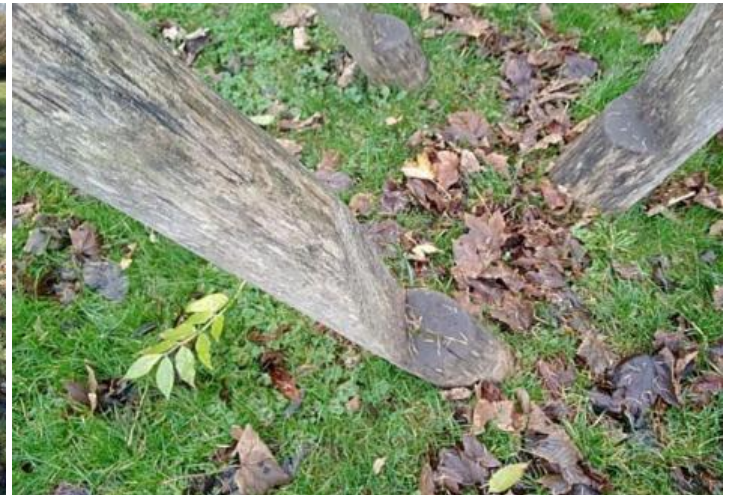
Item: Activity Equipment - Stilts
Manufacturer: Kompan Ltd

Finding: There is algae or moss on the surface of the equipment

Action: Clean and treat appropriately

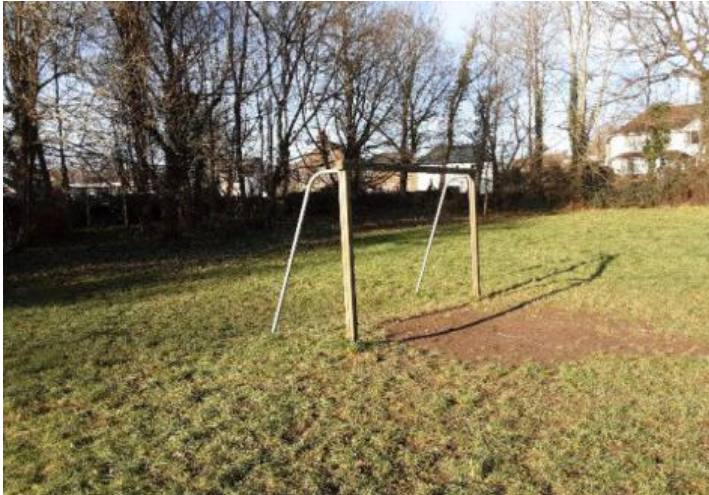
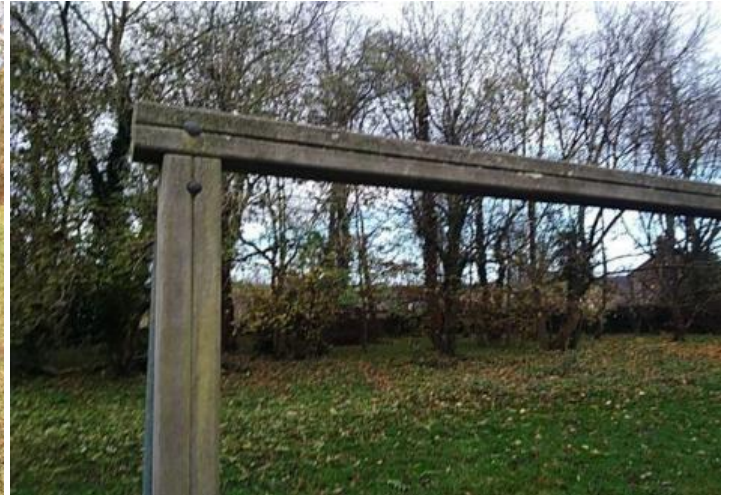
Item: Multi Use Games Area - Football Goal
Manufacturer: Kompan Ltd

Finding: There is algae or moss on the surface of the equipment

Action: Clean and treat appropriately
