# NASH MILLS

## PARISH COUNCIL

### Clerk Report April 2023

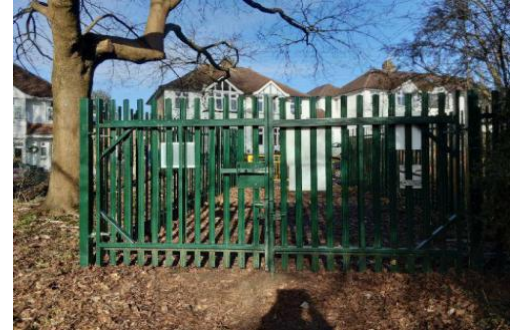
**Item:** Maintenance Gate  
**Manufacturer:** Not Identified  
**Surface Type:** Bitmac  
**Item Quantity:** 1  
**Equipment Compliance:** N/A  
**Surface Area Compliance:** N/A

The bitumen surface is worn or damaged - Repair the bitumen to provide a uniform surface

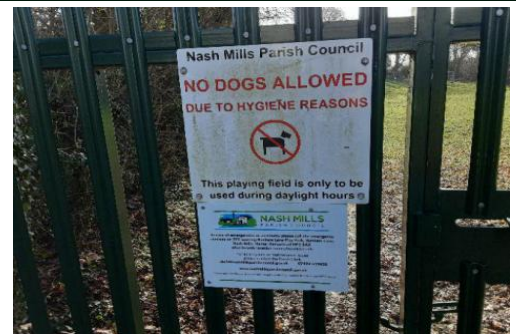
**Item:** Sign  
**Manufacturer:** Owner/Operator  
**Surface Type:** N/A  
**Item Quantity:** 1  
**Equipment Compliance:** N/A  
**Surface Area Compliance:** N/A

There are projecting nail / screw ends present - Remove and provide more appropriate fixings if required

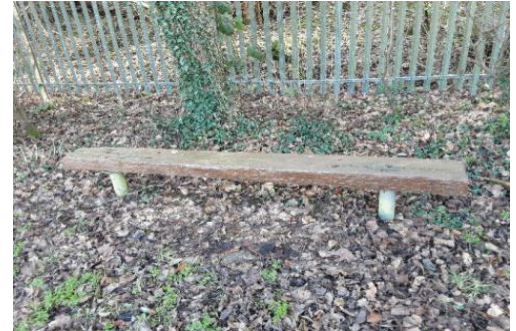
**Item:** Bench  
**Manufacturer:** Not Identified  
**Surface Type:** Concrete  
**Item Quantity:** 1  
**Equipment Compliance:** N/A  
**Surface Area Compliance:** N/A

There are projecting bolt thread(s) present - Remove excess thread length and deburr or provide cap

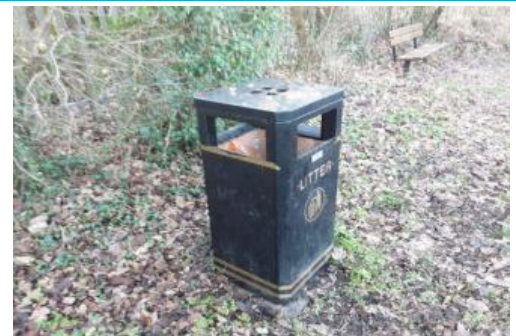
**Item:** Litter Bin  
**Manufacturer:** Not Identified  
**Surface Type:** Grass  
**Item Quantity:** 1  
**Equipment Compliance:** N/A  
**Surface Area Compliance:** N/A

This item is satisfactory - no work required -

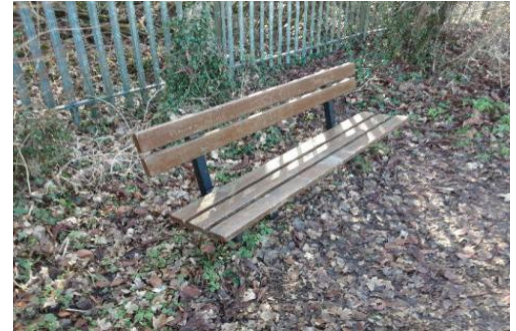
**Item:** Bench  
**Manufacturer:** Not Identified  
**Surface Type:** Grass  
**Item Quantity:** 1  
**Equipment Compliance:** N/A  
**Surface Area Compliance:** N/A

The surface has eroded in some areas - Reinststate the surface

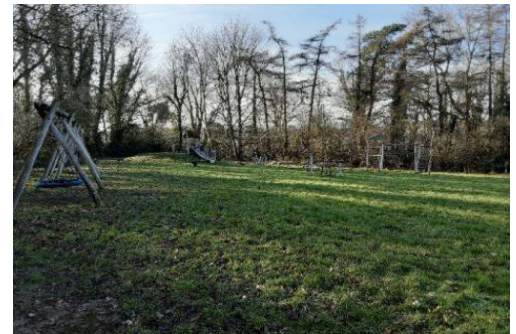
**Item:** Site General  
**Manufacturer:** Owner/Operator  
**Surface Type:** N/A  
**Item Quantity:** 1  
**Equipment Compliance:** N/A  
**Surface Area Compliance:** N/A

There is weed / vegetation growth on, between, or around the edges of the surfacing - Remove weed / vegetation growth

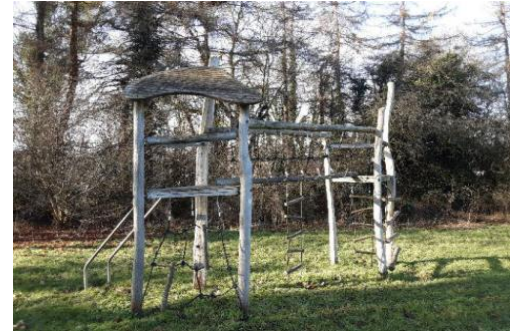
**Item:** Climbing Frame  
**Manufacturer:** Kompan Ltd  
**Surface Type:** Grass Matrix Tiles  
**Item Quantity:** 1  
**Equipment Compliance:** N/A  
**Surface Area Compliance:** N/A

A fixing appears to have been unscrewed - Secure correctly

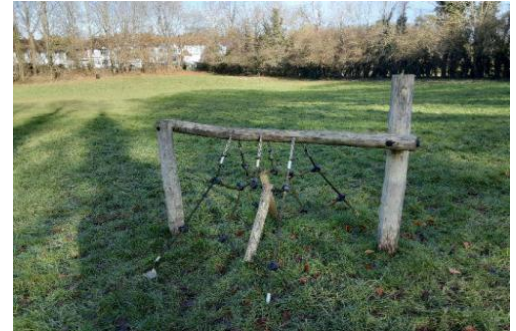
**Item:** A Frame Climber  
**Manufacturer:** Kompan Ltd  
**Surface Type:** Mixed Surface  
**Item Quantity:** 1  
**Equipment Compliance:** N/A  
**Surface Area Compliance:** N/A

The timber has a number of splits/shakes or air cracks and this may affect the stability or allow water ingress which will accelerate the rotting process - Monitor to ensure the splits do not cross through fixing points of the structure and/or cause any instability

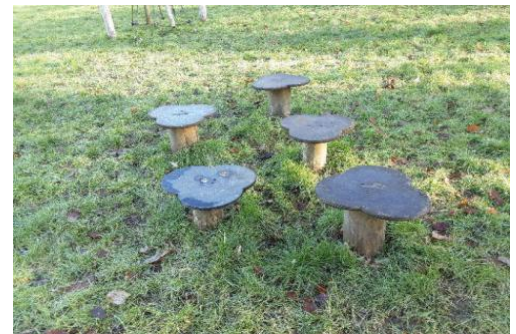
**Item:** Log Walk  
**Manufacturer:** Kompan Ltd  
**Surface Type:** Grass  
**Item Quantity:** 1  
**Equipment Compliance:** Yes  
**Surface Area Compliance:** Yes

The platforms are rotting and the fixings are pulling through - Replace all affected timber

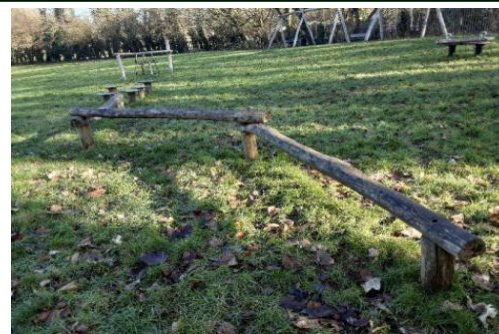
**Item:** Balance Beam  
**Manufacturer:** Kompan Ltd  
**Surface Type:** Grass  
**Item Quantity:** 1  
**Equipment Compliance:** Yes  
**Surface Area Compliance:** Yes

The use of synthetic fillers in timber is not recommended; timber being a natural material will expand and contract as the moisture content changes and the use of fillers can exacerbate the length and depth of these cracks or shakes in the timber. The only treatment that is normally required is the removal of any rough or sharp edges unless the structural integrity of the item is affected. - Remove any rough or sharp edges and monitor timber for any further deterioration

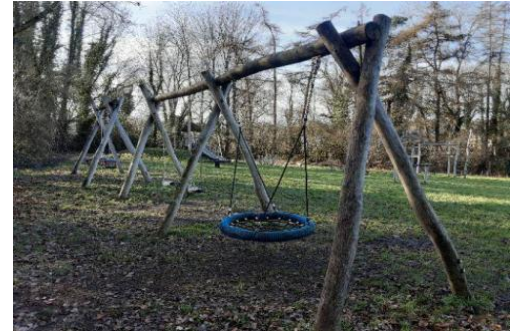
**Item:** 2 Bay 2 Flat 1 Basket Seat  
**Manufacturer:** Kompan Ltd  
**Surface Type:** Grass Matrix Tiles  
**Item Quantity:** 1  
**Equipment Compliance:** No  
**Surface Area Compliance:** Yes

The seat has minor damage or wear - Monitor for any further deterioration and replace as required

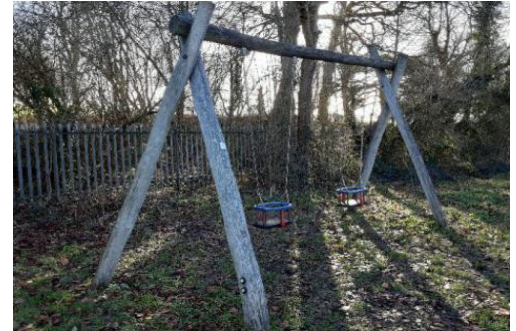
**Item:** 1 Bay 2 Seat (Cradle)  
**Manufacturer:** Kompan Ltd  
**Surface Type:** Grass Matrix Tiles  
**Item Quantity:** 1  
**Equipment Compliance:** Yes  
**Surface Area Compliance:** Yes

The timber has a number of splits/shakes or air cracks and this may affect the stability or allow water ingress which will accelerate the rotting process - Monitor to ensure the splits do not cross through fixing points of the structure and/or cause any instability

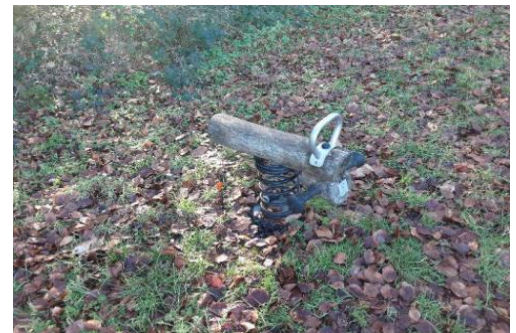
**Item:** Misc Springer  
**Manufacturer:** Kompan Ltd  
**Surface Type:** Grass Matrix Tiles  
**Item Quantity:** 1  
**Equipment Compliance:** Yes  
**Surface Area Compliance:** Yes

This item is satisfactory - no work required -

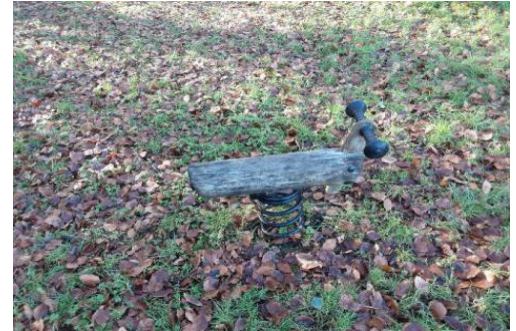
**Item:** Misc Springer  
**Manufacturer:** Kompan Ltd  
**Surface Type:** Grass Matrix Tiles  
**Item Quantity:** 1  
**Equipment Compliance:** Yes  
**Surface Area Compliance:** Yes

Parts of the timber are rough or splintered - Remove all rough or sharp edges

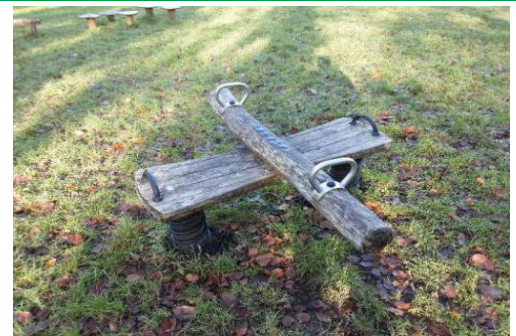
**Item:** Spring See-Saw  
**Manufacturer:** Kompan Ltd  
**Surface Type:** Grass Matrix Tiles  
**Item Quantity:** 1  
**Equipment Compliance:** Yes  
**Surface Area Compliance:** Yes

The use of synthetic fillers in timber is not recommended; timber being a natural material will expand and contract as the moisture content changes and the use of fillers can exacerbate the length and depth of these cracks or shakes in the timber. The only treatment that is normally required is the removal of any rough or sharp edges unless the structural integrity of the item is affected. - Remove any rough or sharp edges and monitor timber for any further deterioration

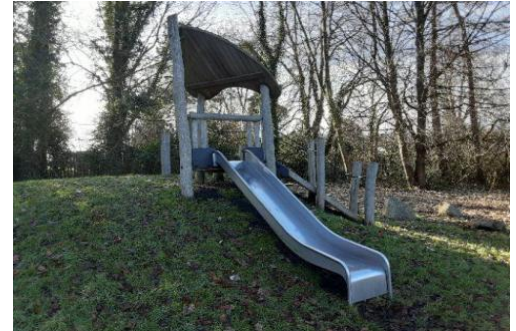
**Item:** Multi Play (Toddler)  
**Manufacturer:** Kompan Ltd  
**Surface Type:** Grass Matrix Tiles  
**Item Quantity:** 1  
**Equipment Compliance:** No  
**Surface Area Compliance:** Yes

There are a number of dents in the slide surface - Monitor for any further deterioration and repair as required

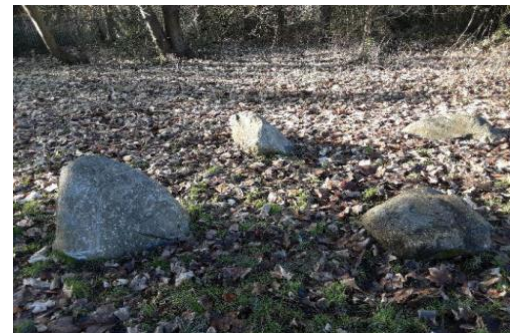
**Item:** Boulders  
**Manufacturer:** Natural Feature  
**Surface Type:** Grass  
**Item Quantity:** 1  
**Equipment Compliance:** N/A  
**Surface Area Compliance:** N/A

The rocks and/or boulders have moss/algae growth apparent - Clean and maintain

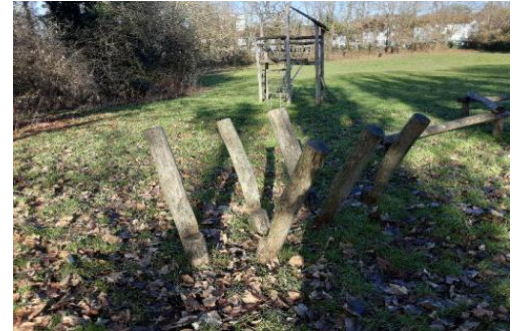
**Item:** Stilts  
**Manufacturer:** Kompan Ltd  
**Surface Type:** Grass  
**Item Quantity:** 1  
**Equipment Compliance:** N/A  
**Surface Area Compliance:** N/A

The timber has a number of splits/shakes or air cracks and this may affect the stability or allow water ingress which will accelerate the rotting process - Monitor to ensure the splits do not cross through fixing points of the structure and/or cause any instability

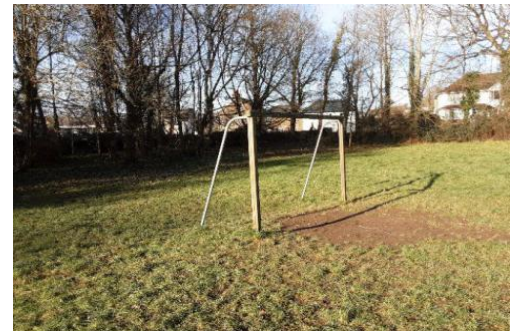
**Item:** Football Goal  
**Manufacturer:** Kompan Ltd  
**Surface Type:** Grass  
**Item Quantity:** 1  
**Equipment Compliance:** N/A  
**Surface Area Compliance:** N/A

The surface has eroded in some areas - Reinstate the surface

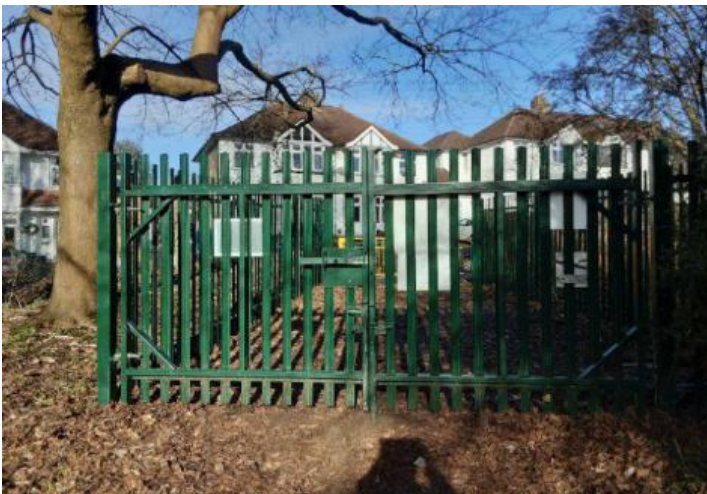
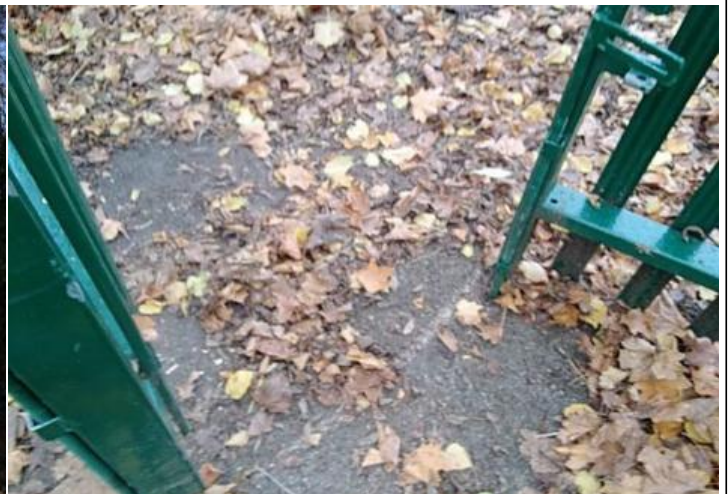
**Item:** Gates - Maintenance Gate  
**Manufacturer:** Not Identified

**Risk Level:** L - Low Risk  
**Surface:** Bitmac

**Finding:** The gate has no drop bolt sleeves and/or drop bolts fitted

**Action:** Provide drop bolt sleeves and/or drop bolts

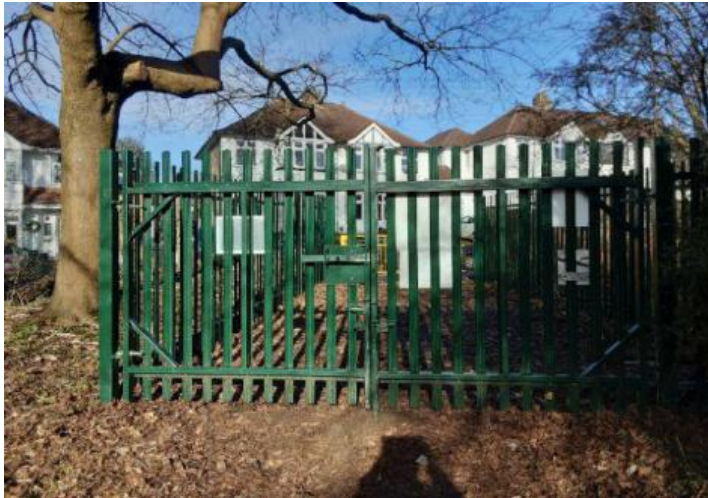
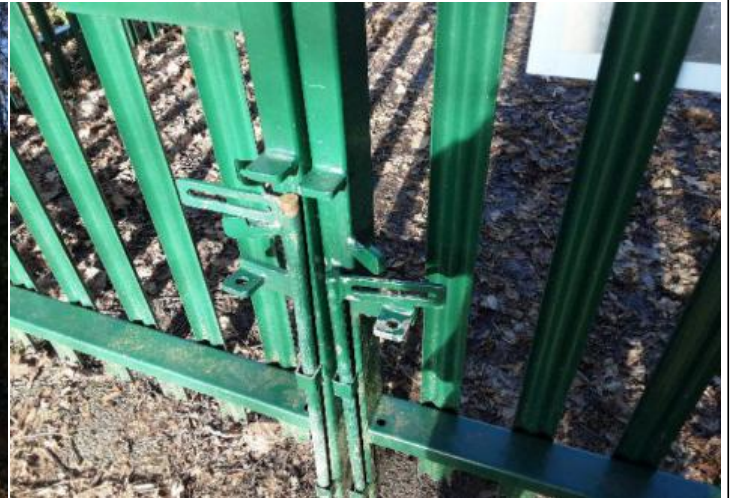
**Item:** Gates - Maintenance Gate  
**Manufacturer:** Not Identified

**Risk Level:** L - Low Risk  
**Surface:** Bitmac

**Finding:** There is no padlock on the maintenance gate

**Action:** Provide a padlock to secure the gate

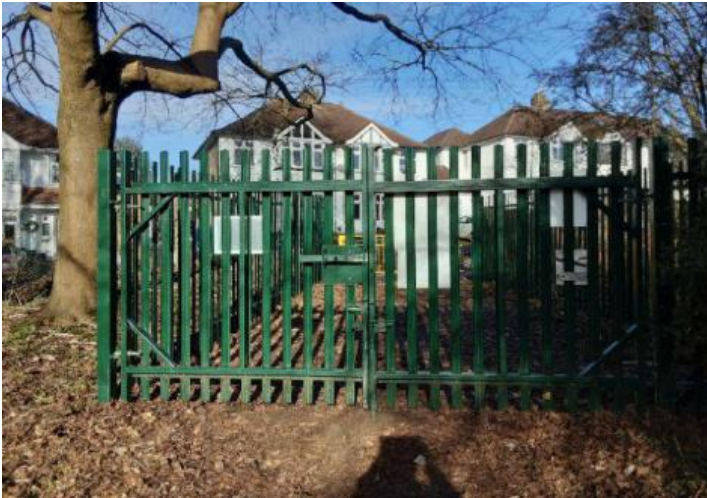
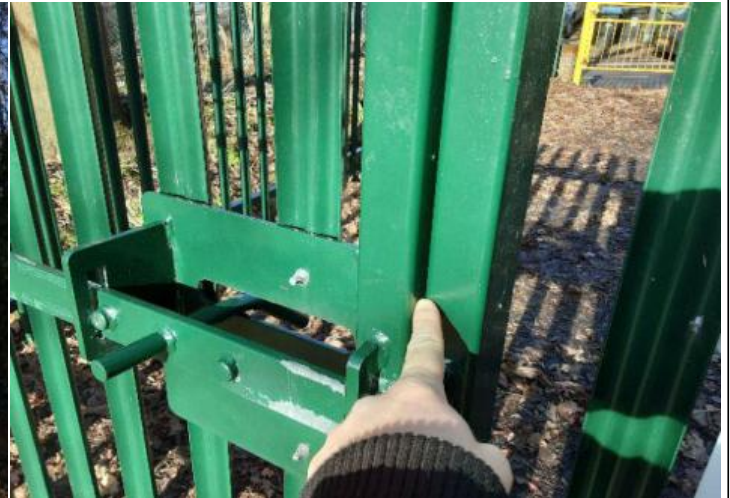
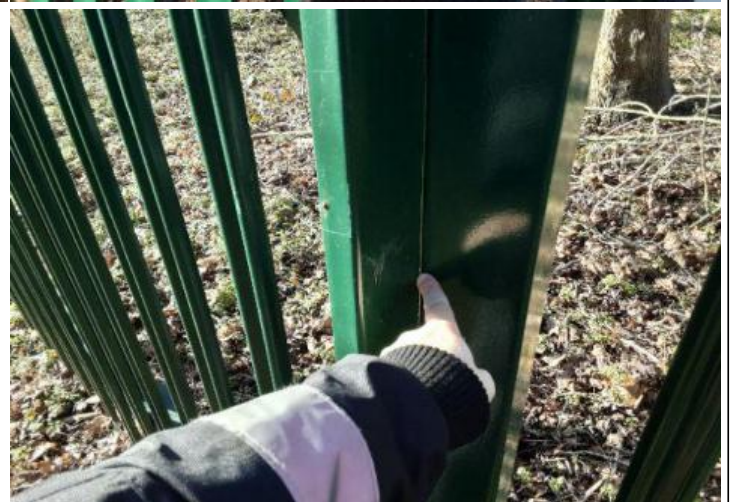
**Item:** Gates - Maintenance Gate  
**Manufacturer:** Not Identified

**Risk Level:** L - Low Risk  
**Surface:** Bitmac

**Finding:** There are openings that are less than 12mm that could trap or crush fingers

**Action:** Provide a 12mm gap throughout full range of motion at both sides of gate

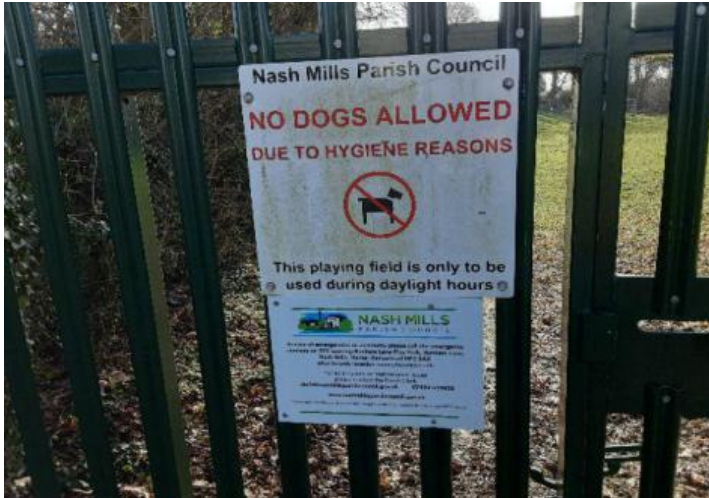
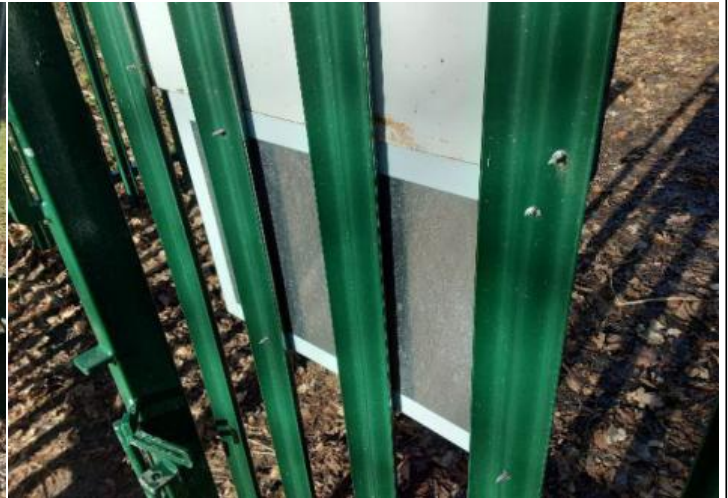
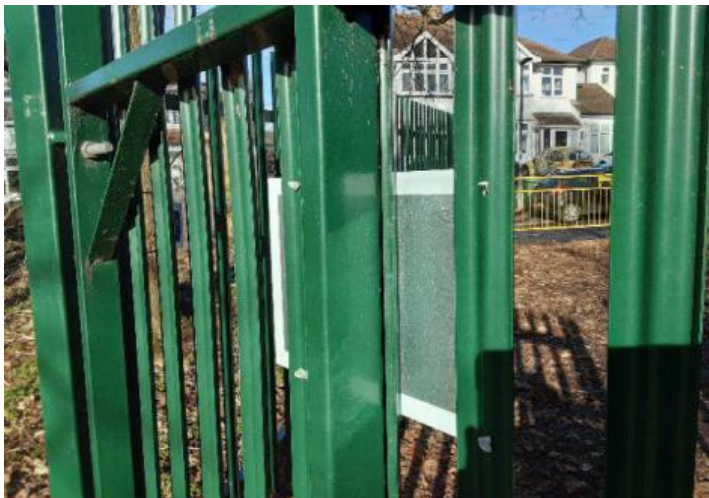
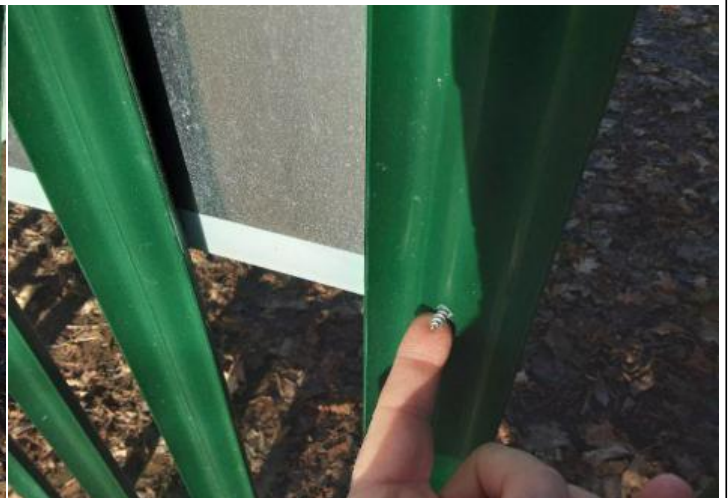
**Item:** Ancillary Items - Sign  
**Manufacturer:** Owner/Operator

**Risk Level:** L - Low Risk  
**Surface:** N/A

**Finding:** There are projecting nail / screw ends present

**Action:** Remove and provide more appropriate fixings if required

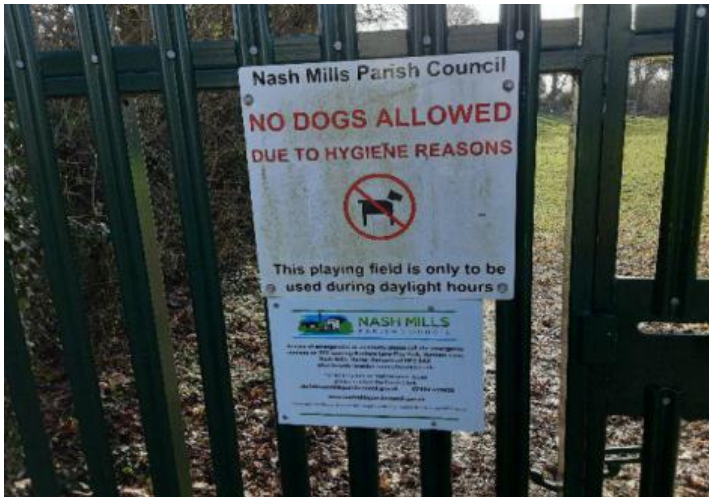
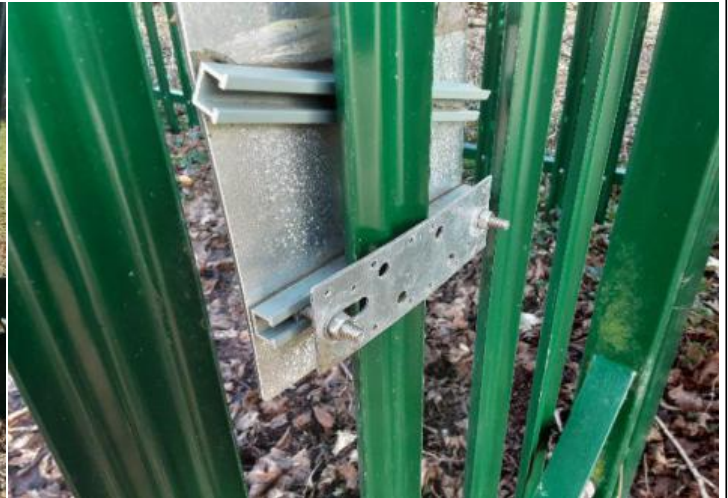
**Item:** Ancillary Items - Sign  
**Manufacturer:** Owner/Operator

**Risk Level:** L - Low Risk  
**Surface:** N/A

**Finding:** There are projecting bolt thread(s) present

**Action:** Remove excess thread length and deburr or provide cap

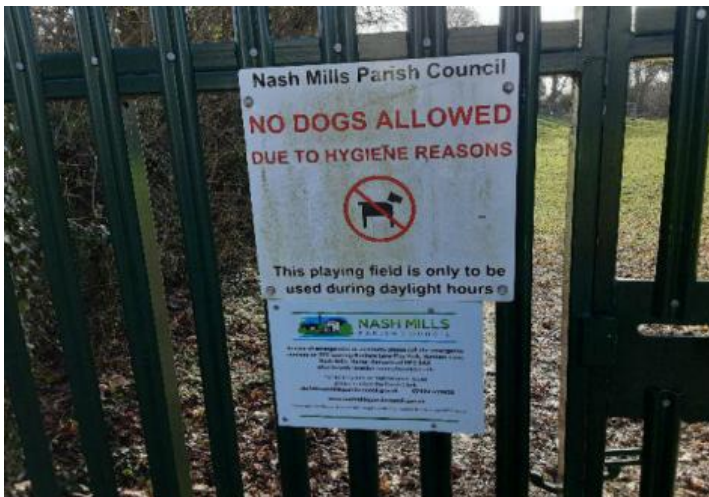
**Item:** Ancillary Items - Sign  
**Manufacturer:** Owner/Operator

**Risk Level:** L - Low Risk  
**Surface:** N/A

**Finding:** There is or are fixings missing on the item

**Action:** Replace all missing fixings

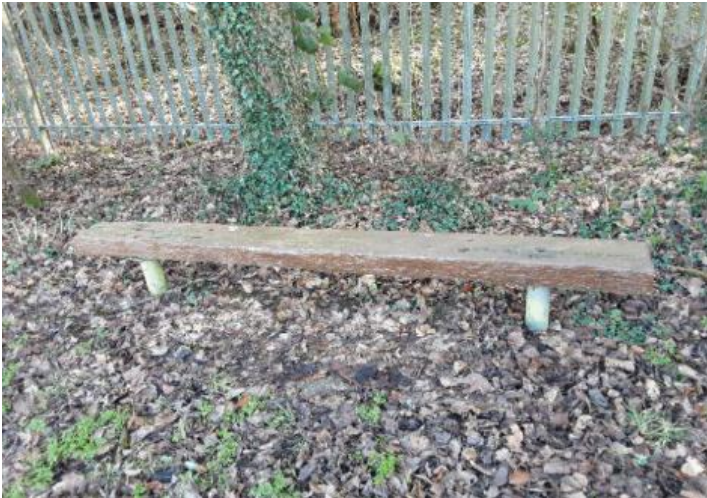
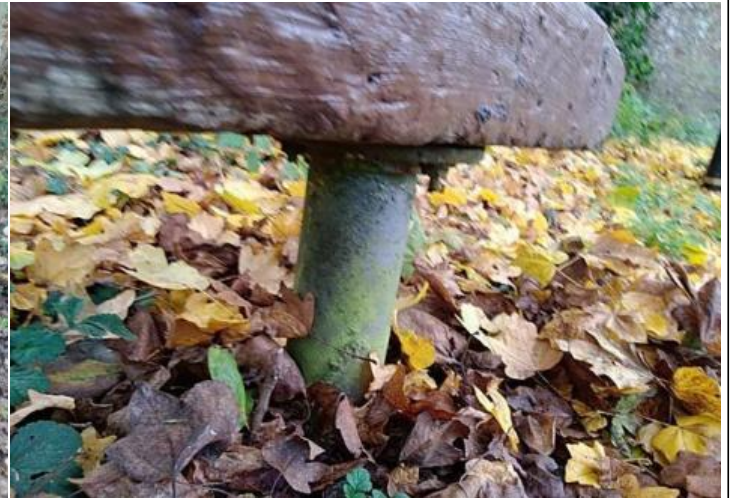
**Item:** Ancillary Items - Bench  
**Manufacturer:** Not Identified

**Risk Level:** L - Low Risk  
**Surface:** Concrete

**Finding:** There are projecting bolt thread(s) present

**Action:** Remove excess thread length and deburr or provide cap

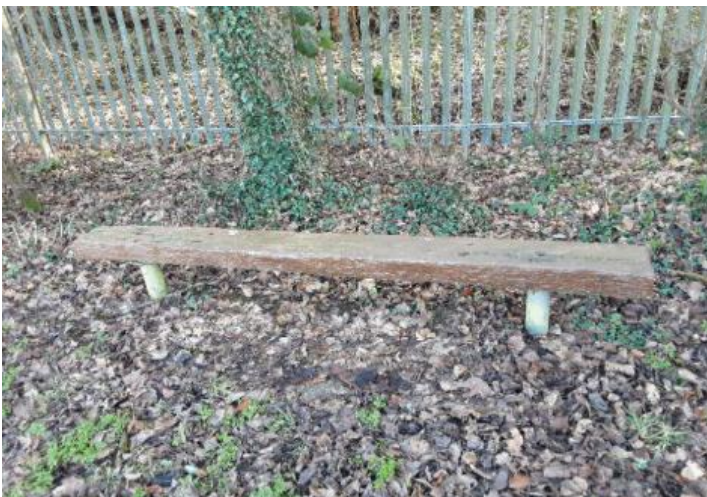
**Item:** Ancillary Items - Bench  
**Manufacturer:** Not Identified

**Risk Level:** L - Low Risk  
**Surface:** Concrete

**Finding:** There is some evidence of rot in the timber

**Action:** Monitor for any further deterioration and replace as required

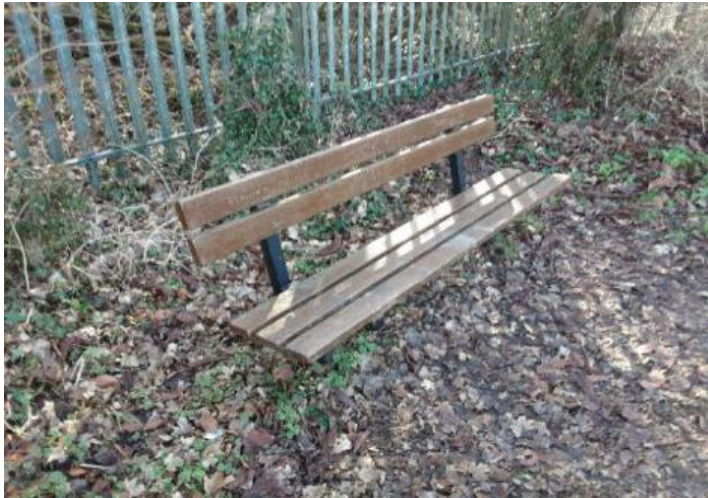
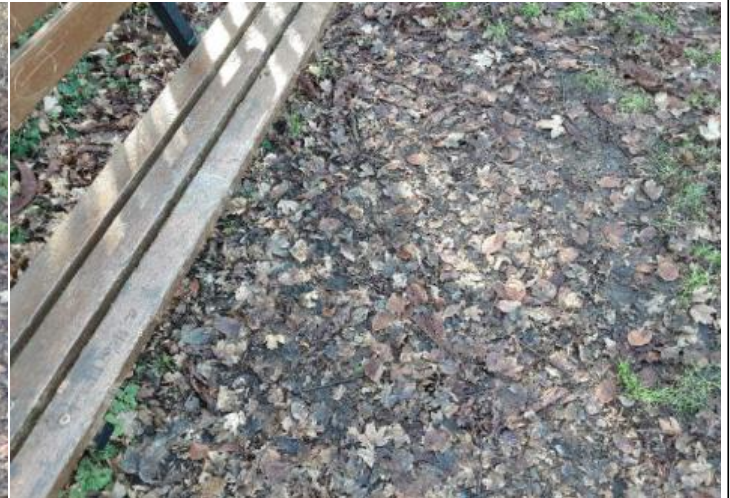
**Finding:** The surface has eroded in some areas

**Action:** Reinststate the surface

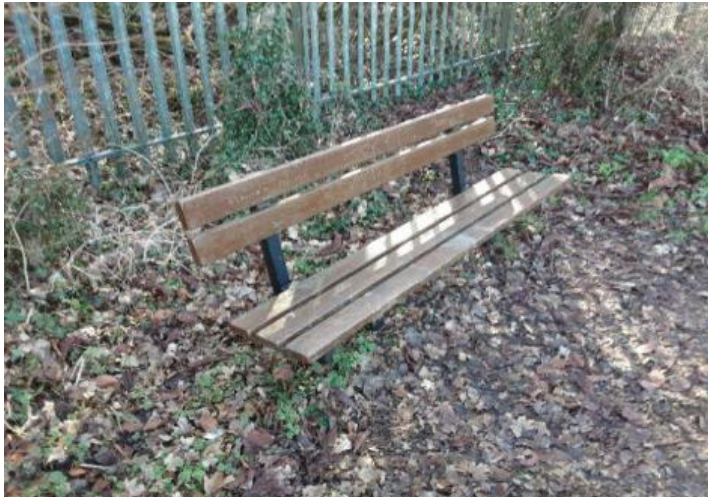
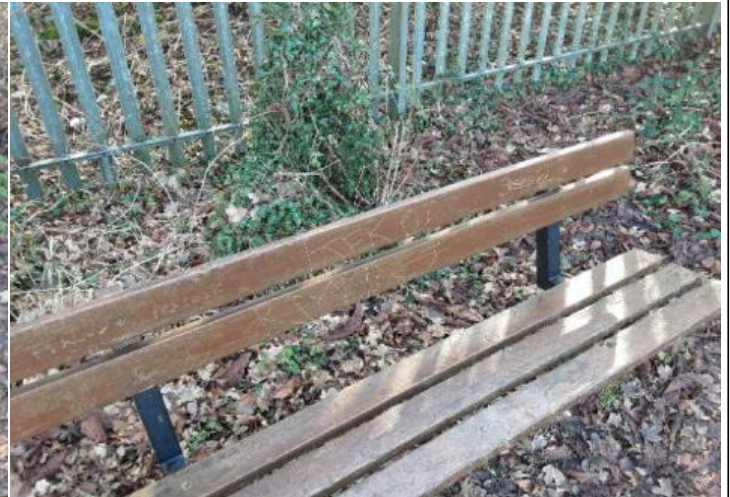
**Finding:** There is offensive graffiti present

**Action:** Remove as soon as practicable

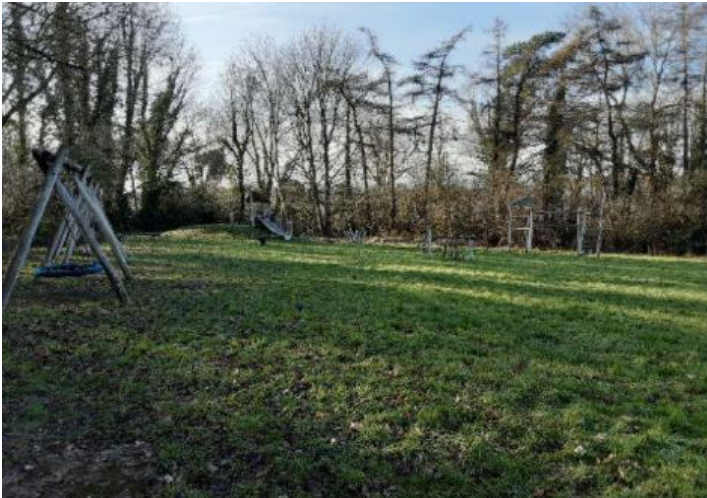
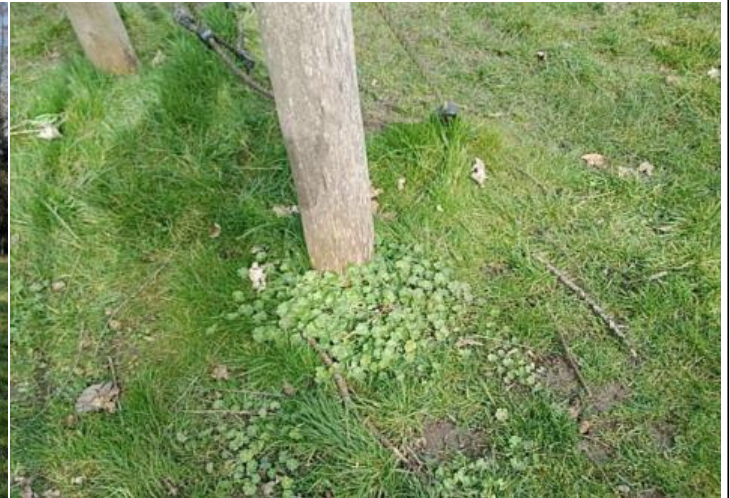
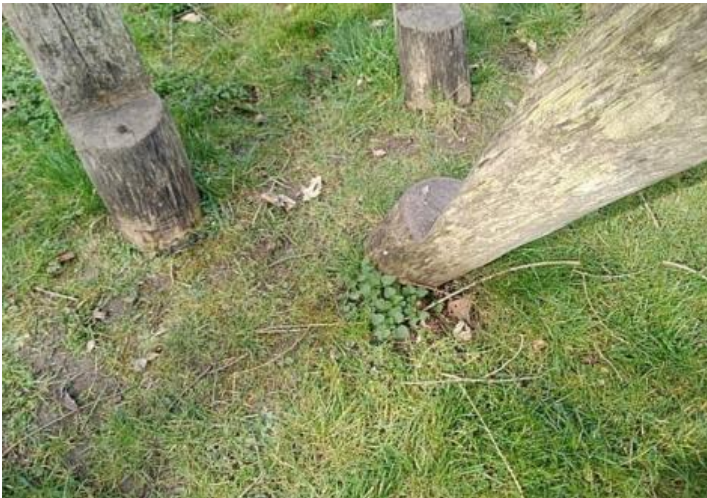
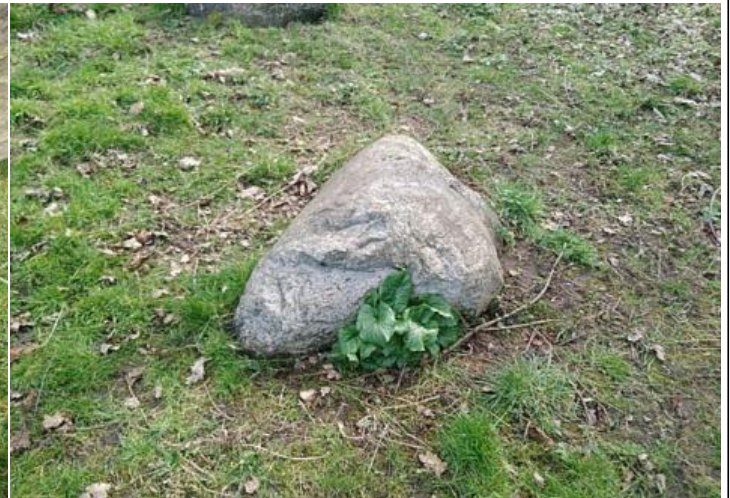
**Finding:** There is weed / vegetation growth on, between, or around the edges of the surfacing  
**Action:** Remove weed / vegetation growth

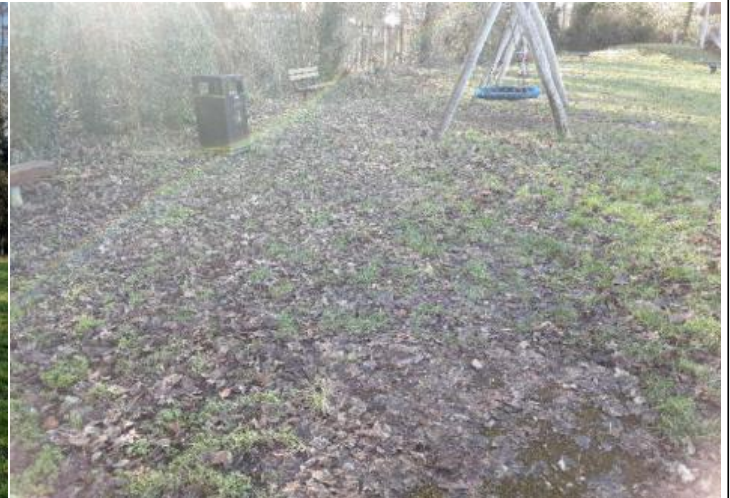
**Finding:** There is some tree debris on the surfacing

**Action:** Remove and maintain

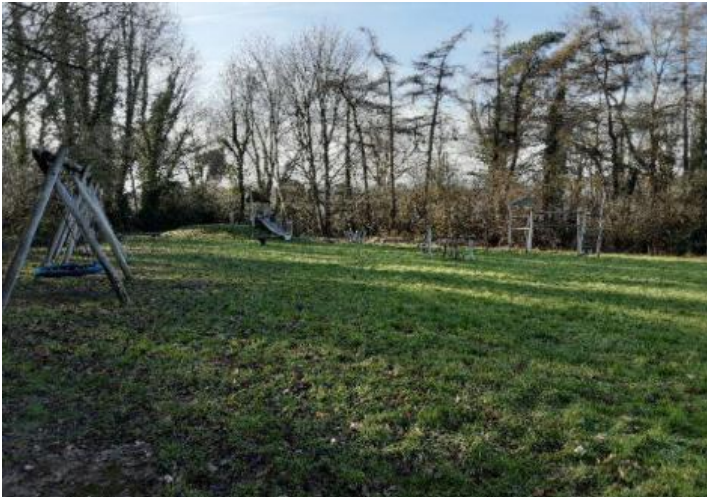
**Finding:** There is algae, silt or moss growth on the pathway surface resulting in slippery conditions

**Action:** Clean and treat appropriately

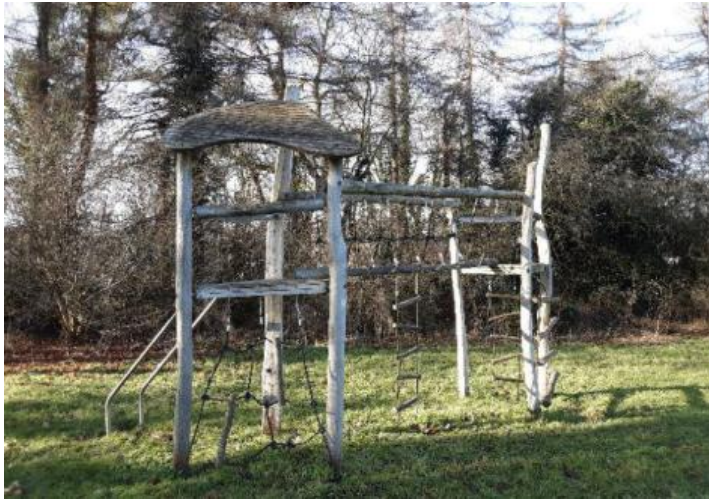
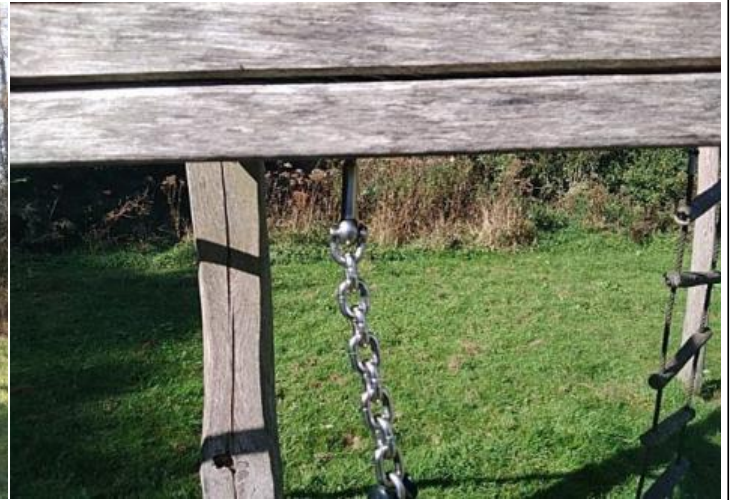
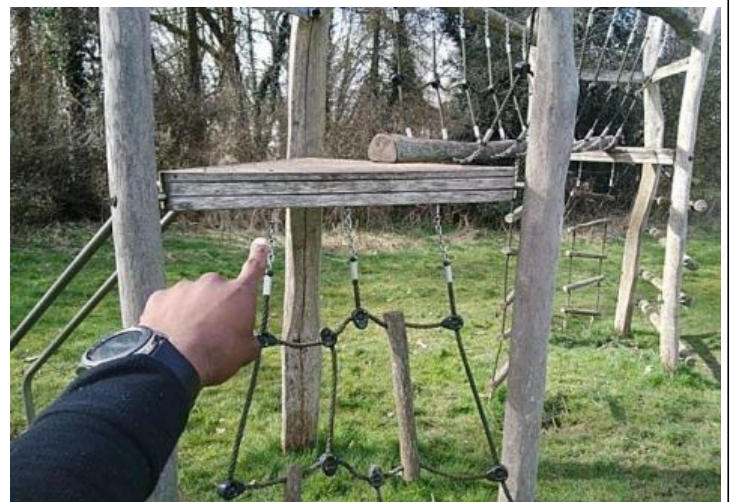
**Finding:** A fixing appears to have been unscrewed

**Action:** Secure correctly

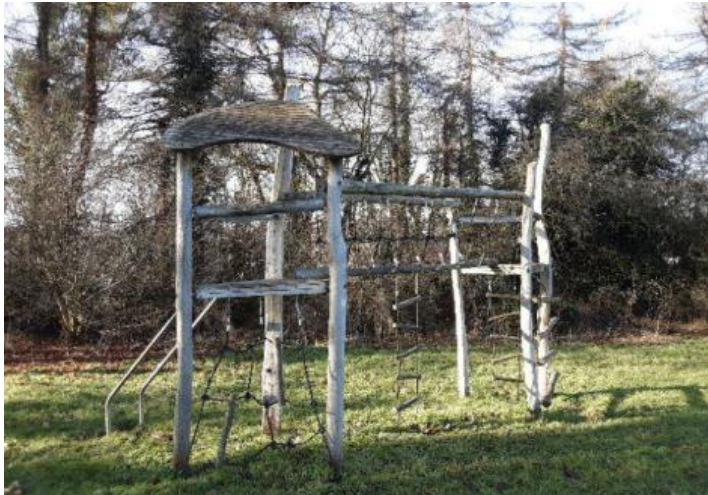
**Finding:** The ropes/nets are worn/damaged in places

**Action:** Monitor for any further deterioration and repair or replace as required

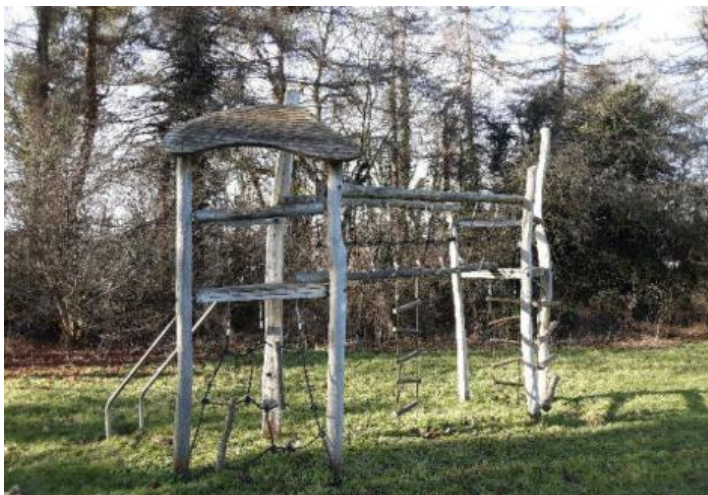
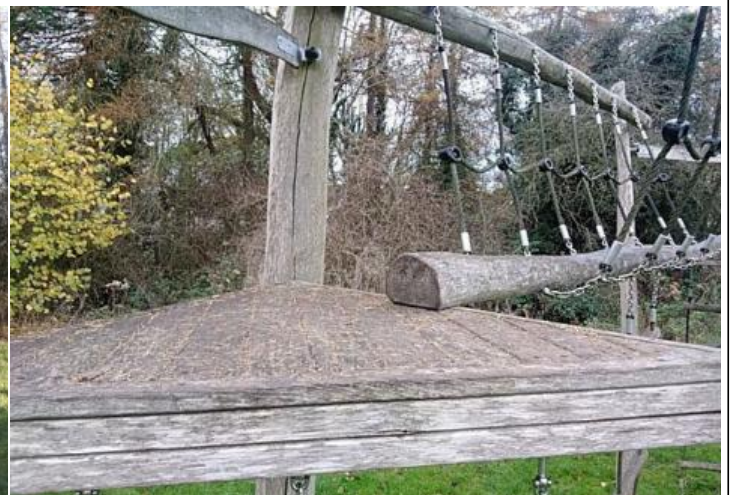
**Finding:** There is algae or moss on the surface of the equipment

**Action:** Clean and treat appropriately

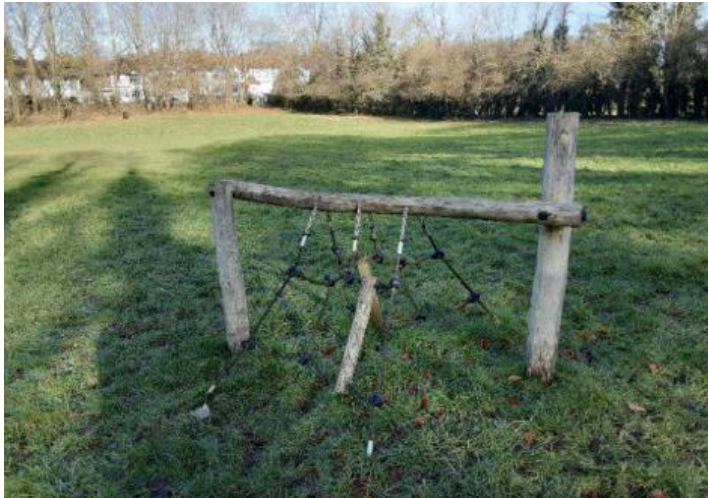
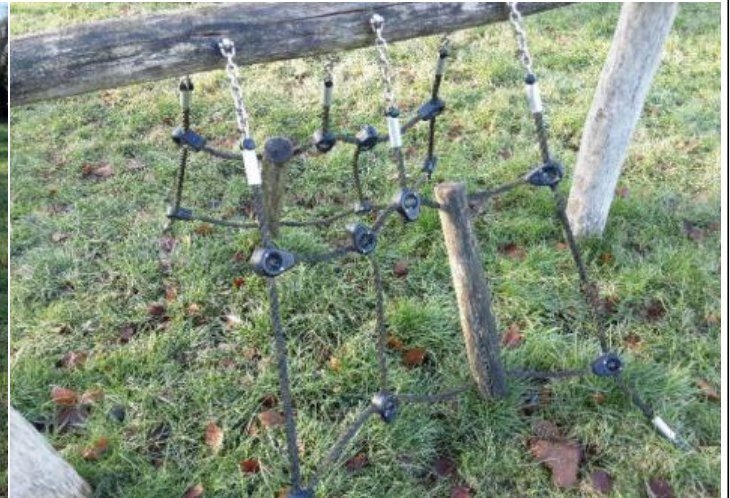
**Finding:** There is algae or moss on the surface of the equipment

**Action:** Clean and treat appropriately

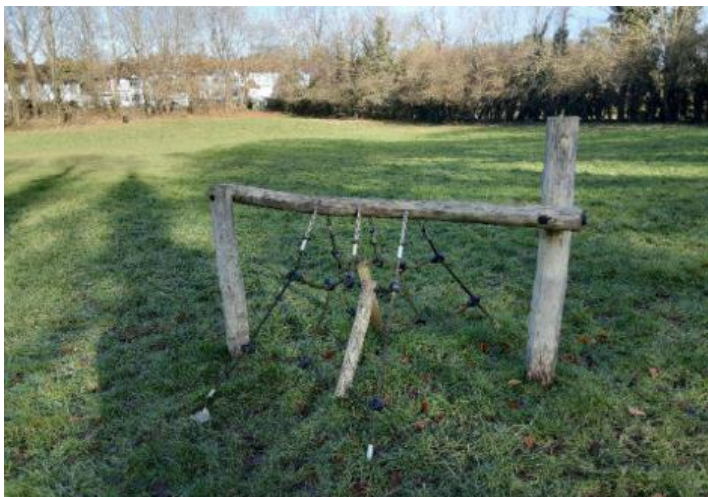
**Finding:** There is some evidence of rot in the timber

**Action:** Monitor for any further deterioration and replace as required

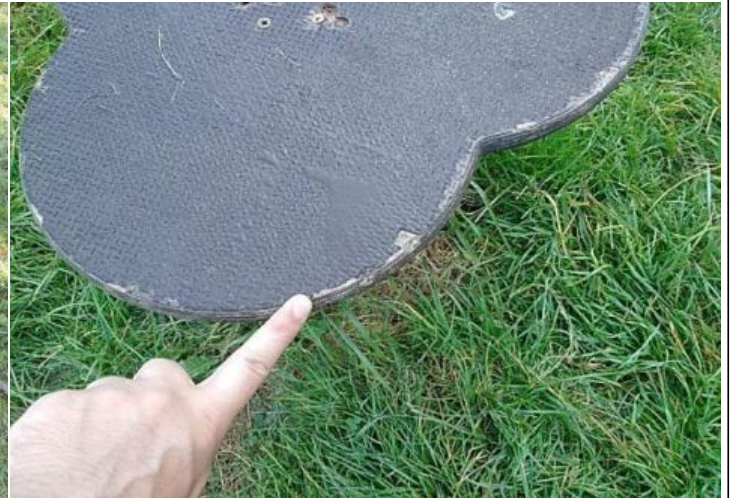
**Finding:** Parts of the timber are rough or splintered

**Action:** Remove all rough or sharp edges

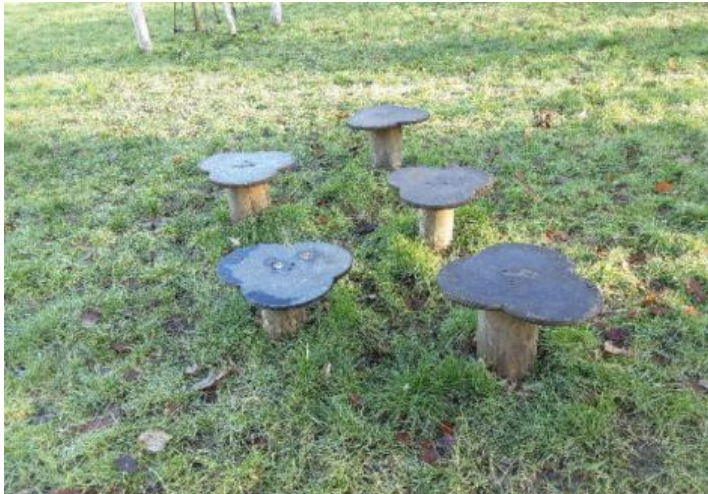
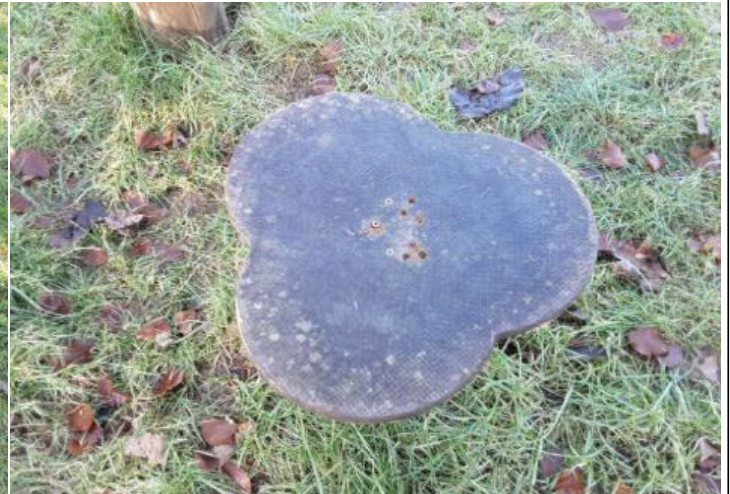
**Finding:** There is algae or moss on the surface of the equipment

**Action:** Clean and treat appropriately

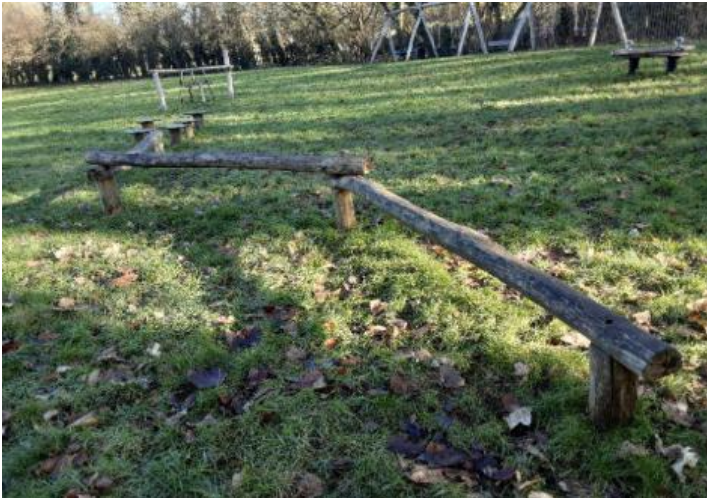
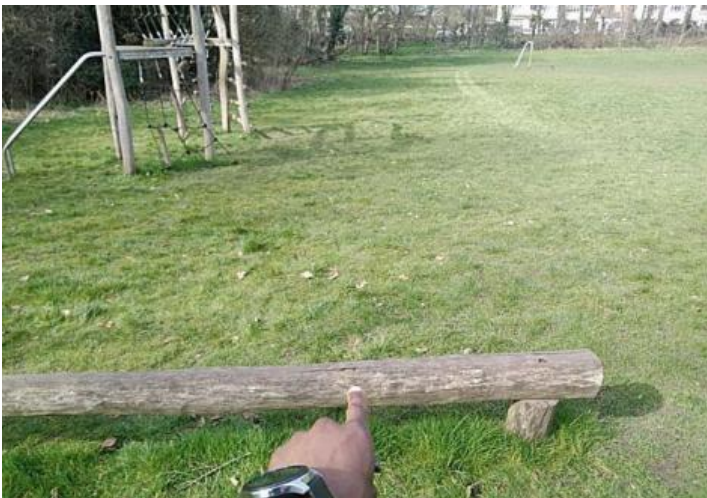
**Finding:** There is some evidence of rot in the timber

**Action:** Monitor for any further deterioration and replace as required

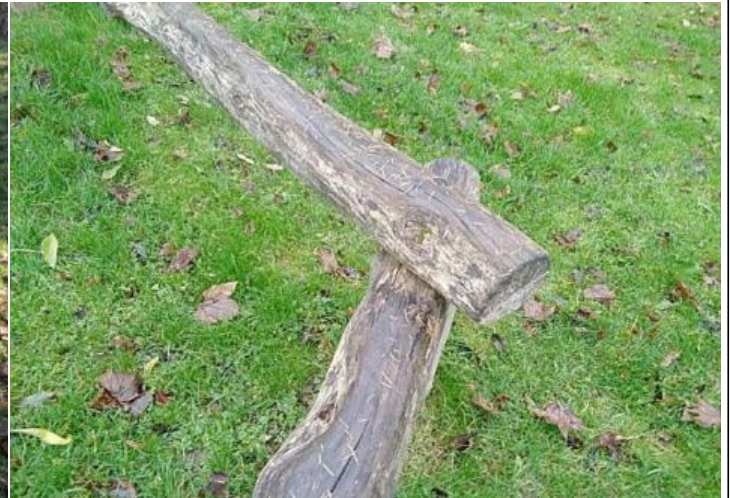
**Finding:** There is algae or moss on the surface of the equipment

**Action:** Clean and treat appropriately

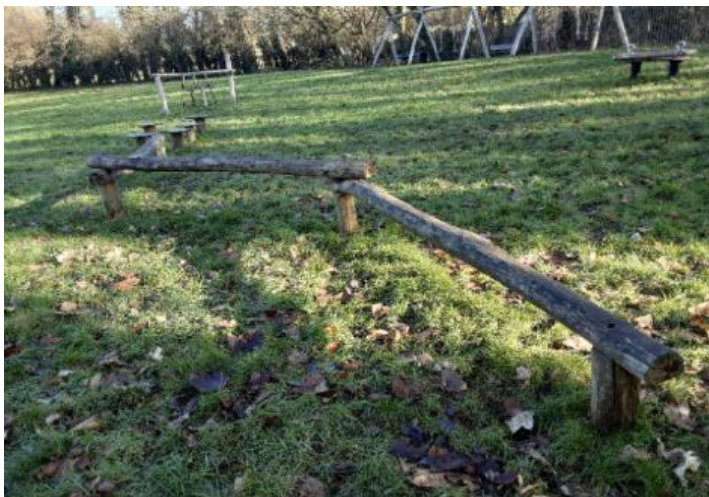
**Finding:** The timber has a number of splits/shakes or air cracks and this may affect the stability or allow water ingress which will accelerate the rotting process

**Action:** Monitor to ensure the splits do not cross through fixing points of the structure and/or cause any instability

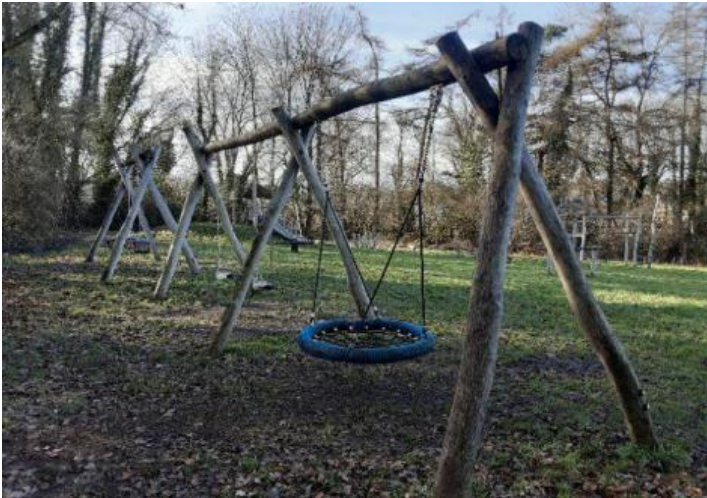
**Finding:** The seat has minor damage or wear

**Action:** Monitor for any further deterioration and replace as required

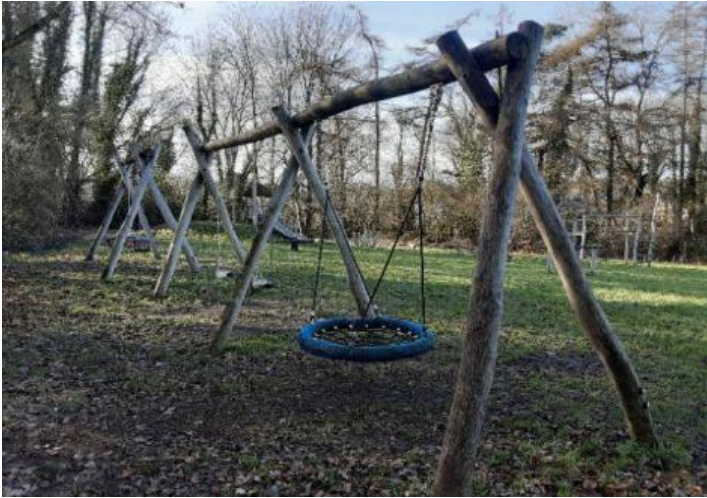
**Finding:** A number of fixing(s) have worked loose on the secondary safety chain

**Action:** Secure all loose fixings
