# NASH MILLS

## PARISH COUNCIL

### Clerk Report April 2023

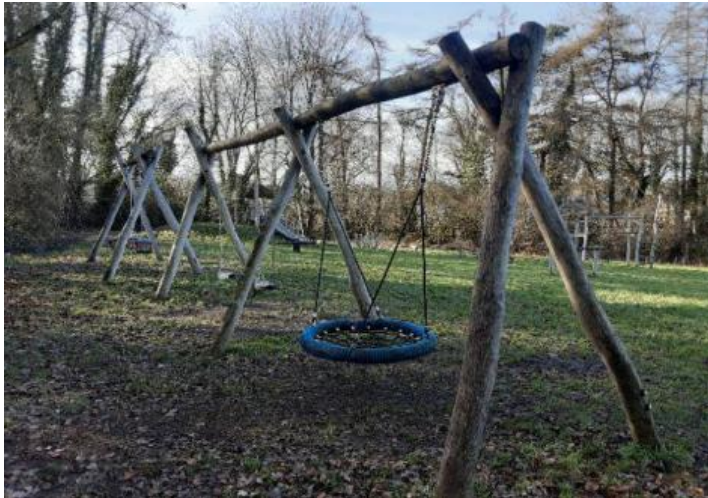
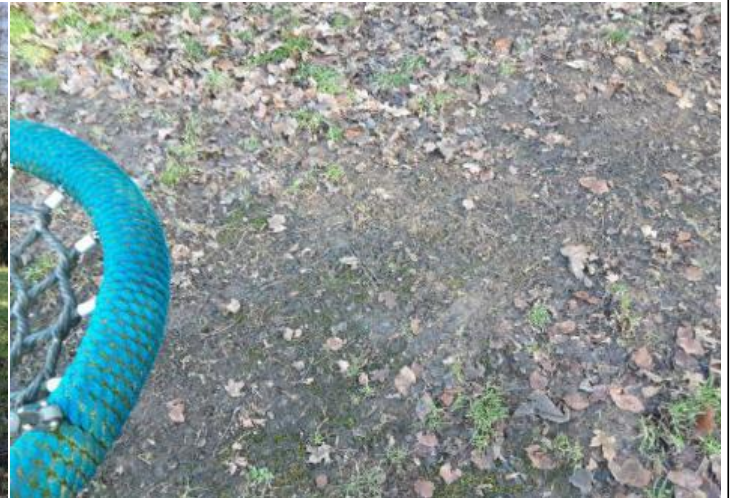
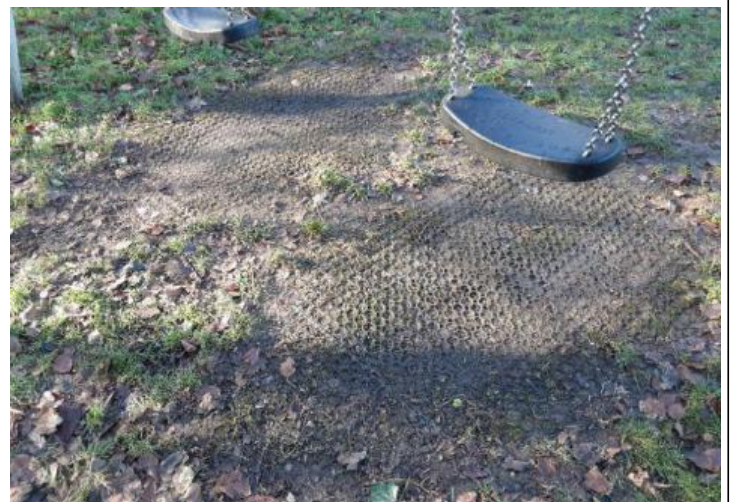
**Finding:** The grass mats are silted up, the soil is compacted and the area will become very slippery when the soil is wet. **Action:** Reinstate as required

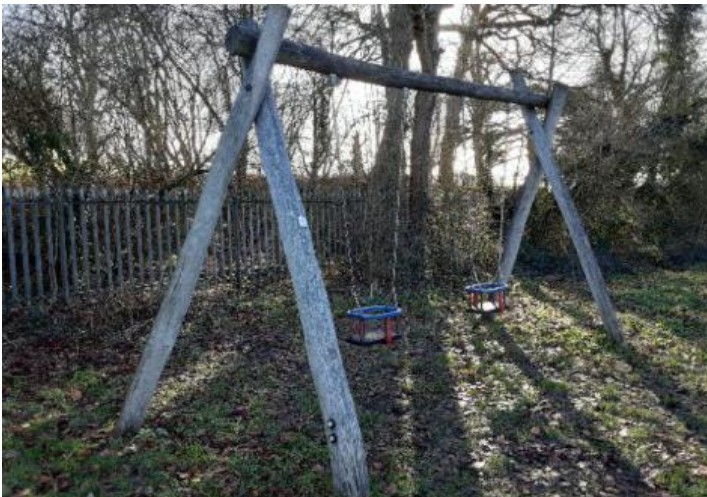
**Finding:** The timber has a number of splits/shakes or air cracks and this may affect the stability or allow water ingress which will accelerate the rotting process

**Action:** Monitor to ensure the splits do not cross through fixing points of the structure and/or cause any instability

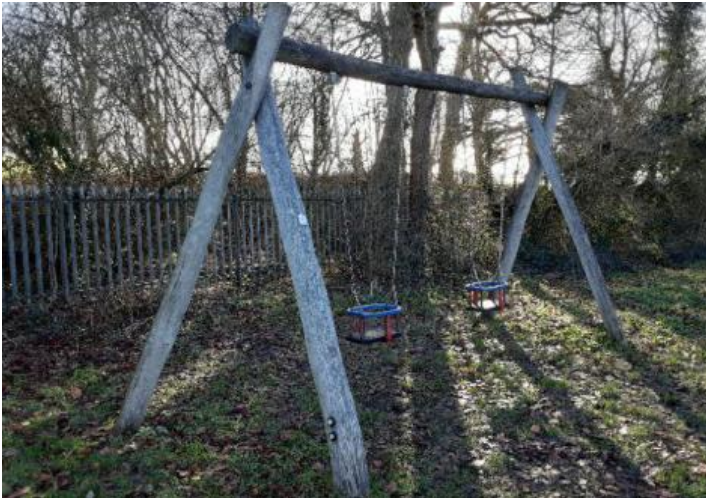
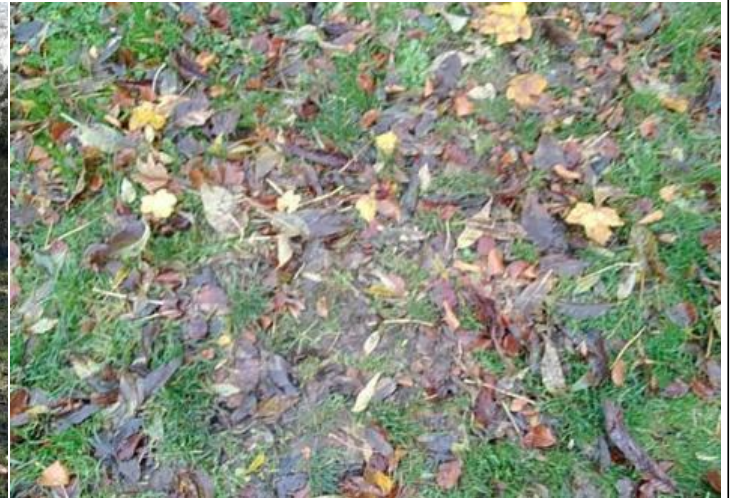
**Finding:** The grass mats are silted up, the soil is compacted and the area will become very slippery when the soil is wet. **Action:** Reinstate as required

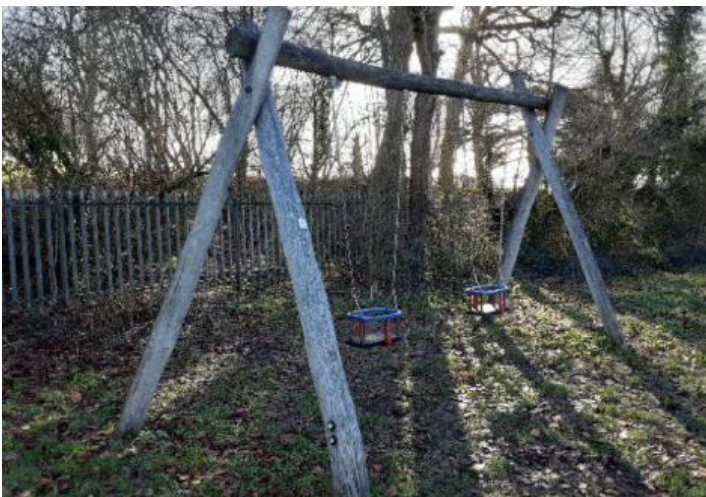
**Finding:** There is some strimmer / machinery damage apparent on the posts, this can penetrate the preservative applied to the timber and accelerate the rotting process **Action:** Monitor for any deterioration (rot) and replace as required

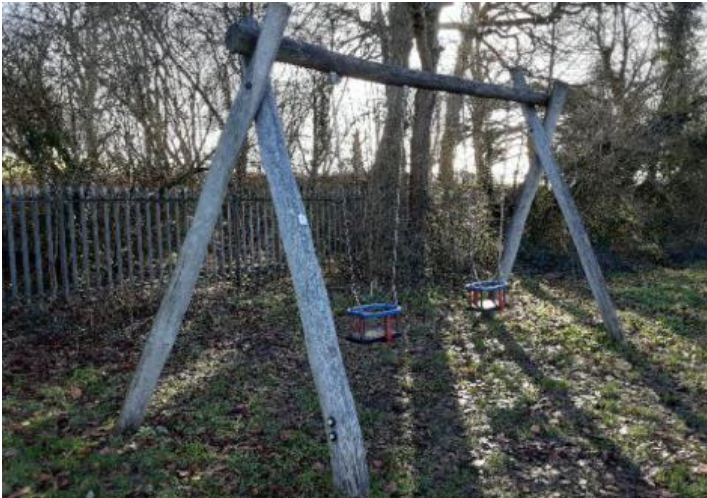
**Finding:** The swing seat frame is severely corroded and requires replacement

**Action:** Replace seat

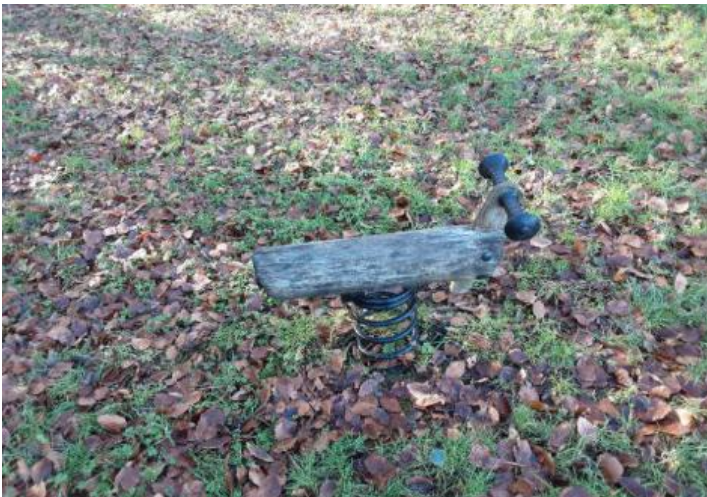
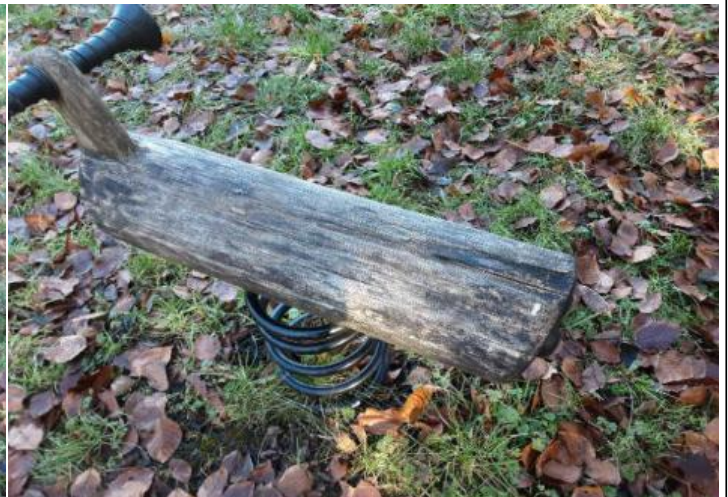
**Finding:** Parts of the timber are rough or splintered

**Action:** Remove all rough or sharp edges

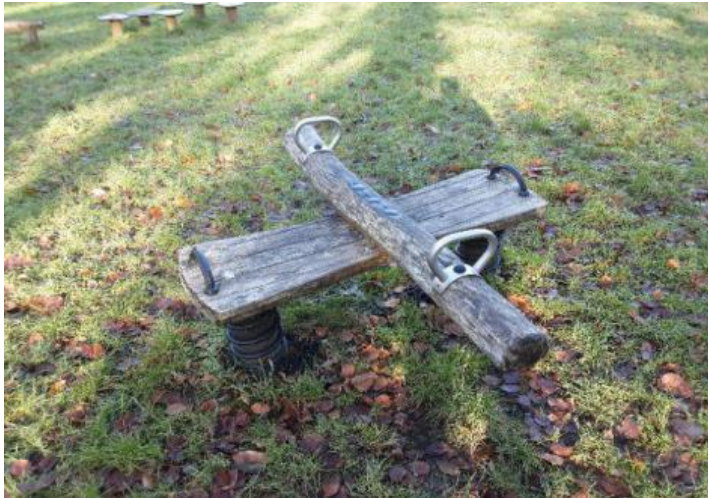
**Finding:** The use of synthetic fillers in timber is not recommended; timber being a natural material will expand and contract as the moisture content changes and the use of fillers can exacerbate the length and depth of these cracks or shakes in the timber. The only treatment that is normally required is the removal of any rough or sharp edges unless the structural integrity of the item is affected.

**Action:** Remove any rough or sharp edges and monitor timber for any further deterioration

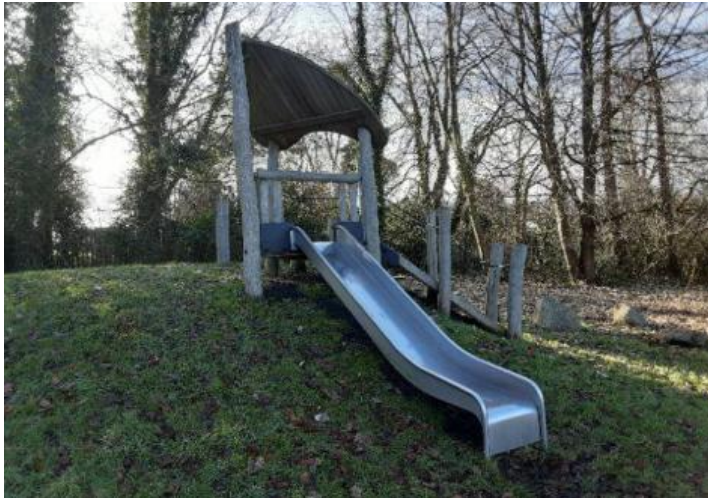
**Finding:** There are a number of dents in the slide surface

**Action:** Monitor for any further deterioration and repair as required

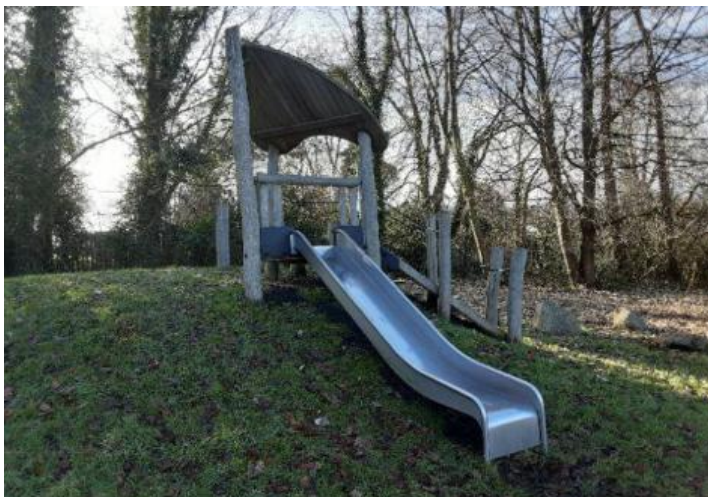
**Item:** Activity Equipment - Multi Play (Toddler)  
**Manufacturer:** Kompan Ltd

**Finding:** The timber has a number of splits/shakes or air cracks and this may affect the stability or allow water ingress which will accelerate the rotting process

**Action:** Monitor to ensure the splits do not cross through fixing points of the structure and/or cause any instability

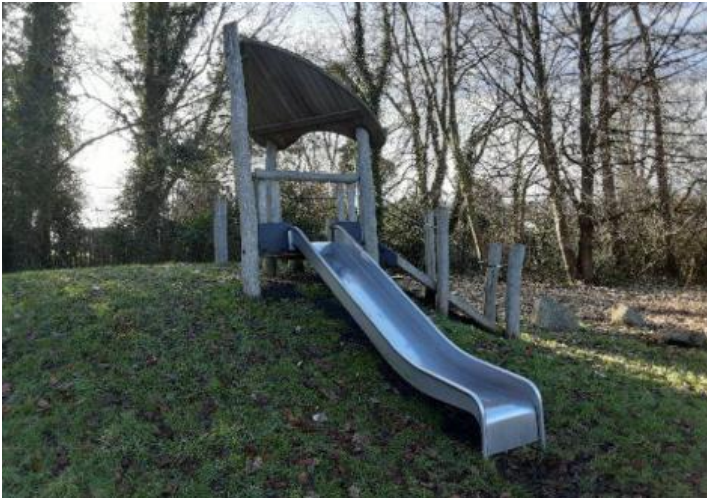
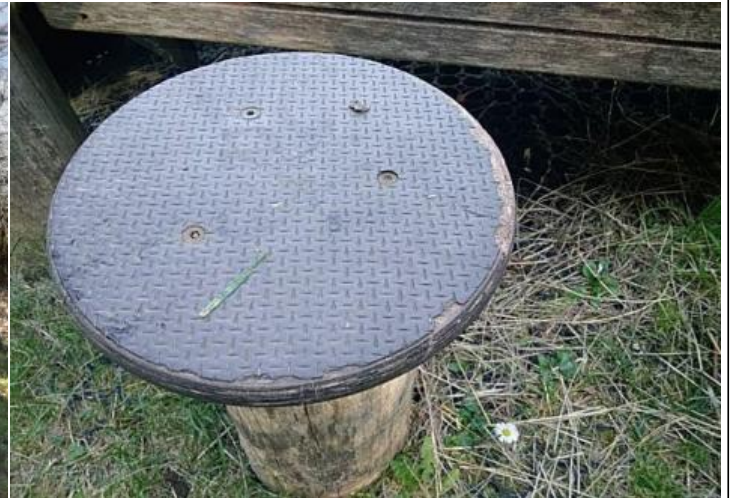
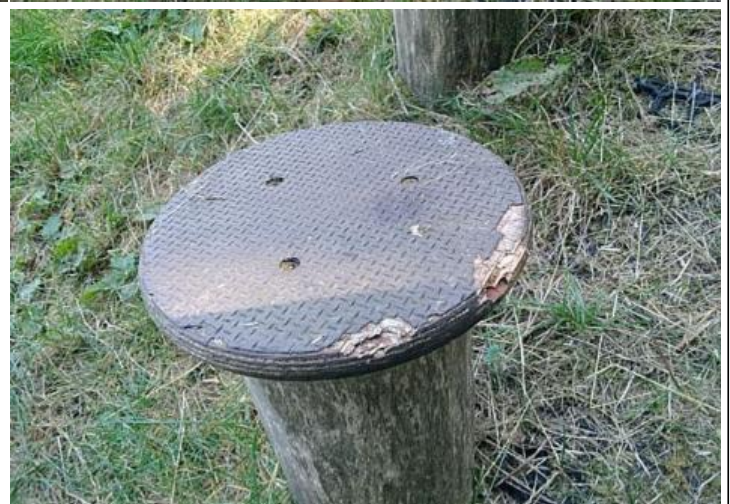
**Item:** Activity Equipment - Multi Play (Toddler)  
**Manufacturer:** Kompan Ltd

**Finding:** Parts of the timber are rough or splintered

**Action:** Remove all rough or sharp edges

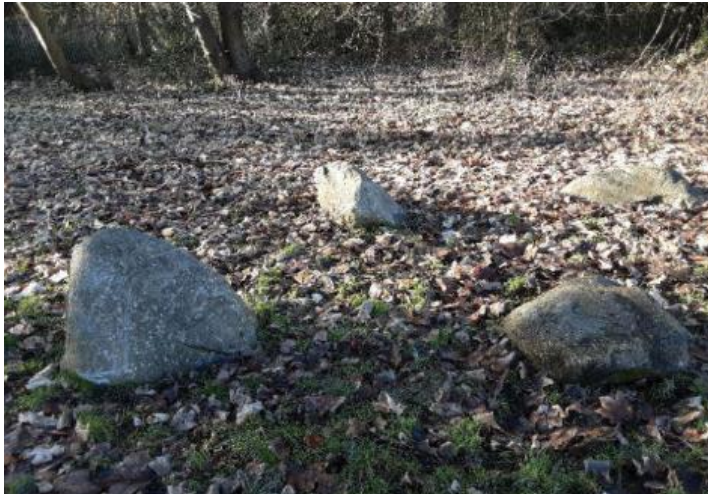
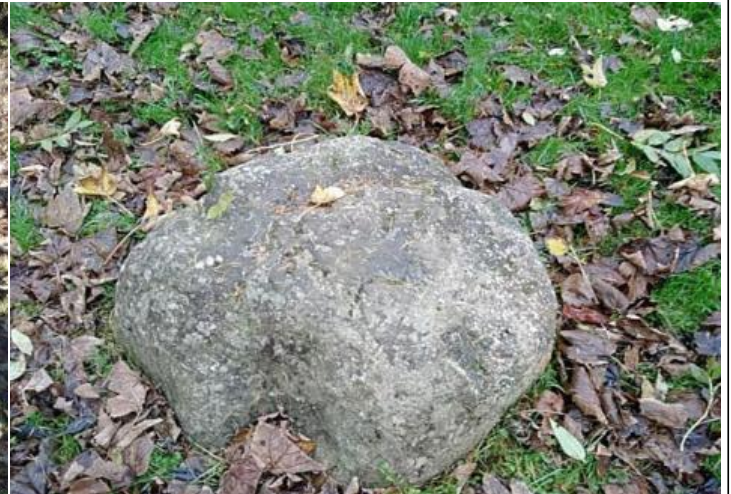
**Item:** Ancillary Items - Boulders  
**Manufacturer:** Natural Feature

**Finding:** The rocks and/or boulders have moss/algae growth apparent

**Action:** Clean and maintain

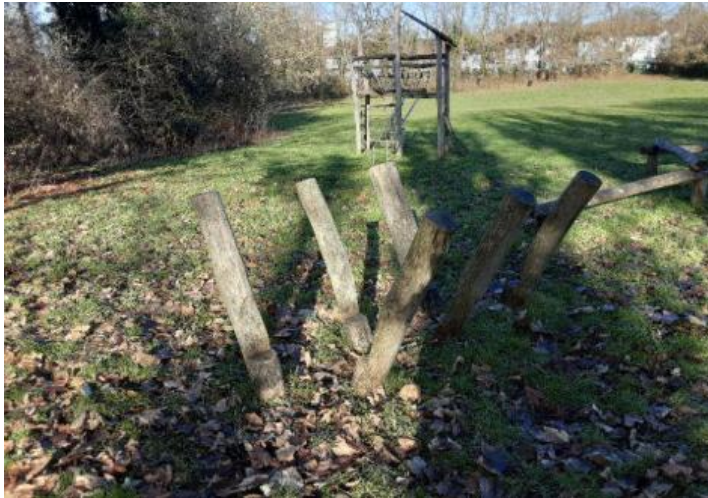
**Item:** Activity Equipment - Stilts  
**Manufacturer:** Kompan Ltd

**Finding:** The timber has a number of splits/shakes or air cracks and this may affect the stability or allow water ingress which will accelerate the rotting process

**Action:** Monitor to ensure the splits do not cross through fixing points of the structure and/or cause any instability

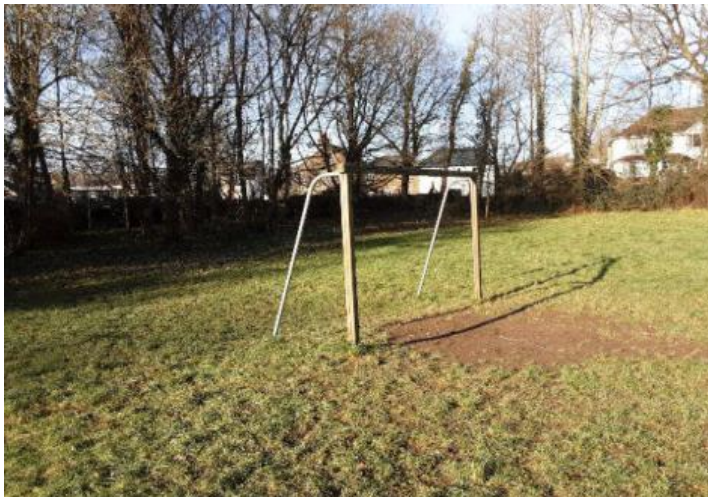
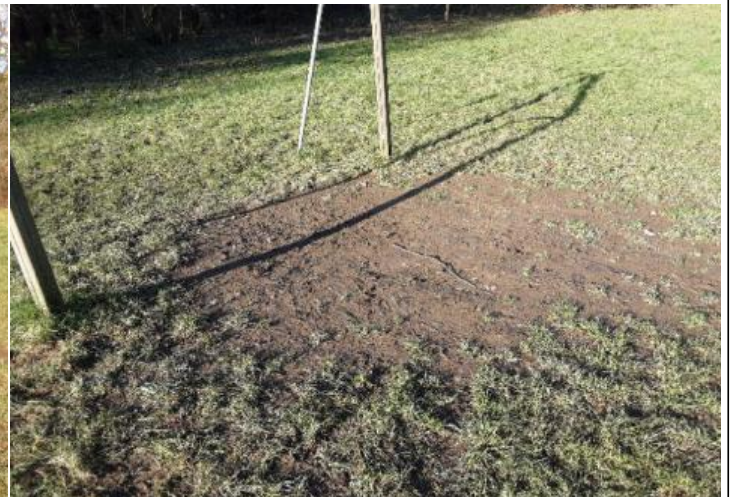
**Item:** Multi Use Games Area - Football Goal  
**Manufacturer:** Kompan Ltd

**Finding:** The surface has eroded in some areas

**Action:** Reinststate the surface

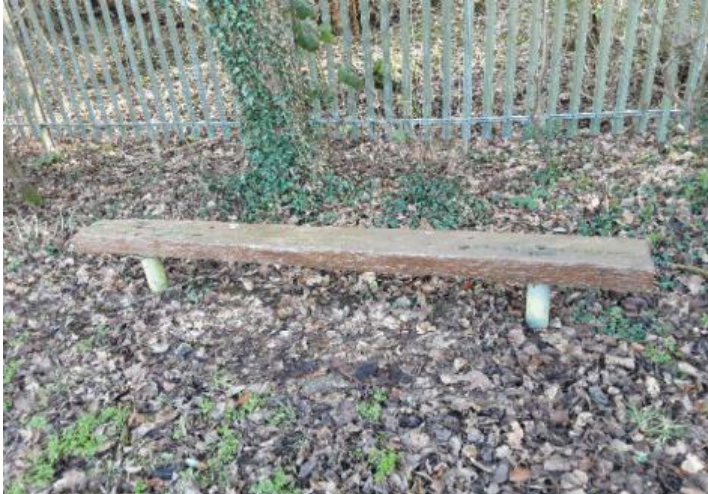
**Item:** Ancillary Items - Bench  
**Manufacturer:** Not Identified

**Finding:** There are trip hazards at the edges of the surface

**Action:** Reinstate surrounding surface levels to remove the trip points

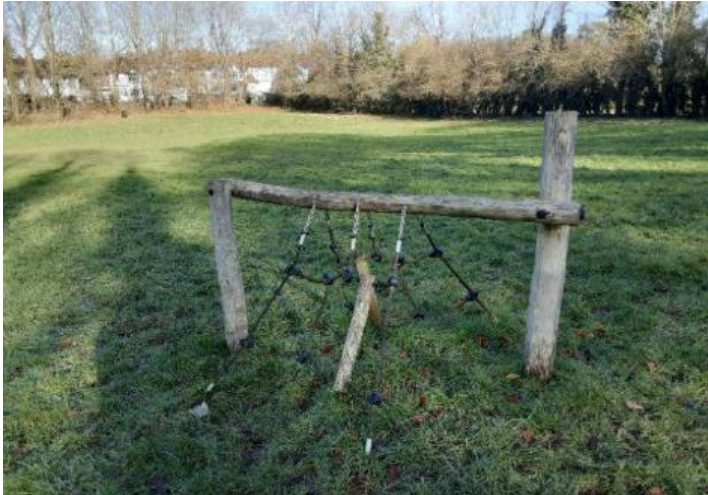
**Item:** Activity Equipment - A Frame Climber  
**Manufacturer:** Kompan Ltd

**Finding:** The use of synthetic fillers in timber is not recommended; timber being a natural material will expand and contract as the moisture content changes and the use of fillers can exacerbate the length and depth of these cracks or shakes in the timber. The only treatment that is normally required is the removal of any rough or sharp edges unless the structural integrity of the item is affected.

**Action:** Remove any rough or sharp edges and monitor timber for any further deterioration

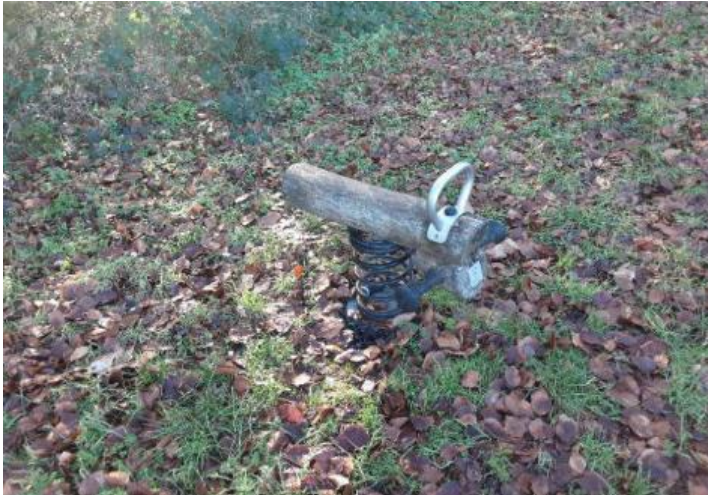
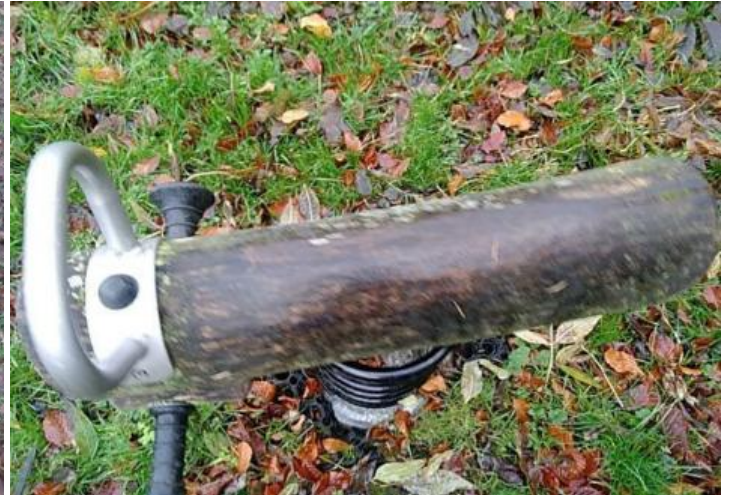
**Item:** Rocking Equipment - Misc Springer  
**Manufacturer:** Kompan Ltd

**Finding:** There is algae or moss on the surface of the equipment

**Action:** Clean and treat appropriately

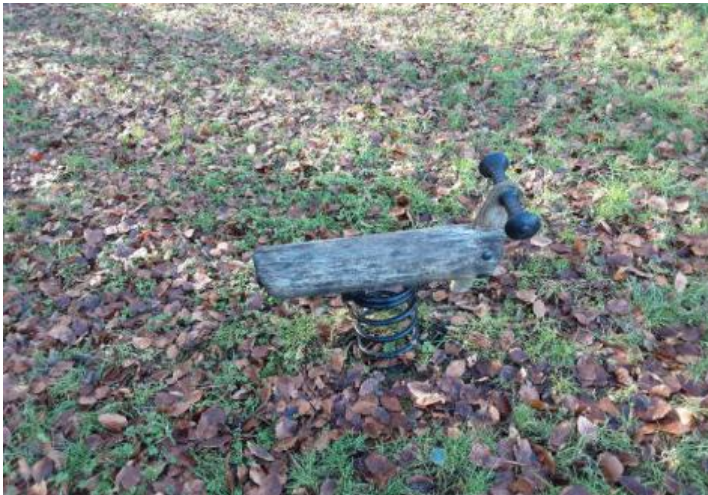
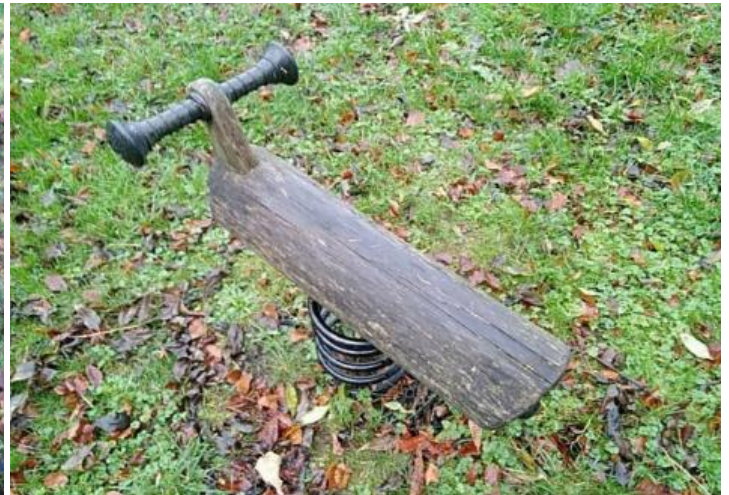
**Item:** Rocking Equipment - Misc Springer  
**Manufacturer:** Kompan Ltd

**Finding:** There is algae or moss on the surface of the equipment

**Action:** Clean and treat appropriately

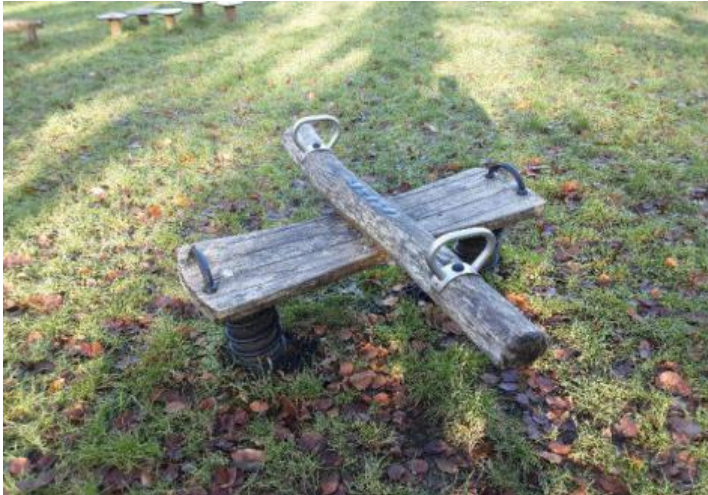
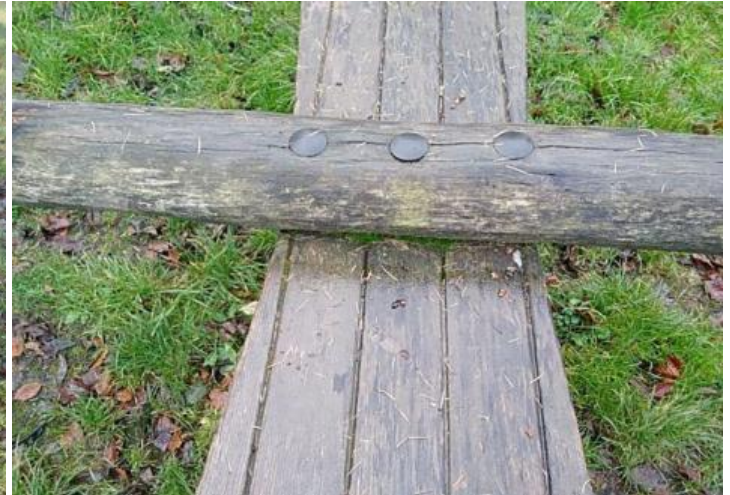
**Item:** Rocking Equipment - Spring See-Saw  
**Manufacturer:** Kompan Ltd

**Finding:** There is algae or moss on the surface of the equipment

**Action:** Clean and treat appropriately

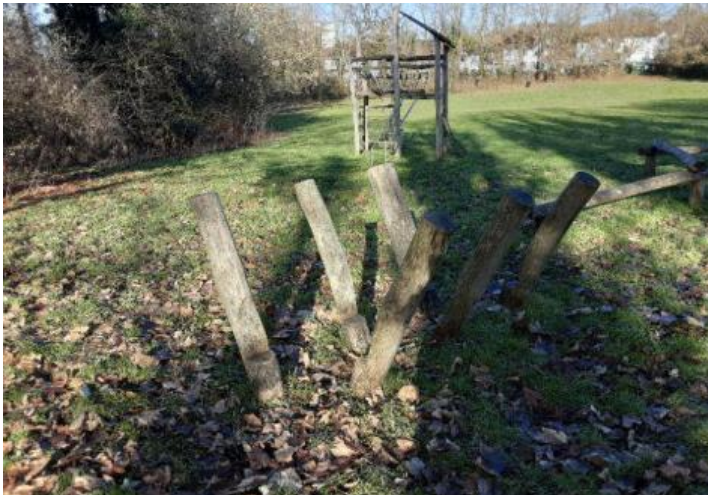
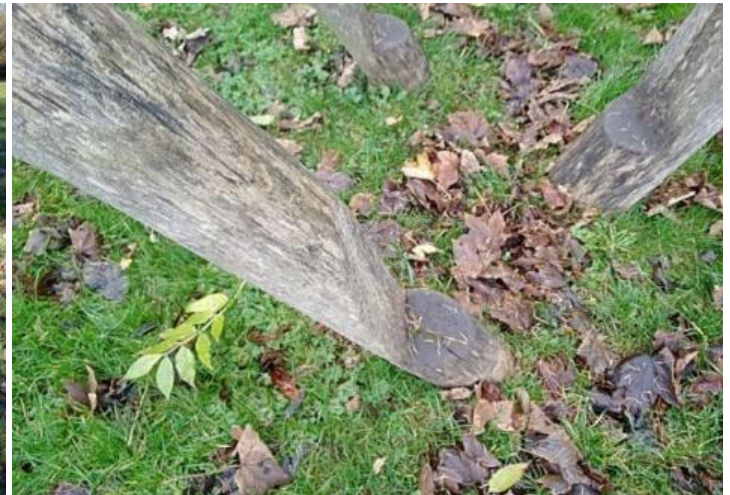
**Item:** Activity Equipment - Stilts  
**Manufacturer:** Kompan Ltd

**Finding:** There is algae or moss on the surface of the equipment

**Action:** Clean and treat appropriately

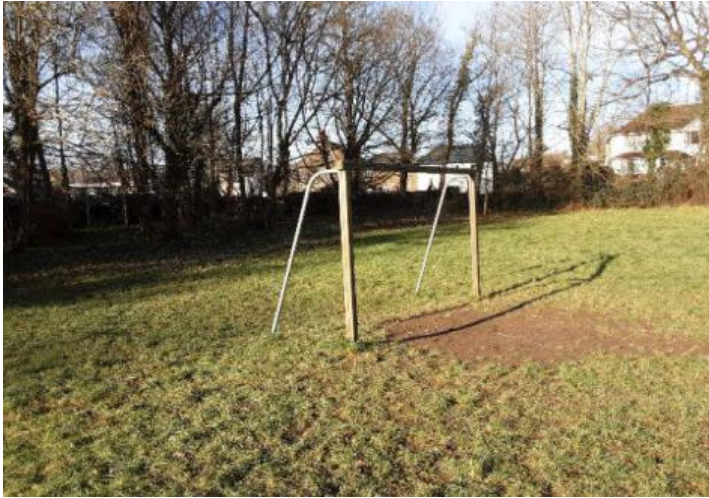
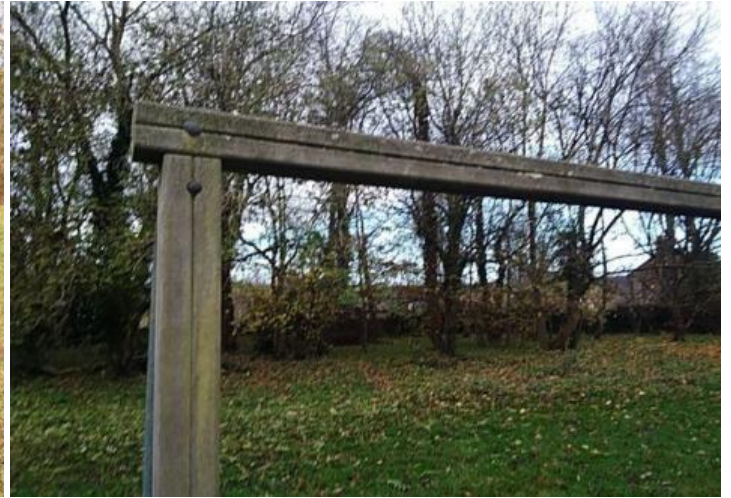
**Item:** Multi Use Games Area - Football Goal  
**Manufacturer:** Kompan Ltd

**Finding:** There is algae or moss on the surface of the equipment

**Action:** Clean and treat appropriately
