the **play** inspection company

Operational Inspection

Nashmills Parish Council

Bunkers Lane Play Area

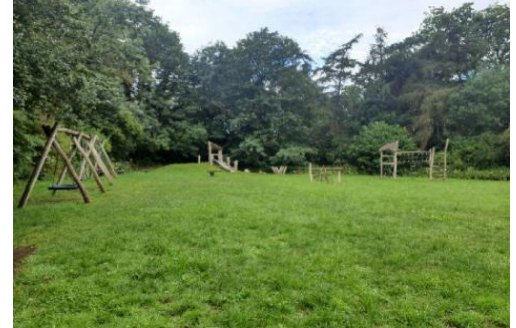
Item: Site General
Manufacturer: Owner/Operator
Surface Type: N/A
Item Quantity: 1
Equipment Compliance: N/A
Surface Area Compliance: N/A

There is weed / vegetation growth on, between, or around the edges of the surfacing - Remove weed / vegetation growth

There is algae, silt or moss growth on the pathway surface resulting in slippery conditions - Clean and treat appropriately

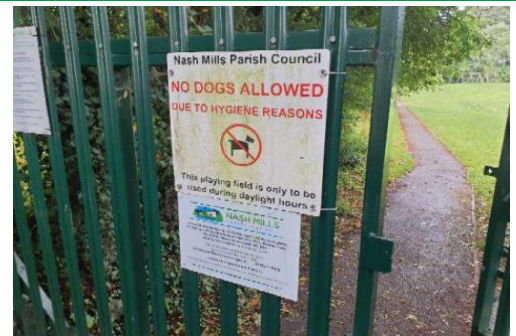
Item: Sign
Manufacturer: Owner/Operator
Surface Type: N/A
Item Quantity: 1
Equipment Compliance: N/A
Surface Area Compliance: N/A

Cable ties have been used to secure the sign to the gate - Consider providing a more permanent method of security

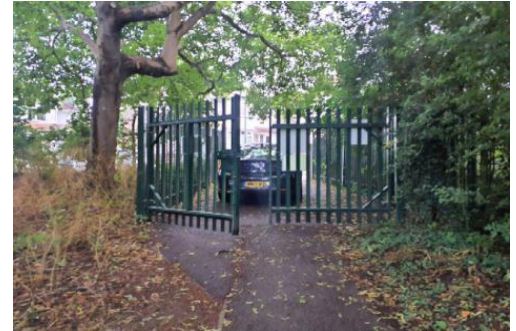
Item: Maintenance Gate
Manufacturer: Not Identified
Surface Type: Bitmac
Item Quantity: 1
Equipment Compliance: N/A
Surface Area Compliance: N/A

The bitumen surface is worn or damaged - Repair the bitumen to provide a uniform surface

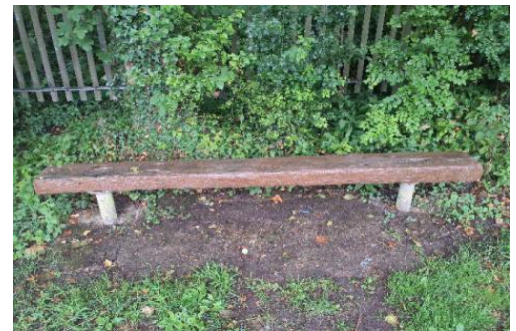
Item: Bench
Manufacturer: Not Identified
Surface Type: Concrete
Item Quantity: 1
Equipment Compliance: N/A
Surface Area Compliance: N/A

There are projecting bolt thread(s) present - Remove excess thread length and deburr or provide cap

The concrete base has been damaged - Monitor for any further deterioration and replace as required

There is some evidence of rot in the timber - Monitor for any further deterioration and replace as required

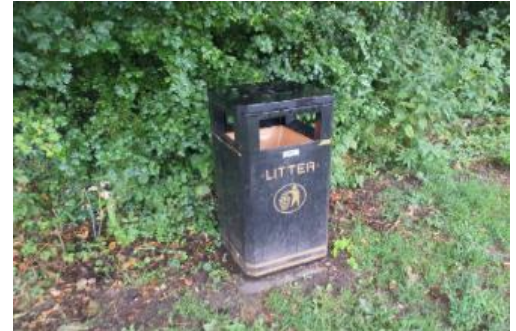
Item: Litter Bin
Manufacturer: Not Identified
Surface Type: Grass
Item Quantity: 1
Equipment Compliance: N/A
Surface Area Compliance: N/A

This item is satisfactory - no work required -

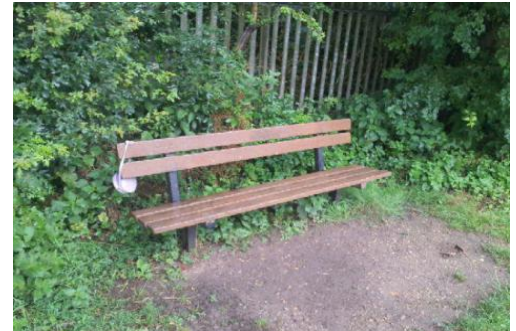
Item: Bench
Manufacturer: Not Identified
Surface Type: Grass
Item Quantity: 1
Equipment Compliance: N/A
Surface Area Compliance: N/A

The surface has eroded in some areas - Reinstate the surface

The paintwork on this item has been damaged or worn exposing the metal underneath which is rusting - Treat any rusting components and repaint

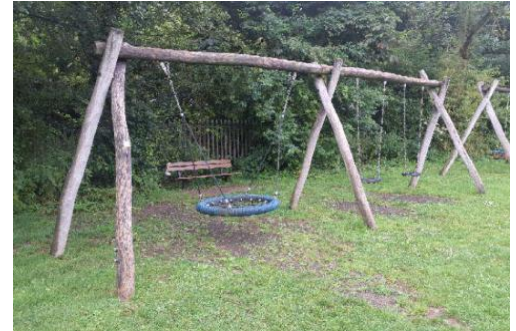
Item: 2 Bay 2 Flat 1 Basket Seat
Manufacturer: Kompan Ltd
Surface Type: Grass Matrix Tiles
Item Quantity: 1
Equipment Compliance: No
Surface Area Compliance: Yes

The seat has minor damage or wear - Monitor for any further deterioration and replace as required

There is a large cavity within the timber support and the inspector has some concerns about the internal condition of the timber and was unable to verify the structural integrity without further testing. We recommend a Resi-PD survey to establish the condition of the timber at it's core. - Contact the Play Inspection Company office for further information

A number of fixing(s) have worked loose on the suspension mounts. The office and client have been notified of this - Secure all loose fixings

A number of fixing(s) have worked loose on the secondary safety chain - Secure all loose fixings

There is some evidence of fire damage to the item - Monitor for any further deterioration and repair as required

There is some notable evidence of chain wear - Monitor for any further deterioration and replace when 40% worn

This design of swing joint has been known to fail on the weld connecting the joint to the threaded stud - We would recommend that the joint be dismantled and checked on a regular basis or consulting with manufacturer on whether a Secondary Safety Device can be fitted

The bushes are showing signs of wear - Monitor for any further deterioration and replace as required

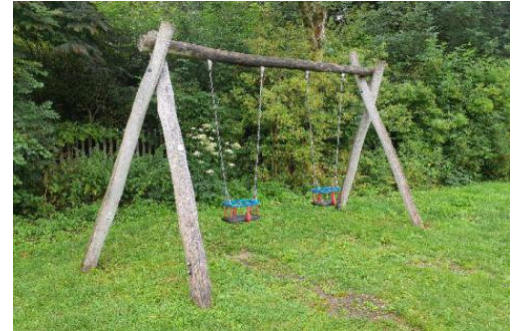
Item: 1 Bay 2 Seat (Cradle)
Manufacturer: Kompan Ltd
Surface Type: Grass Matrix Tiles
Item Quantity: 1
Equipment Compliance: Yes
Surface Area Compliance: Yes

The timber has a number of splits/shakes or air cracks and this may affect the stability or allow water ingress which will accelerate the rotting process - Monitor to ensure the splits do not cross through fixing points of the structure and/or cause any instability

There is some strimmer / machinery damage apparent on the posts, this can penetrate the preservative applied to the timber and accelerate the rotting process - Monitor for any deterioration (rot) and replace as required

This design of swing joint has been known to fail on the weld connecting the joint to the threaded stud - We would recommend that the joint be dismantled and checked on a regular basis or consulting with manufacturer on whether a Secondary Safety Device can be fitted

The swing seat frame is severely corroded and requires replacement - Replace seat

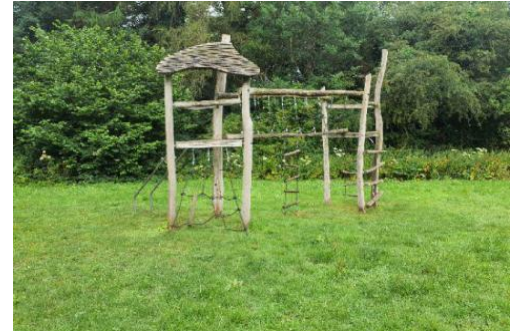
Item: Climbing Frame
Manufacturer: Kompan Ltd
Surface Type: Grass Matrix Tiles
Item Quantity: 1
Equipment Compliance: N/A
Surface Area Compliance: N/A

A fixing appears to have been unscrewed - Secure correctly

There is some strimmer / machinery damage apparent on the posts, this can penetrate the preservative applied to the timber and accelerate the rotting process - Monitor for any deterioration (rot) and replace as required

The ropes/nets are worn/damaged in places - Monitor for any further deterioration and repair or replace as required

A number of fixing(s) have worked loose - Secure all loose fixings

The roof slats are lifting - Monitor for any further deterioration and repair as required

There is some damage apparent on the posts, this can penetrate the preservative applied to the timber and accelerate the rotting process - Monitor for any deterioration (rot) and replace as required

There is some evidence of rot in the timber - Monitor for any further deterioration and replace as required

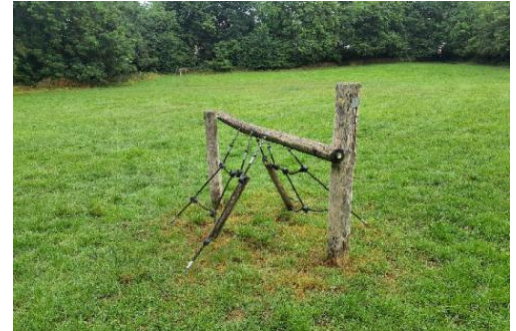
Item: A Frame Climber
Manufacturer: Kompan Ltd
Surface Type: Mixed Surface
Item Quantity: 1
Equipment Compliance: N/A
Surface Area Compliance: N/A

The timber has a number of splits/shakes or air cracks and this may affect the stability or allow water ingress which will accelerate the rotting process - Monitor to ensure the splits do not cross through fixing points of the structure and/or cause any instability

There is some evidence of rot in the timber - Monitor for any further deterioration and replace as required

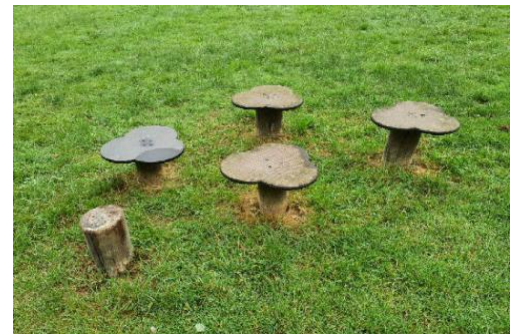
Item: Log Walk
Manufacturer: Kompan Ltd
Surface Type: Grass
Item Quantity: 1
Equipment Compliance: Yes
Surface Area Compliance: Yes

The platforms are rotting and the fixings are pulling through - Replace all affected timber

A number of fixing(s) have worked loose tops - Secure all loose fixings

The timber has a number of splits/shakes or air cracks and this may affect the stability or allow water ingress which will accelerate the rotting process - Monitor to ensure the splits do not cross through fixing points of the structure and/or cause any instability

The item has missing component(s) (step top) - Consider replacing missing components

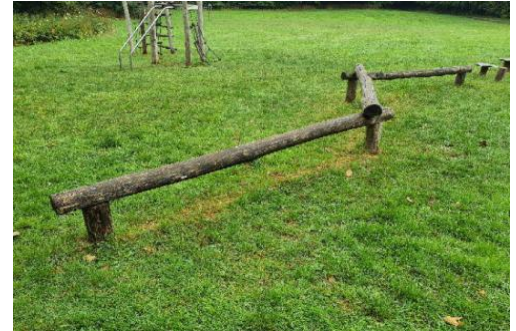
Item: Balance Beam
Manufacturer: Kompan Ltd
Surface Type: Grass
Item Quantity: 1
Equipment Compliance: Yes
Surface Area Compliance: Yes

The use of synthetic fillers in timber is not recommended; timber being a natural material will expand and contract as the moisture content changes and the use of fillers can exacerbate the length and depth of these cracks or shakes in the timber. The only treatment that is normally required is the removal of any rough or sharp edges unless the structural integrity of the item is affected. - Remove any rough or sharp edges and monitor timber for any further deterioration

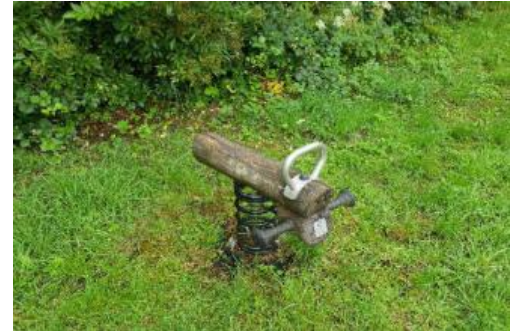
Item: Misc Springer
Manufacturer: Kompan Ltd
Surface Type: Grass Matrix Tiles
Item Quantity: 1
Equipment Compliance: Yes
Surface Area Compliance: Yes

This item is satisfactory - no work required -

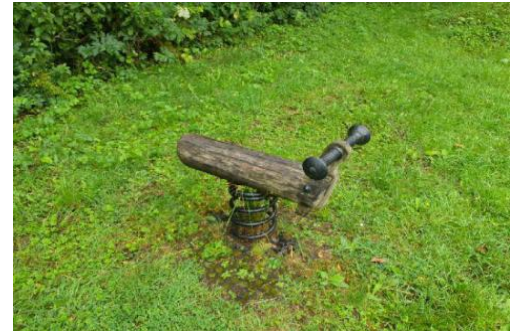
Item: Misc Springer
Manufacturer: Kompan Ltd
Surface Type: Grass Matrix Tiles
Item Quantity: 1
Equipment Compliance: Yes
Surface Area Compliance: Yes

Parts of the timber are rough or splintered - Remove all rough or sharp edges

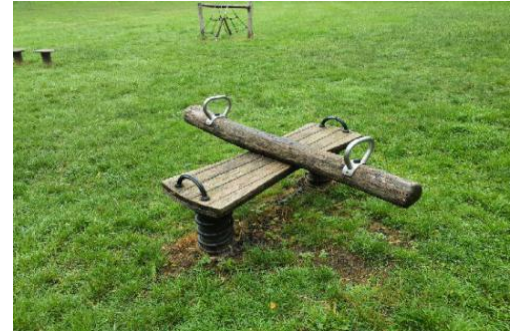
Item: Spring See-Saw
Manufacturer: Kompan Ltd
Surface Type: Grass Matrix Tiles
Item Quantity: 1
Equipment Compliance: Yes
Surface Area Compliance: Yes

The use of synthetic fillers in timber is not recommended; timber being a natural material will expand and contract as the moisture content changes and the use of fillers can exacerbate the length and depth of these cracks or shakes in the timber. The only treatment that is normally required is the removal of any rough or sharp edges unless the structural integrity of the item is affected. - Remove any rough or sharp edges and monitor timber for any further deterioration

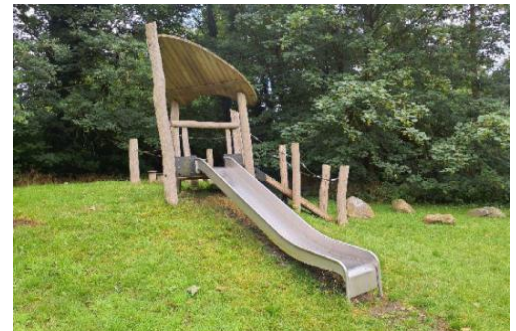
Item: Multi Play (Toddler)
Manufacturer: Kompan Ltd
Surface Type: Grass Matrix Tiles
Item Quantity: 1
Equipment Compliance: No
Surface Area Compliance: Yes

There are a number of dents in the slide surface - Monitor for any further deterioration and repair as required

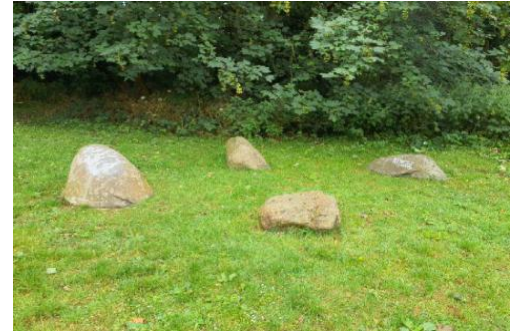
Item: Boulders
Manufacturer: Natural Feature
Surface Type: Grass
Item Quantity: 1
Equipment Compliance: N/A
Surface Area Compliance: N/A

The rocks and/or boulders have moss/algae growth apparent - Clean and maintain

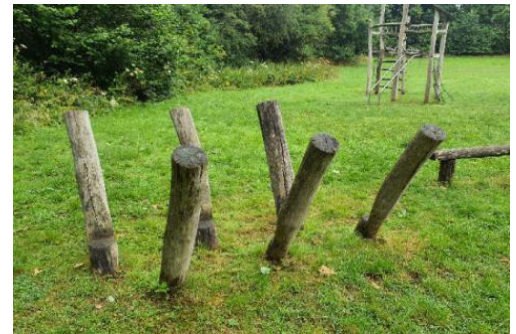
Item: Stilts
Manufacturer: Kompan Ltd
Surface Type: Grass
Item Quantity: 1
Equipment Compliance: N/A
Surface Area Compliance: N/A

The timber has a number of splits/shakes or air cracks and this may affect the stability or allow water ingress which will accelerate the rotting process - Monitor to ensure the splits do not cross through fixing points of the structure and/or cause any instability

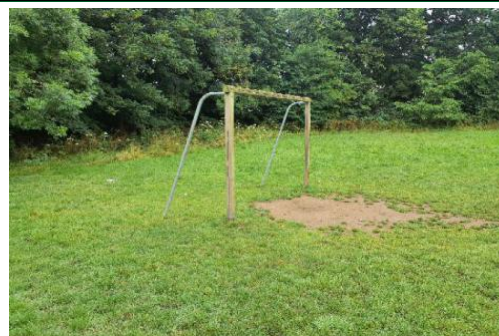
Item: Football Goal
Manufacturer: Kompan Ltd
Surface Type: Grass
Item Quantity: 1
Equipment Compliance: N/A
Surface Area Compliance: N/A

The surface has eroded in some areas - Reinstate the surface

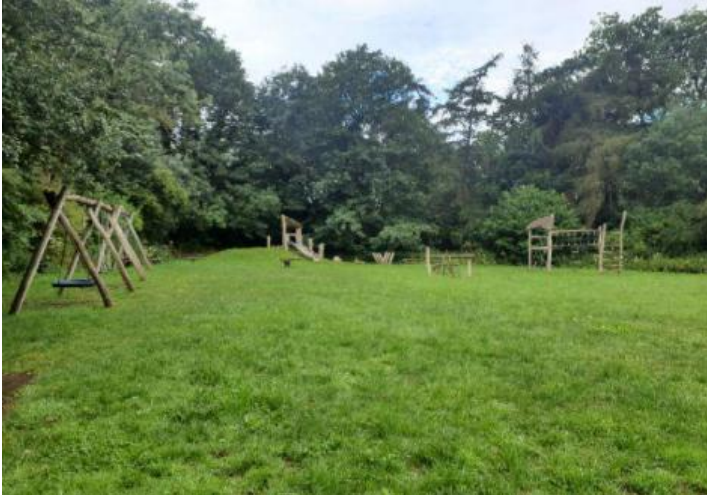
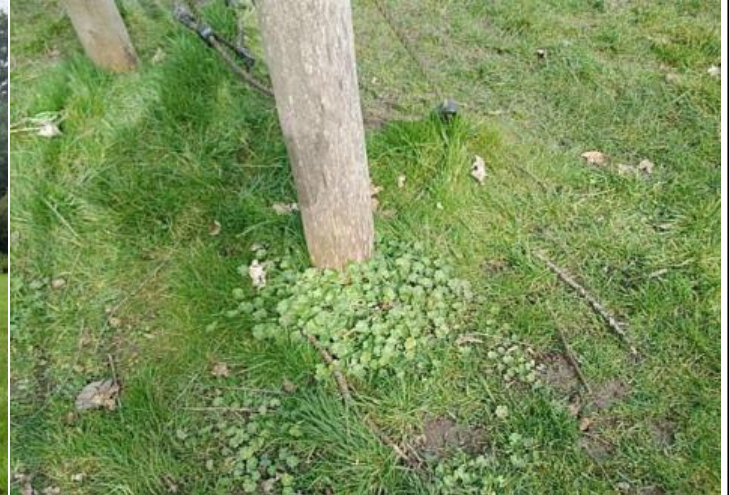
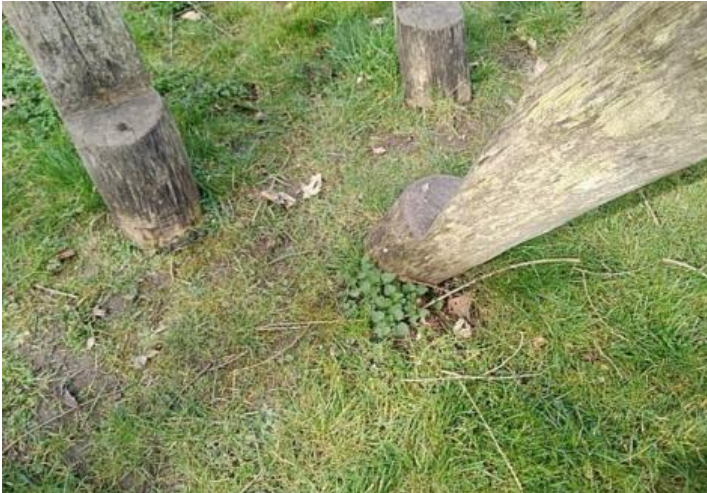
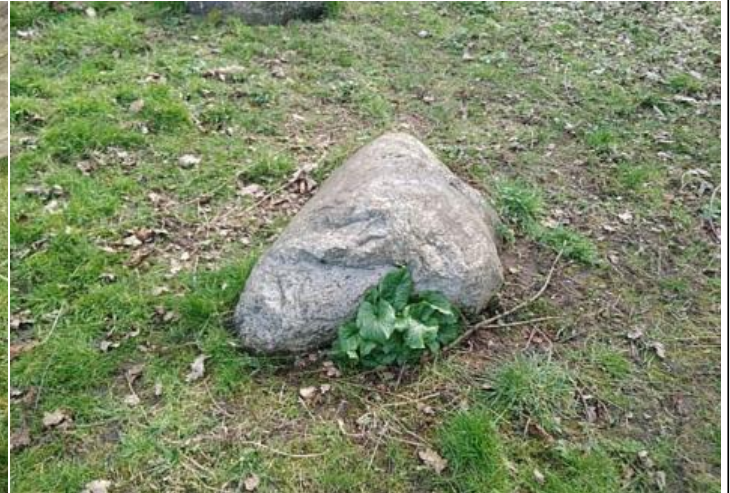
Item: Ancillary Items - Site General
Manufacturer: Owner/Operator

Finding: There is weed / vegetation growth on, between, or around the edges of the surfacing
Action: Remove weed / vegetation growth

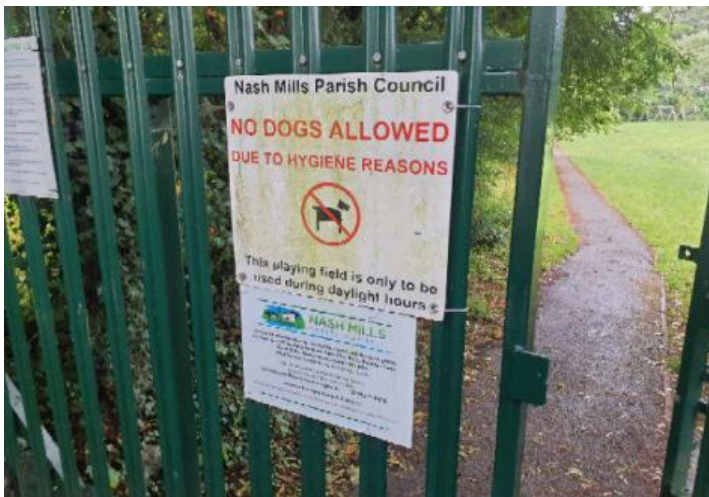
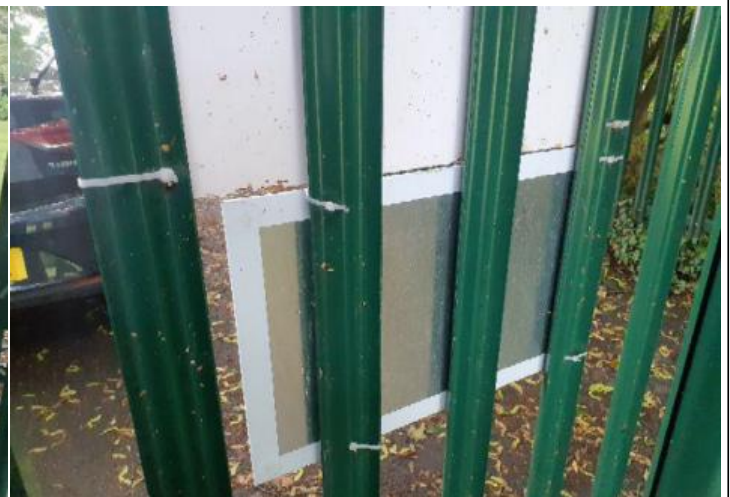
Item: Ancillary Items - Sign
Manufacturer: Owner/Operator

Finding: Cable ties have been used to secure the sign to the gate
Action: Consider providing a more permanent method of security

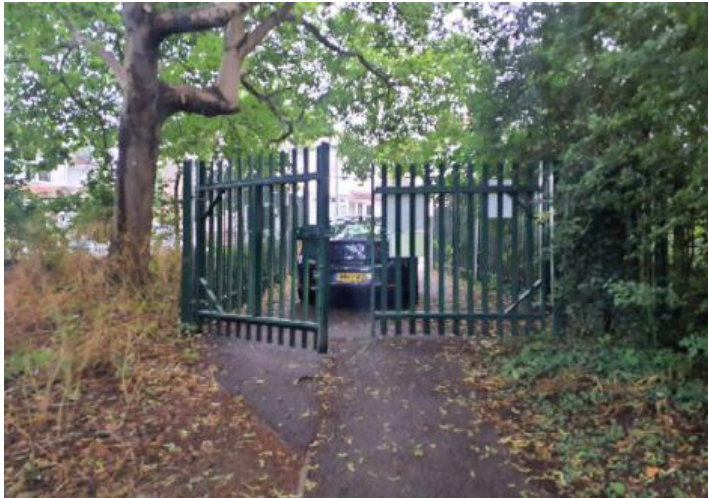
Item: Gates - Maintenance Gate
Manufacturer: Not Identified

Finding: The bitumen surface is worn or damaged

Action: Repair the bitumen to provide a uniform surface

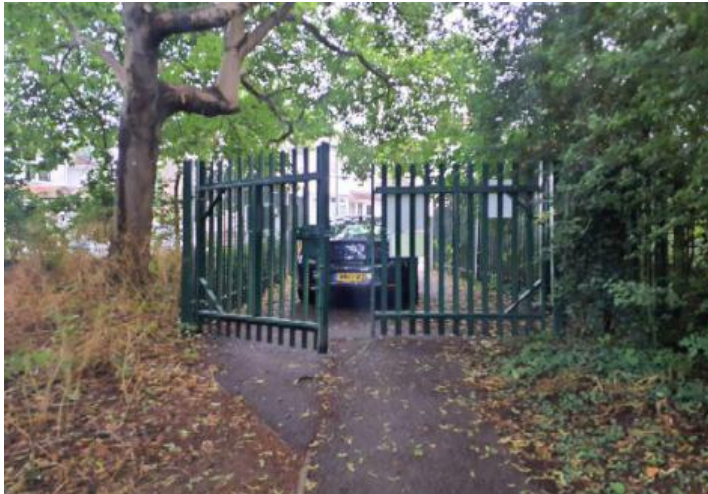
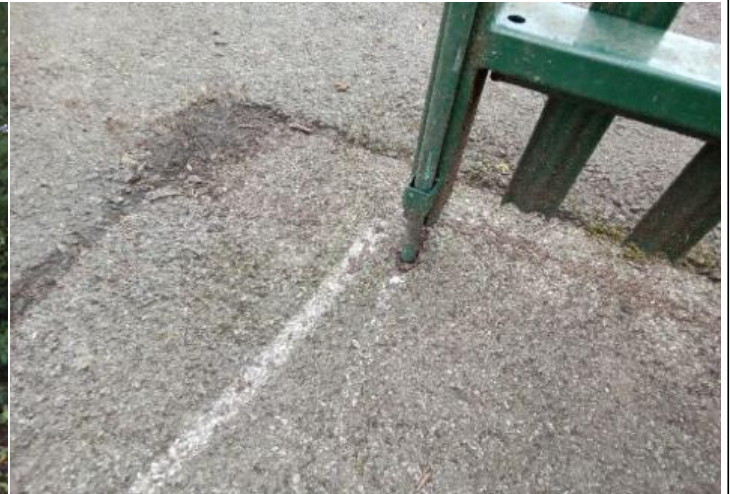
Item: Gates - Maintenance Gate
Manufacturer: Not Identified

Finding: The gate has no drop bolt sleeves and/or drop bolts fitted

Action: Provide drop bolt sleeves and/or drop bolts

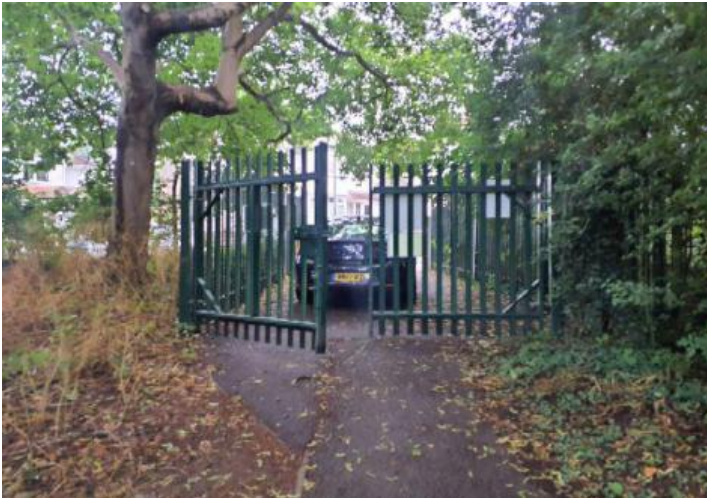
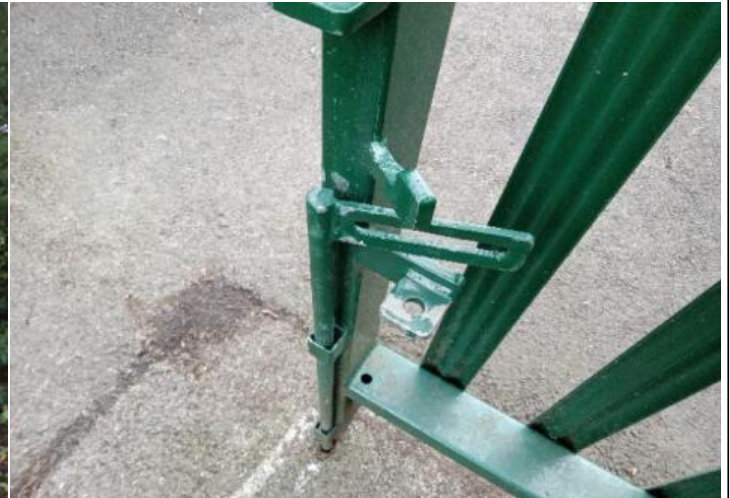
Item: Gates - Maintenance Gate
Manufacturer: Not Identified

Finding: There is no padlock on the maintenance gate

Action: Provide a padlock to secure the gate

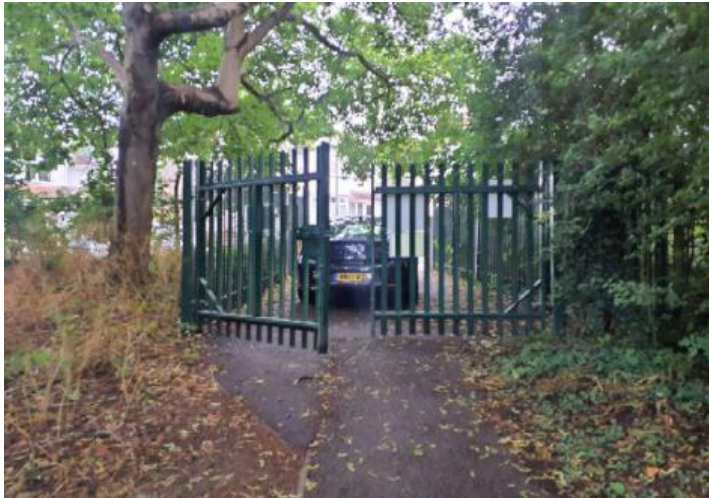
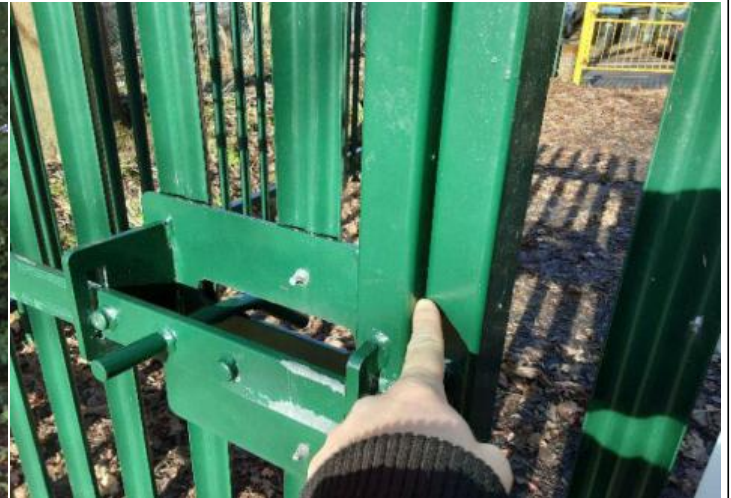
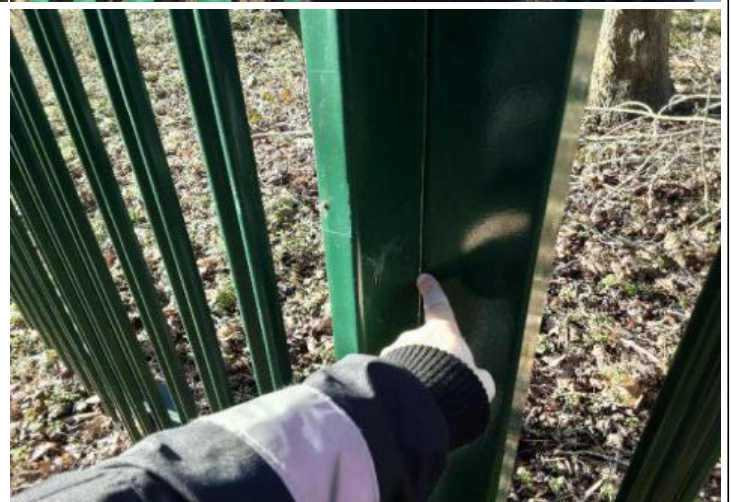
Item: Gates - Maintenance Gate
Manufacturer: Not Identified

Finding: There are openings that are less than 12mm that could trap or crush fingers

Action: Provide a 12mm gap throughout full range of motion at both sides of gate

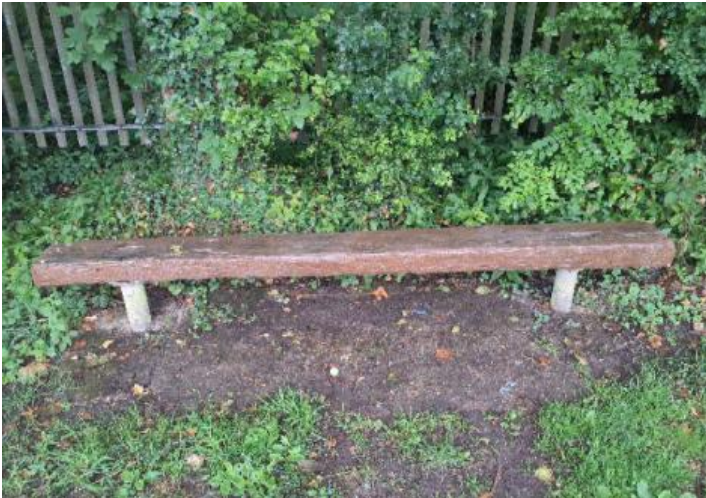
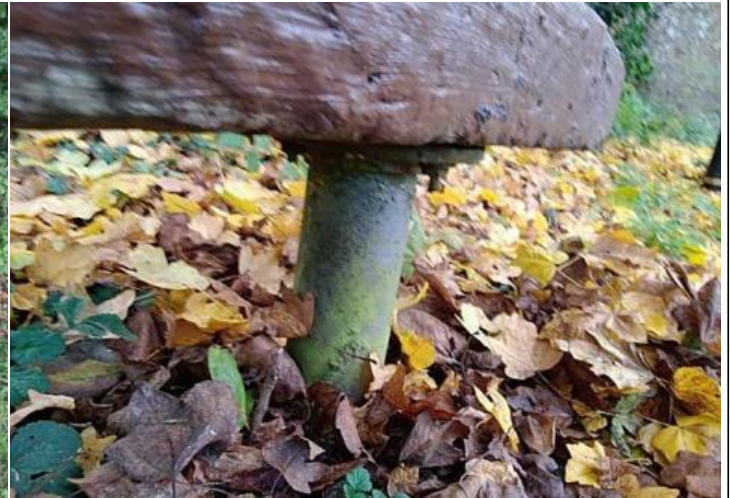
Item: Ancillary Items - Bench
Manufacturer: Not Identified

Finding: There are projecting bolt thread(s) present

Action: Remove excess thread length and deburr or provide cap

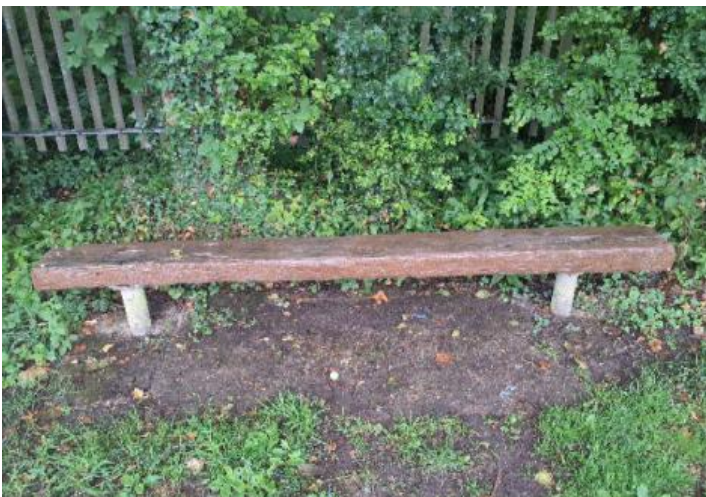
Item: Ancillary Items - Bench
Manufacturer: Not Identified

Finding: There is some evidence of rot in the timber

Action: Monitor for any further deterioration and replace as required

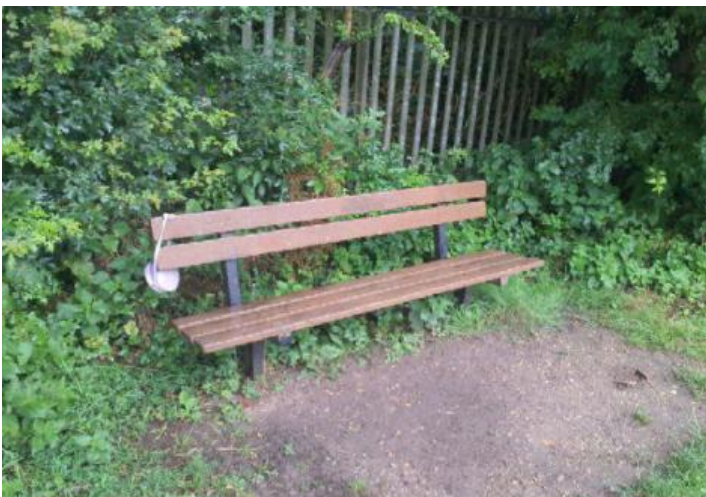
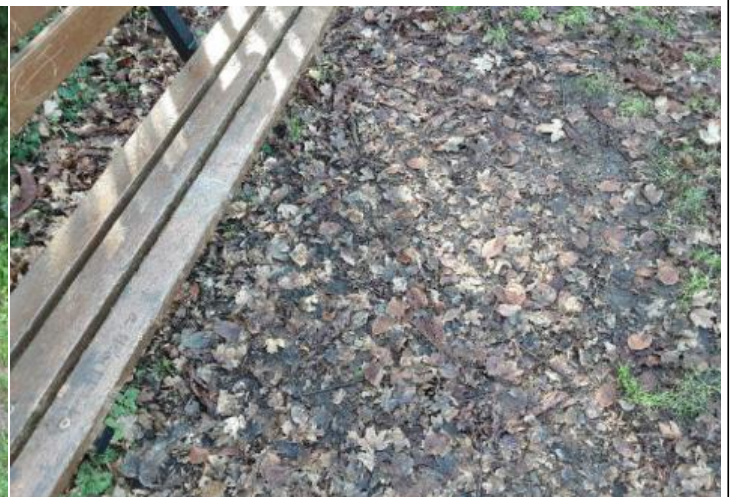
Item: Ancillary Items - Bench
Manufacturer: Not Identified

Finding: The surface has eroded in some areas

Action: Reinstate the surface

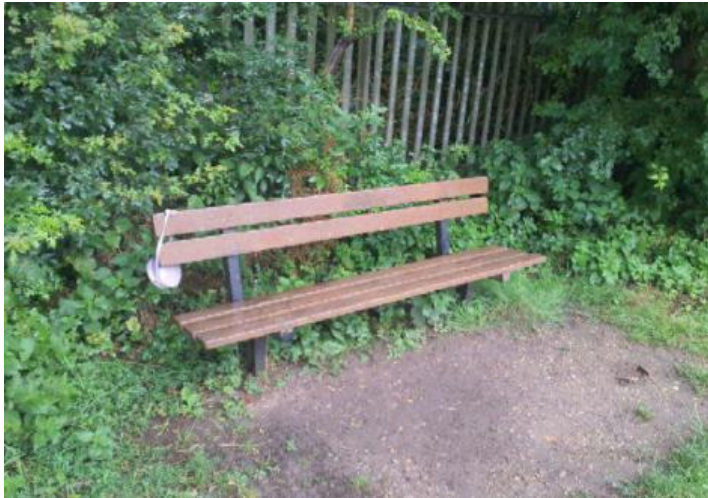
Item: Ancillary Items - Bench
Manufacturer: Not Identified

Finding: The paintwork on this item has been damaged or worn exposing the metal underneath which is rusting

Action: Treat any rusting components and repaint

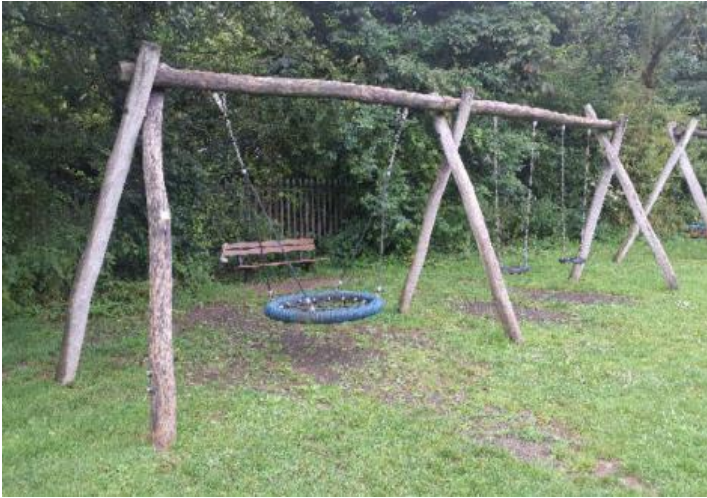
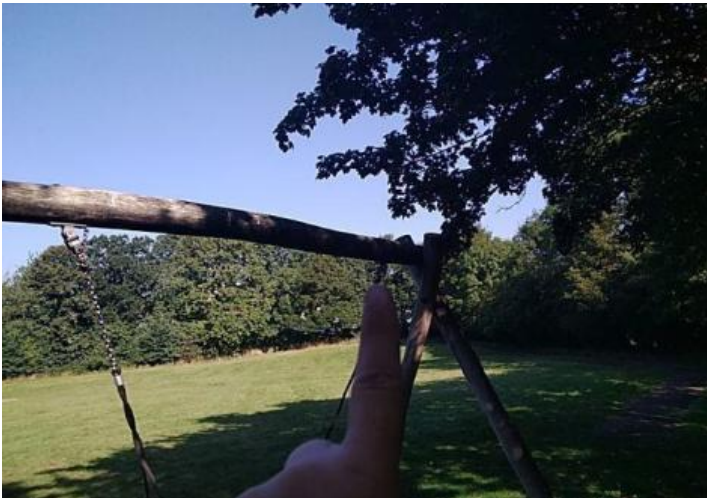
Item: Swings - 2 Bay 2 Flat 1 Basket Seat
Manufacturer: Kompan Ltd

Finding: A number of fixing(s) have worked loose on the secondary safety chain

Action: Secure all loose fixings

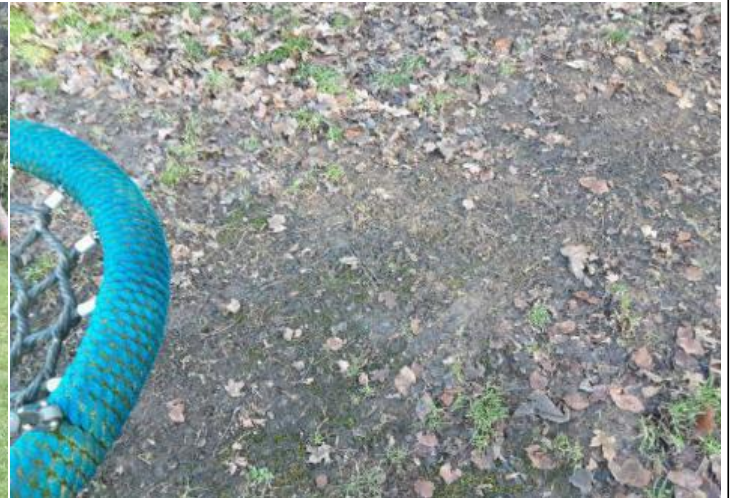
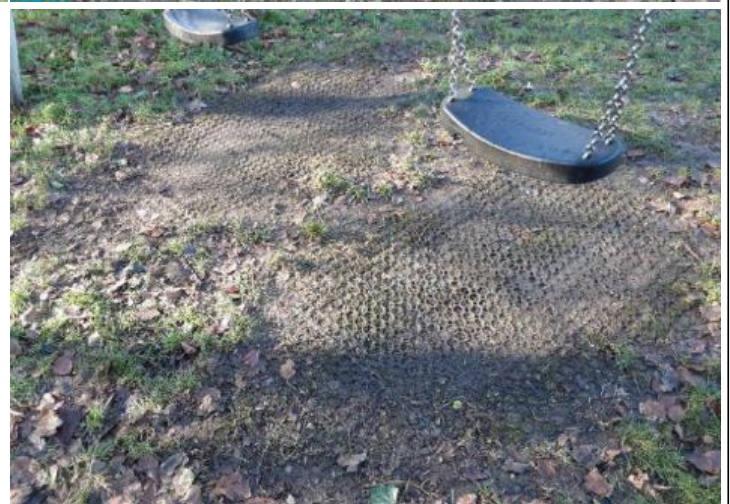
Item: Swings - 2 Bay 2 Flat 1 Basket Seat
Manufacturer: Kompan Ltd

Finding: The grass mats are silted up, the soil is compacted and the area will become very slippery when the soil is wet. **Action:** Reinstate as required

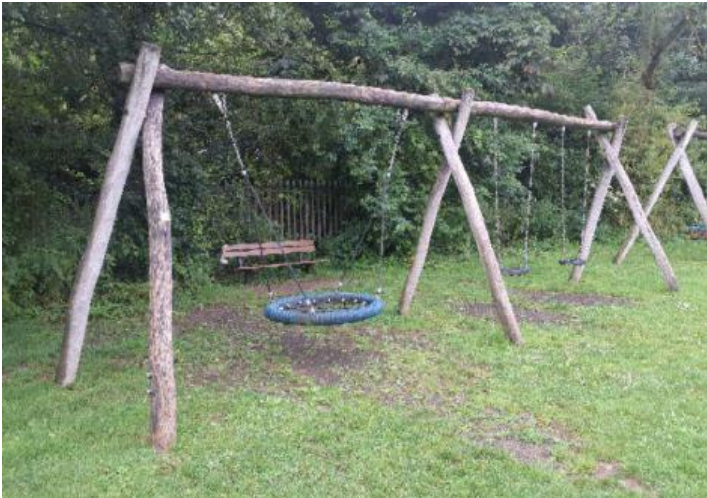
Item: Swings - 2 Bay 2 Flat 1 Basket Seat
Manufacturer: Kompan Ltd

Finding: This design of swing joint has been known to fail on the weld connecting the joint to the threaded stud

Action: We would recommend that the joint be dismantled and checked on a regular basis or consulting with manufacturer on whether a Secondary Safety Device can be fitted

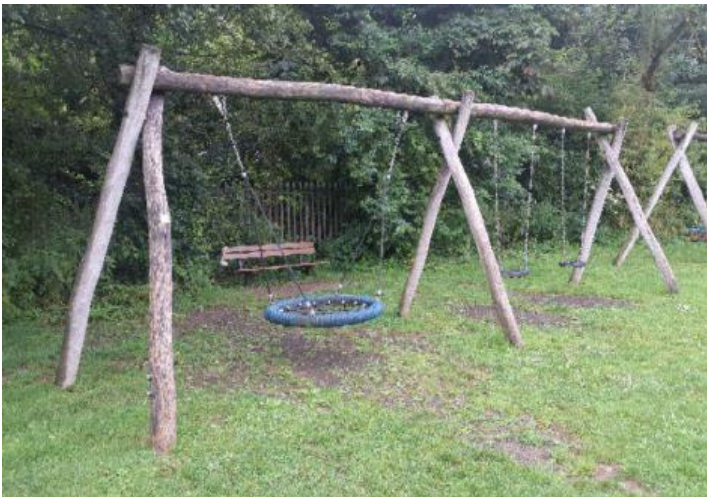
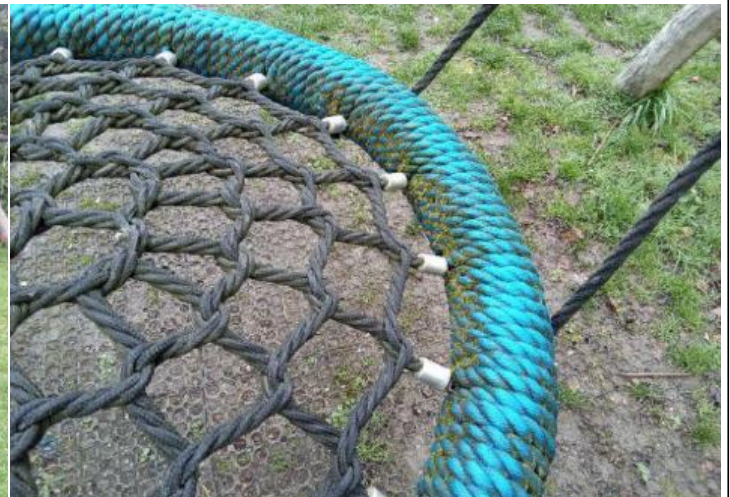
Item: Swings - 2 Bay 2 Flat 1 Basket Seat
Manufacturer: Kompan Ltd

Finding: There is algae or moss on the surface of the equipment

Action: Clean and treat appropriately

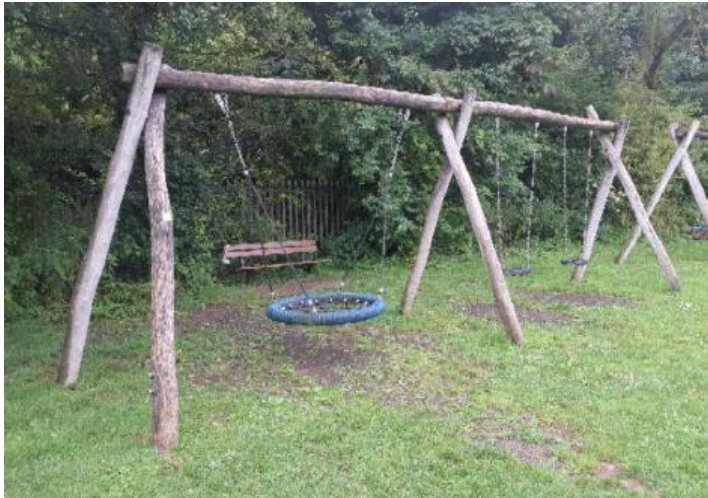
Item: Swings - 2 Bay 2 Flat 1 Basket Seat
Manufacturer: Kompan Ltd

Finding: The bushes are showing signs of wear

Action: Monitor for any further deterioration and replace as required

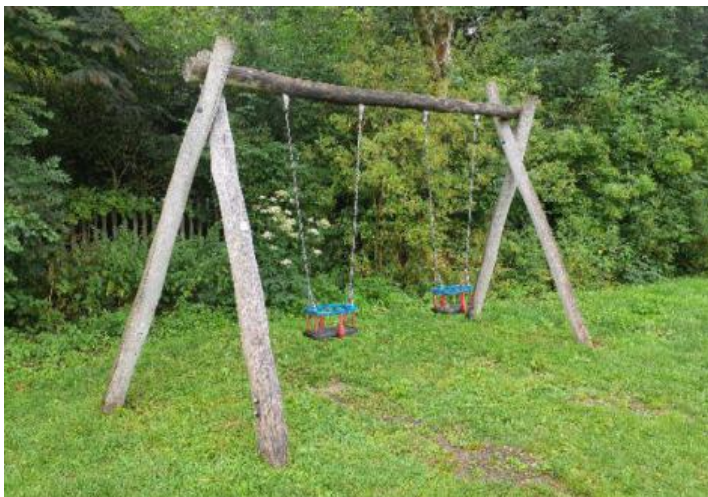
Item: Swings - 1 Bay 2 Seat (Cradle)
Manufacturer: Kompan Ltd

Finding: The timber has a number of splits/shakes or air cracks and this may affect the stability or allow water ingress which will accelerate the rotting process

Action: Monitor to ensure the splits do not cross through fixing points of the structure and/or cause any instability

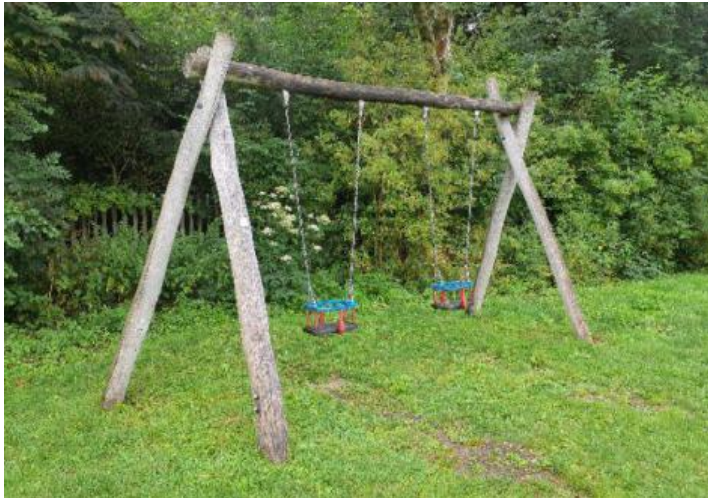
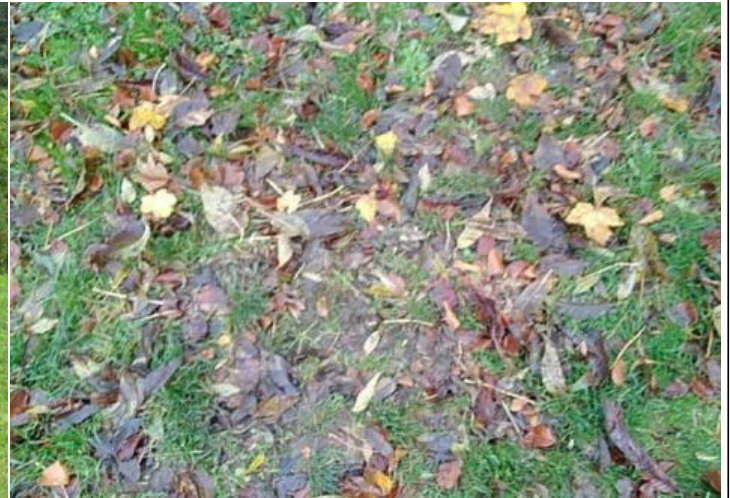
Item: Swings - 1 Bay 2 Seat (Cradle)
Manufacturer: Kompan Ltd

Finding: The grass mats are silted up, the soil is compacted and the area will become very slippery when the soil is wet. **Action:** Reinststate as required

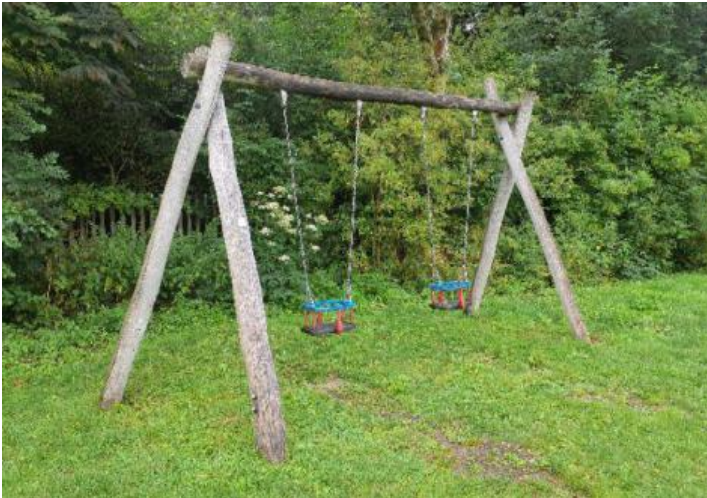
Item: Swings - 1 Bay 2 Seat (Cradle)
Manufacturer: Kompan Ltd

Finding: The swing seat frame is severely corroded and requires replacement

Action: Replace seat

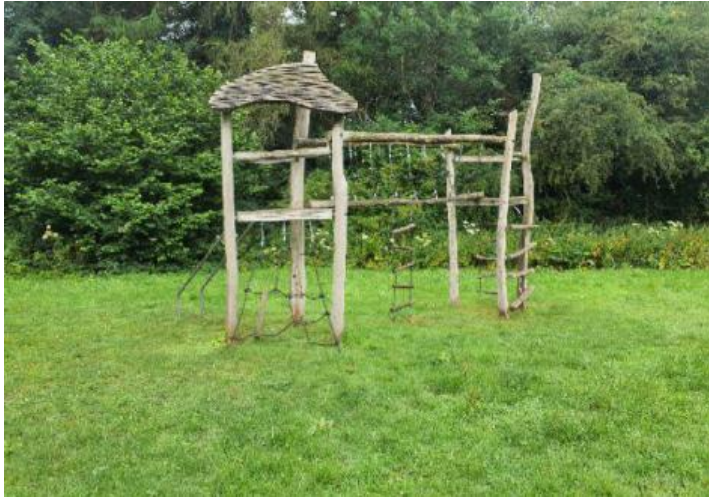
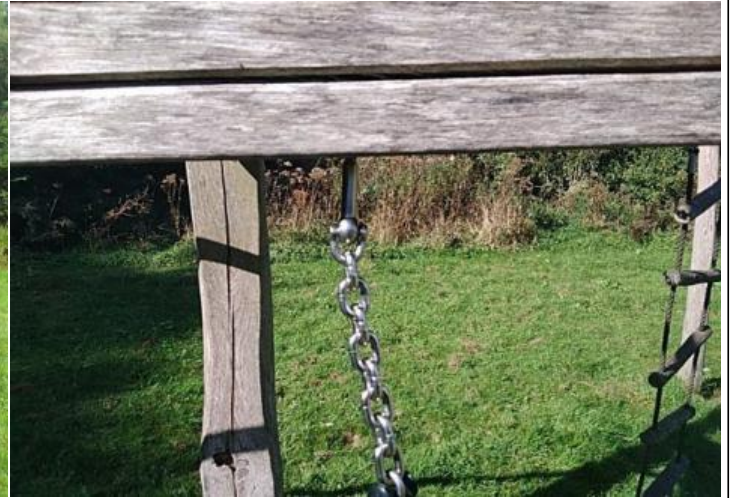
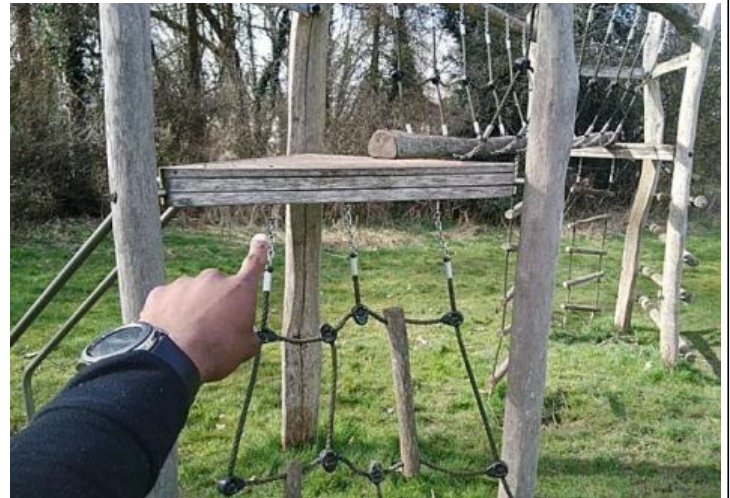
Item: Activity Equipment - Climbing Frame
Manufacturer: Kompan Ltd

Finding: A fixing appears to have been unscrewed

Action: Secure correctly

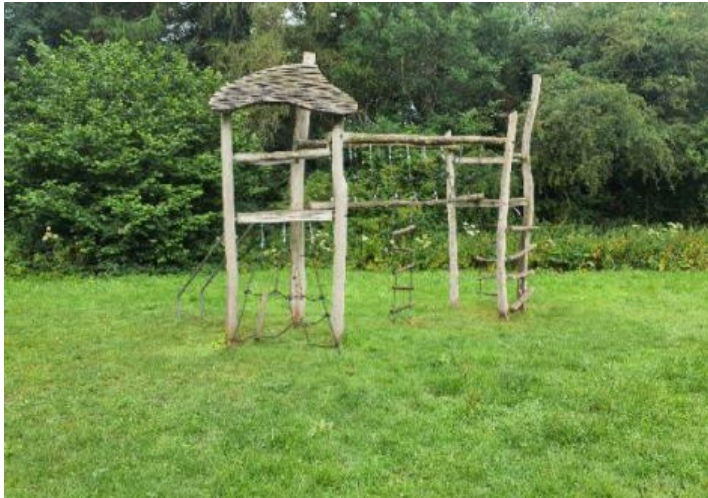
Item: Activity Equipment - Climbing Frame
Manufacturer: Kompan Ltd

Finding: There is some strimmer / machinery damage apparent on the posts, this can penetrate the preservative applied to the timber and accelerate the rotting process

Action: Monitor for any deterioration (rot) and replace as required

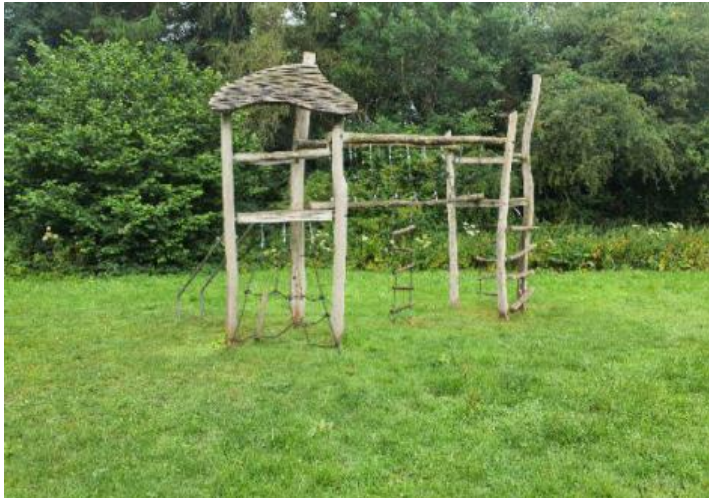
Item: Activity Equipment - Climbing Frame
Manufacturer: Kompan Ltd

Finding: The ropes/nets are worn/damaged in places

Action: Monitor for any further deterioration and repair or replace as required

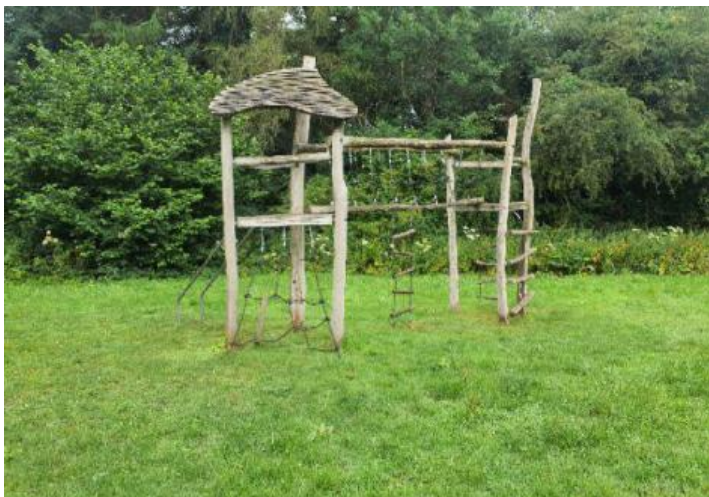
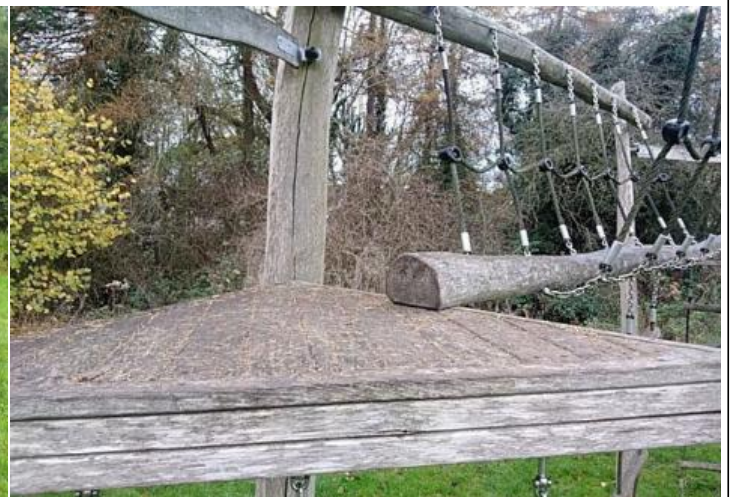
Item: Activity Equipment - Climbing Frame
Manufacturer: Kompan Ltd

Finding: There is algae or moss on the surface of the equipment

Action: Clean and treat appropriately

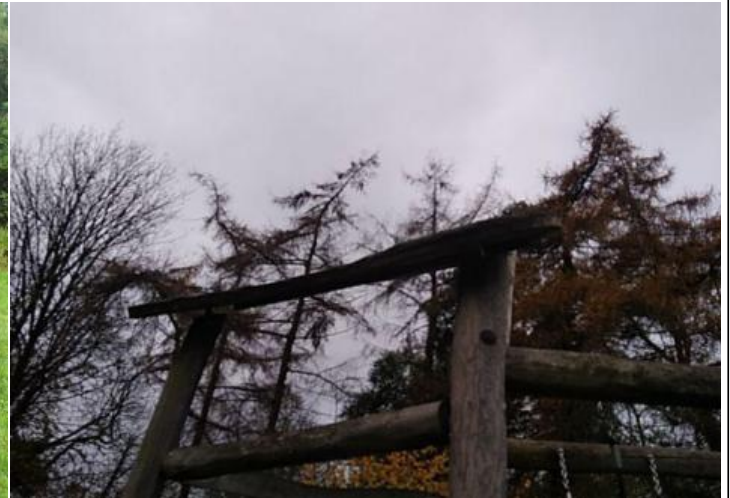
Item: Activity Equipment - Climbing Frame
Manufacturer: Kompan Ltd

Finding: The roof slats are lifting

Action: Monitor for any further deterioration and repair as required

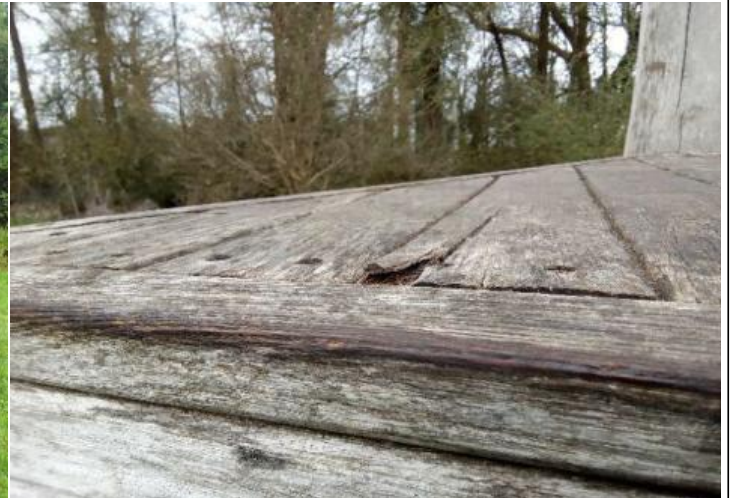
Item: Activity Equipment - Climbing Frame
Manufacturer: Kompan Ltd

Finding: Parts of the timber are rough or splintered

Action: Remove all rough or sharp edges

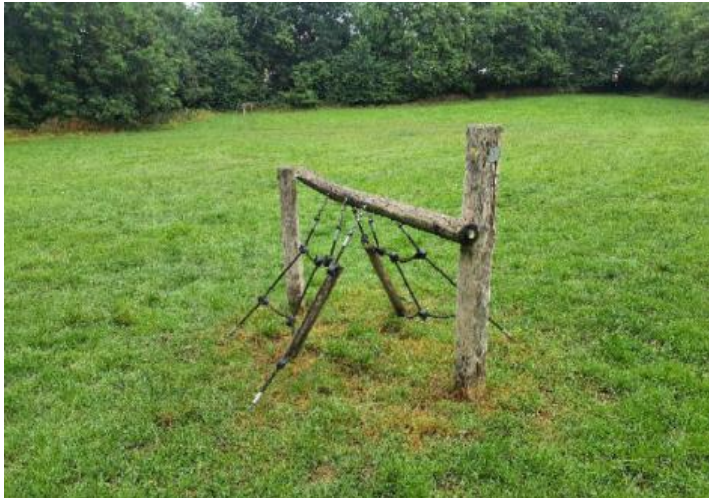
Item: Activity Equipment - A Frame Climber
Manufacturer: Kompan Ltd

Finding: The timber has a number of splits/shakes or air cracks and this may affect the stability or allow water ingress which will accelerate the rotting process

Action: Monitor to ensure the splits do not cross through fixing points of the structure and/or cause any instability

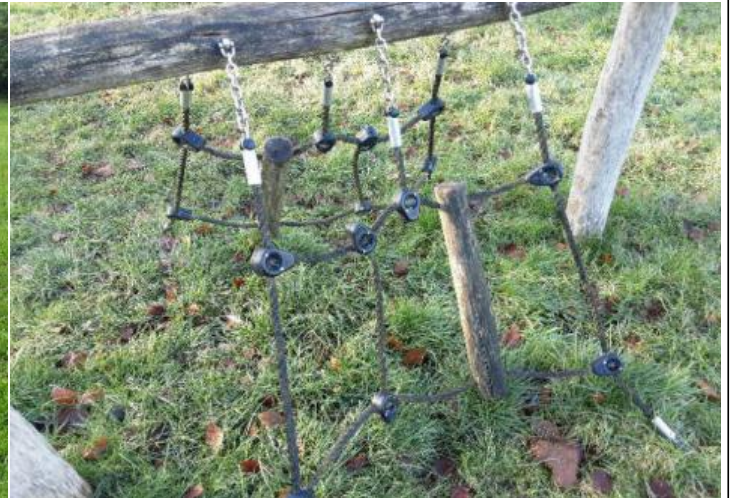
Item: Activity Equipment - A Frame Climber
Manufacturer: Kompan Ltd

Finding: There is algae or moss on the surface of the equipment

Action: Clean and treat appropriately
