the **play** inspection company

Operational Inspection

Nashmills Parish Council

Bunkers Lane Play Area

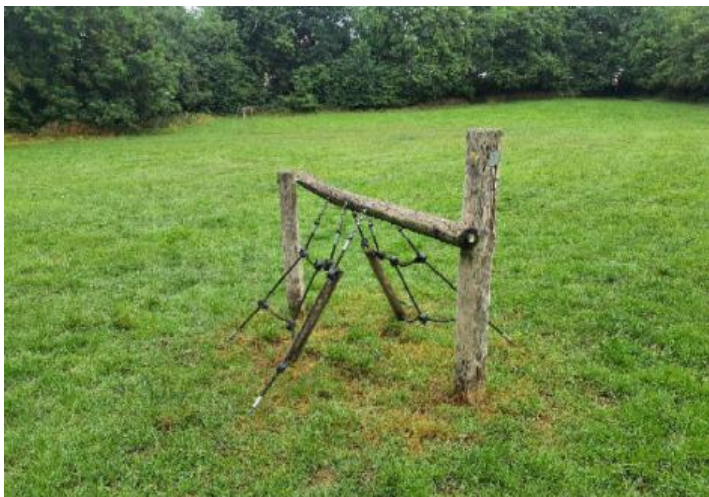
Item: Activity Equipment - A Frame Climber
Manufacturer: Kompan Ltd

Finding: There is some evidence of rot in the timber

Action: Monitor for any further deterioration and replace as required

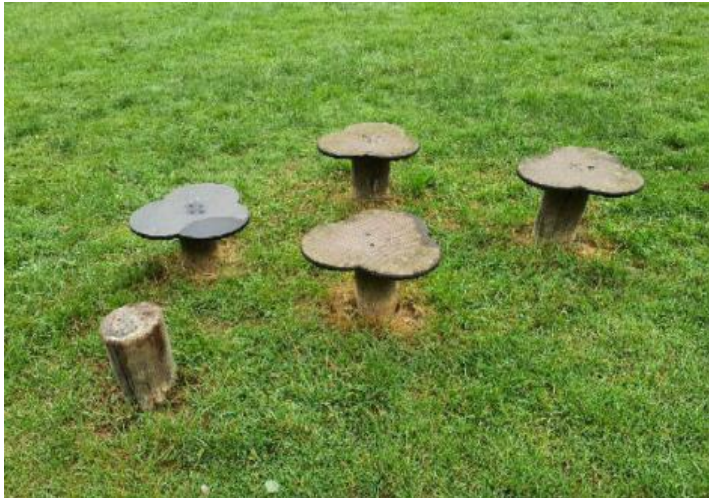
Item: Activity Equipment - Log Walk
Manufacturer: Kompan Ltd

Finding: The platforms are rotting and the fixings are pulling through
Action: Replace all affected timber

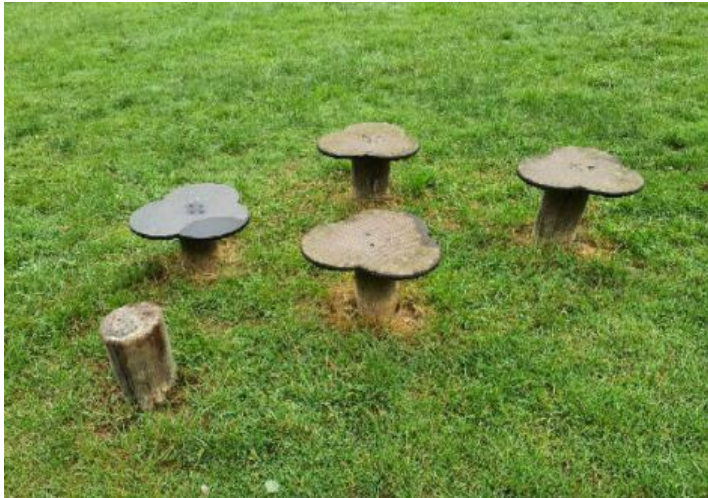
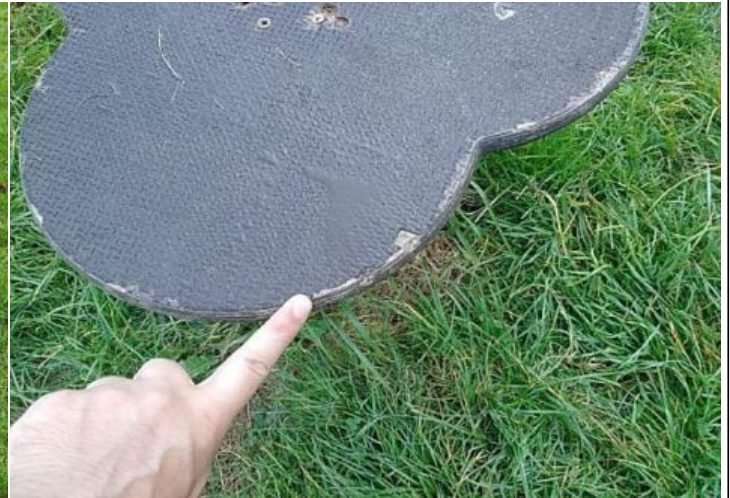
Item: Activity Equipment - Log Walk
Manufacturer: Kompan Ltd

Finding: Parts of the timber are rough or splintered

Action: Remove all rough or sharp edges

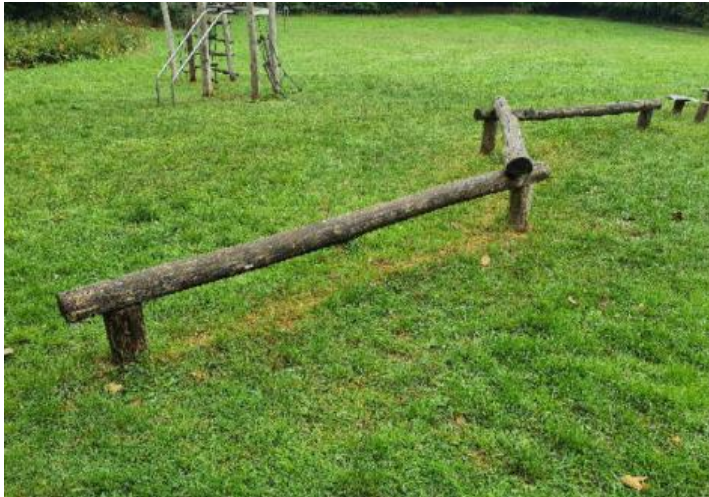
Item: Activity Equipment - Balance Beam
Manufacturer: Kompan Ltd

Finding: The use of synthetic fillers in timber is not recommended; timber being a natural material will expand and contract as the moisture content changes and the use of fillers can exacerbate the length and depth of these cracks or shakes in the timber. The only treatment that is normally required is the removal of any rough or sharp edges unless the structural integrity of the item is affected.

Action: Remove any rough or sharp edges and monitor timber for any further deterioration

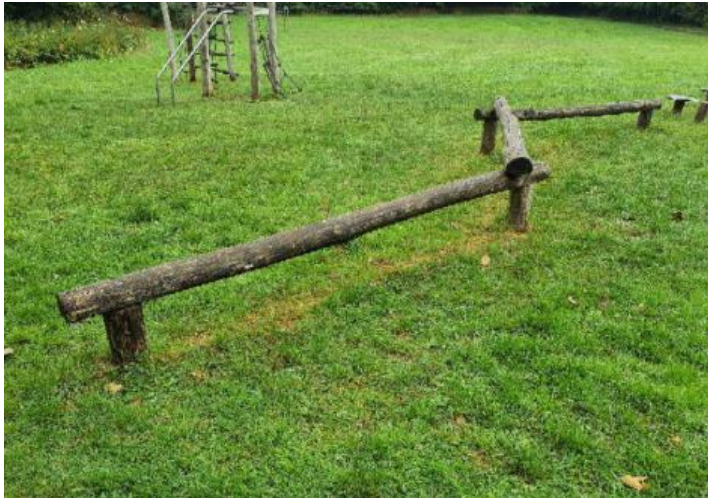
Item: Activity Equipment - Balance Beam
Manufacturer: Kompan Ltd

Finding: There is some strimmer / machinery damage apparent on the posts, this can penetrate the preservative applied to the timber and accelerate the rotting process

Action: Monitor for any deterioration (rot) and replace as required

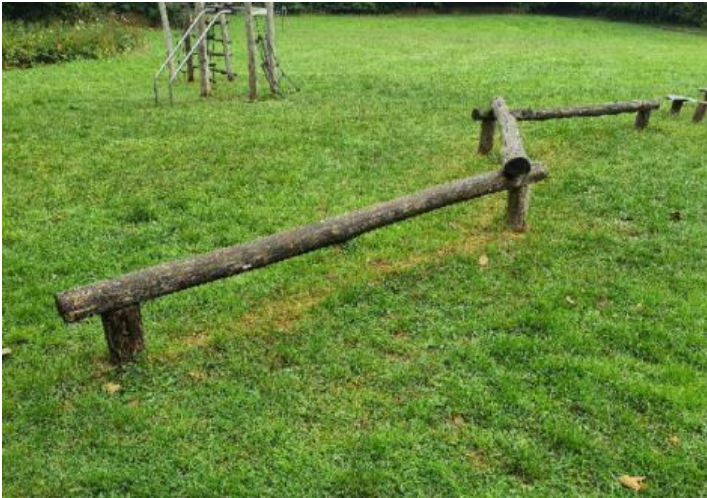
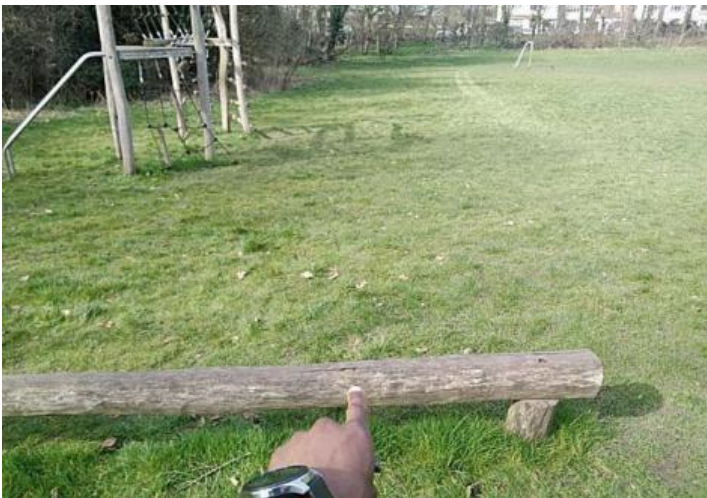
Item: Activity Equipment - Balance Beam
Manufacturer: Kompan Ltd

Finding: There is some evidence of rot in the timber

Action: Monitor for any further deterioration and replace as required

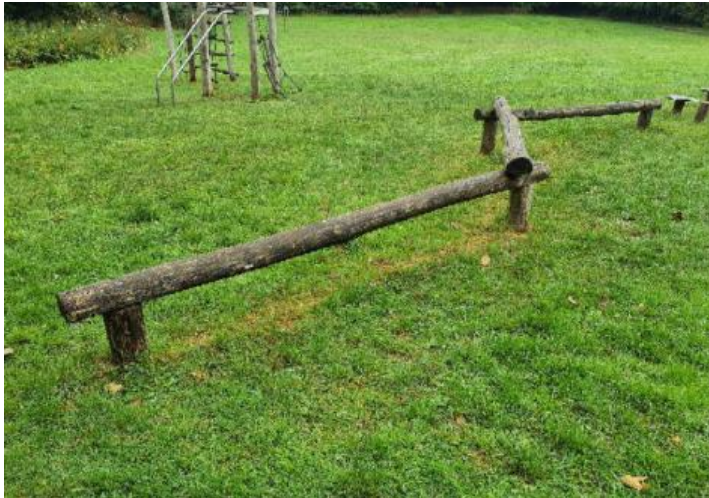
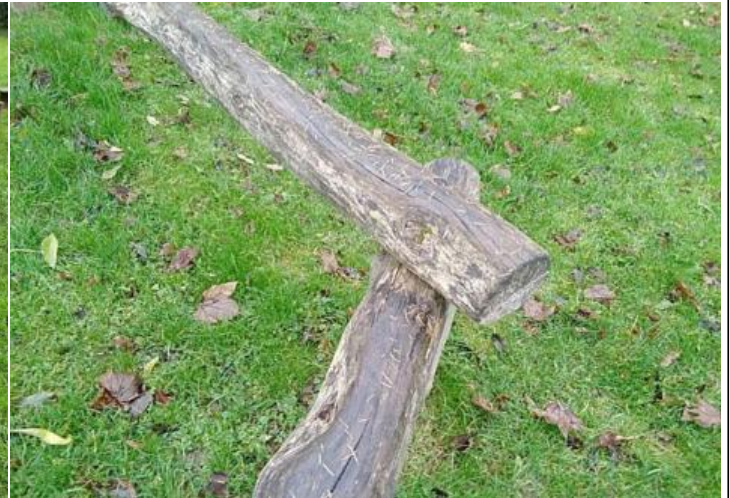
Item: Activity Equipment - Balance Beam
Manufacturer: Kompan Ltd

Finding: There is algae or moss on the surface of the equipment

Action: Clean and treat appropriately

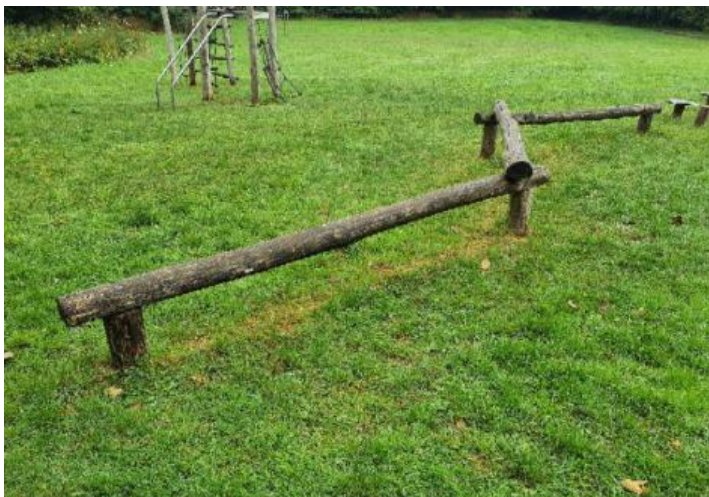
Item: Activity Equipment - Balance Beam
Manufacturer: Kompan Ltd

Finding: The timber has a number of splits/shakes or air cracks and this may affect the stability or allow water ingress which will accelerate the rotting process

Action: Monitor to ensure the splits do not cross through fixing points of the structure and/or cause any instability

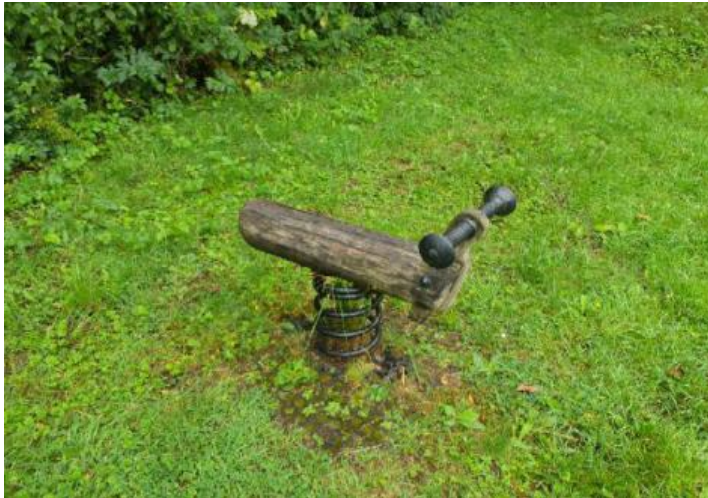
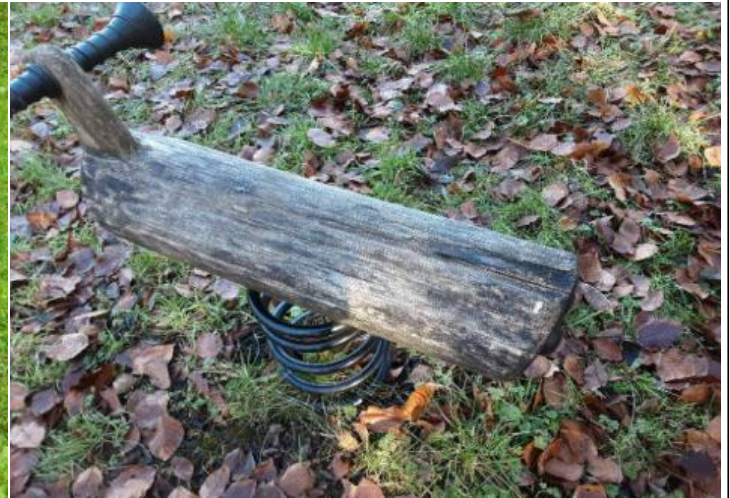
Item: Rocking Equipment - Misc Springer
Manufacturer: Kompan Ltd

Finding: Parts of the timber are rough or splintered

Action: Remove all rough or sharp edges

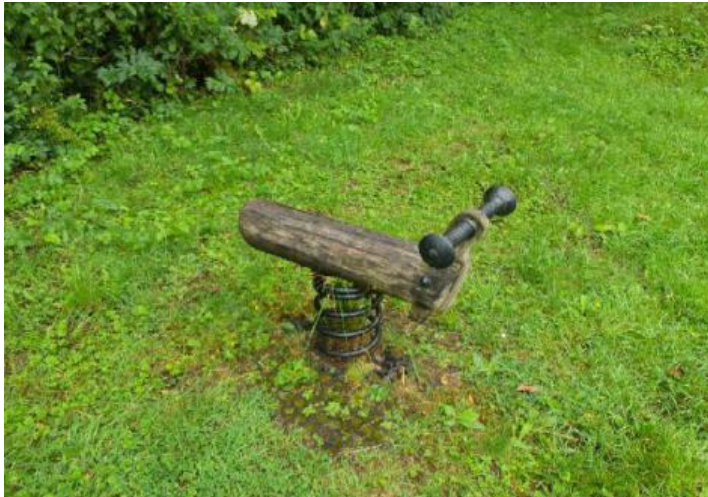
Item: Rocking Equipment - Misc Springer
Manufacturer: Kompan Ltd

Finding: There is some minor damage to the hand grips

Action: Monitor for any further deterioration and replace as required

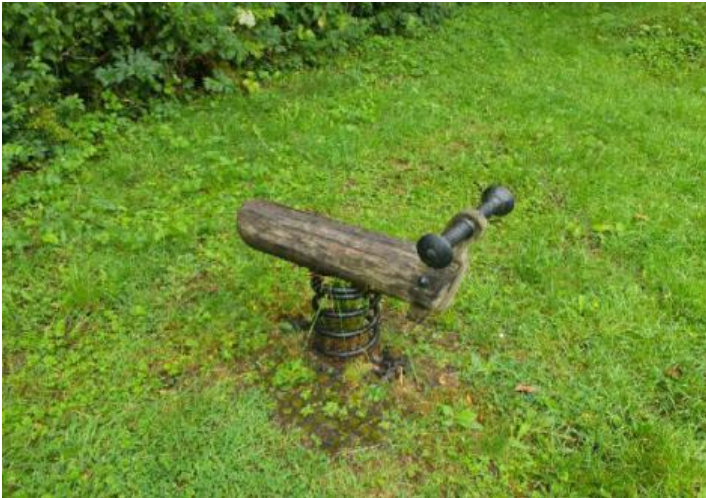
Item: Rocking Equipment - Misc Springer
Manufacturer: Kompan Ltd

Finding: The item has been damaged

Action: Monitor for any further deterioration and replace as required

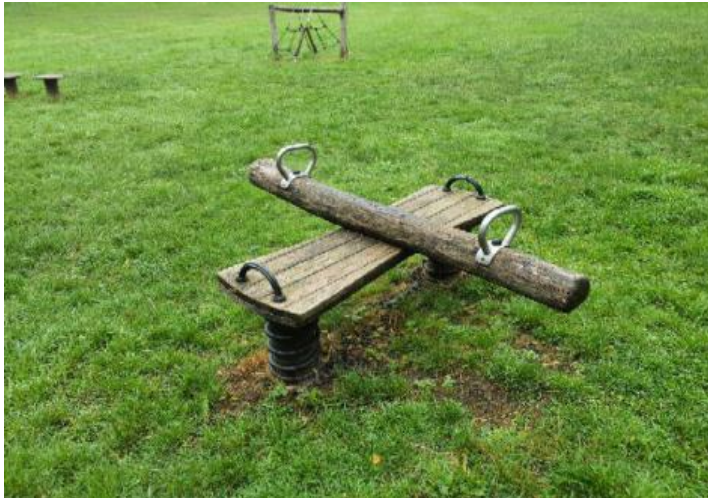
Item: Rocking Equipment - Spring See-Saw
Manufacturer: Kompan Ltd

Finding: The use of synthetic fillers in timber is not recommended; timber being a natural material will expand and contract as the moisture content changes and the use of fillers can exacerbate the length and depth of these cracks or shakes in the timber. The only treatment that is normally required is the removal of any rough or sharp edges unless the structural integrity of the item is affected.

Action: Remove any rough or sharp edges and monitor timber for any further deterioration

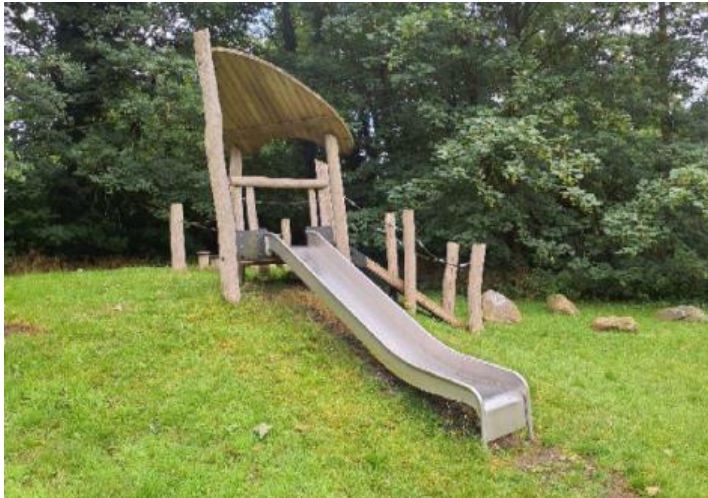
Item: Activity Equipment - Multi Play (Toddler)
Manufacturer: Kompan Ltd

Finding: There are a number of dents in the slide surface

Action: Monitor for any further deterioration and repair as required

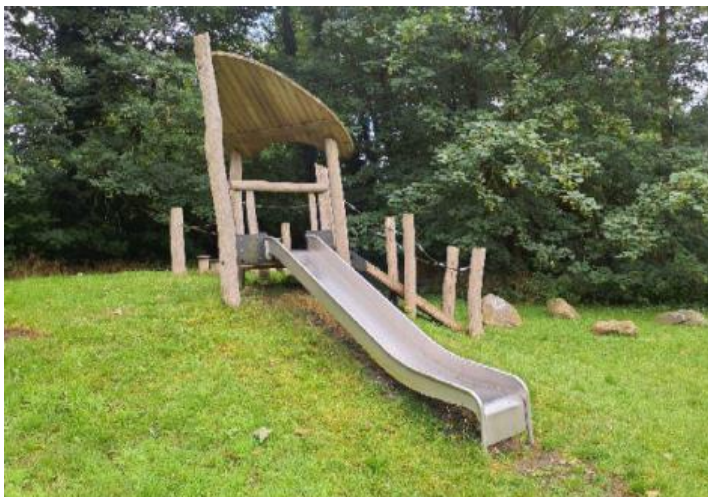
Item: Activity Equipment - Multi Play (Toddler)
Manufacturer: Kompan Ltd

Finding: The timber has a number of splits/shakes or air cracks and this may affect the stability or allow water ingress which will accelerate the rotting process

Action: Monitor to ensure the splits do not cross through fixing points of the structure and/or cause any instability

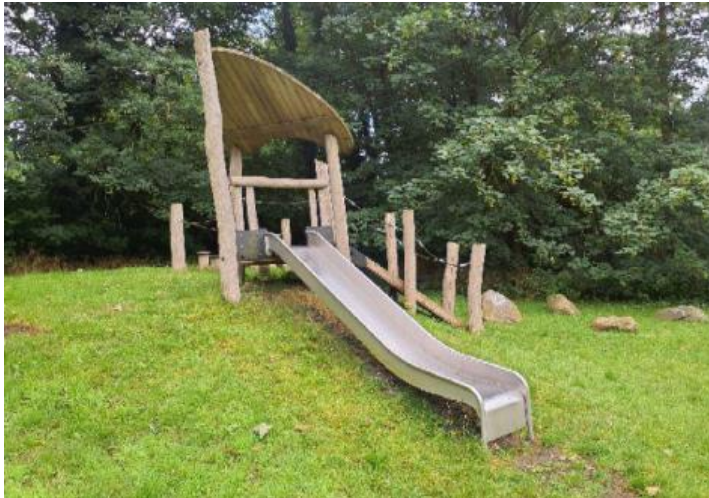
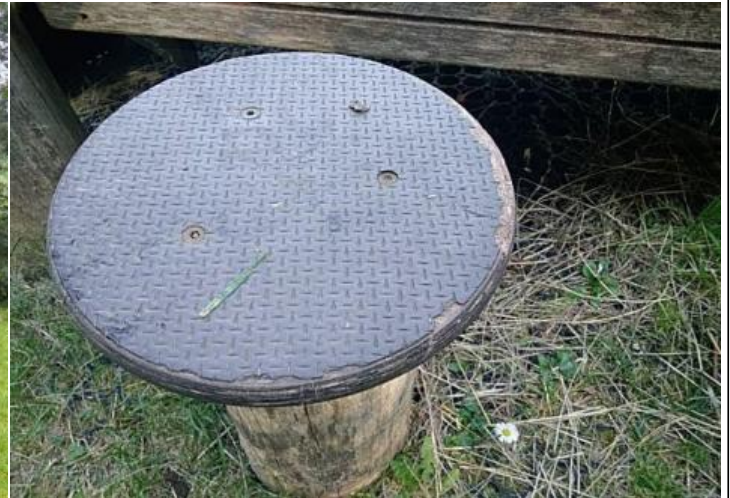
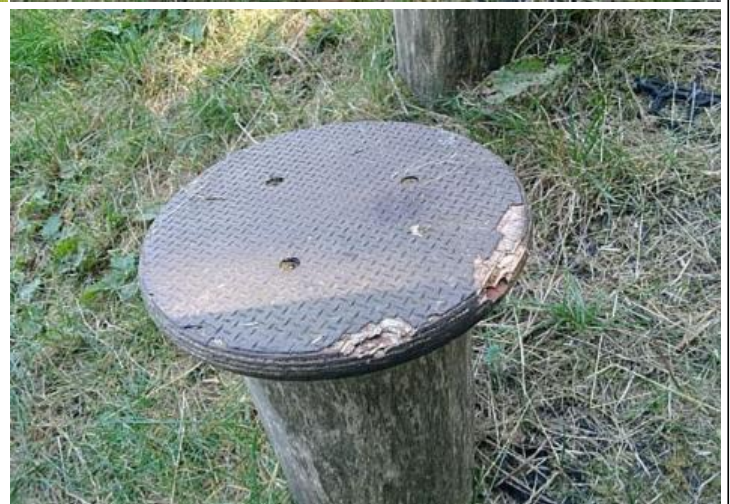
Item: Activity Equipment - Multi Play (Toddler)
Manufacturer: Kompan Ltd

Finding: Parts of the timber are rough or splintered

Action: Remove all rough or sharp edges

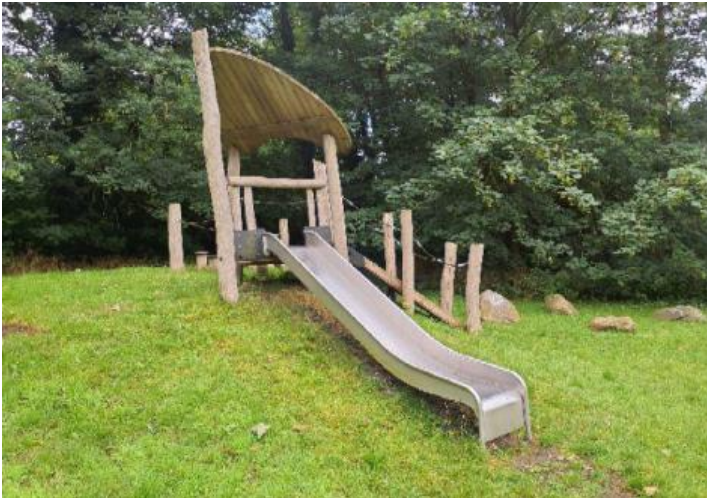
Item: Activity Equipment - Multi Play (Toddler)
Manufacturer: Kompan Ltd

Finding: There is some evidence of rot in the timber

Action: Monitor for any further deterioration and replace as required

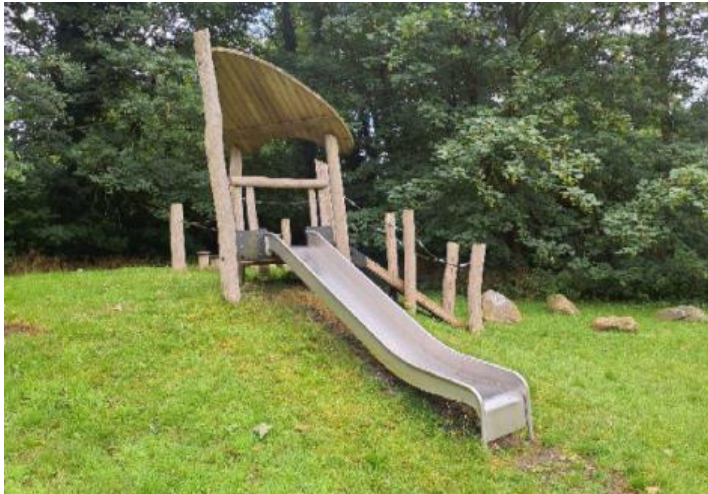
Item: Activity Equipment - Multi Play (Toddler)
Manufacturer: Kompan Ltd

Finding: There are areas or parts of the timber on the structure that have rotted

Action: Replace all affected timbers

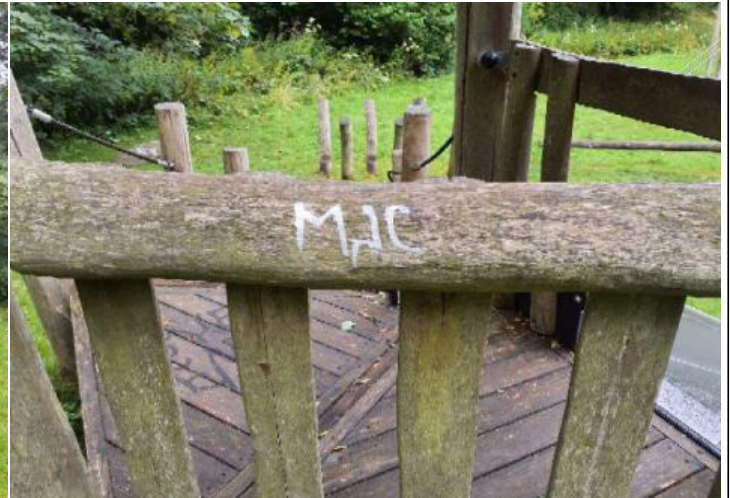
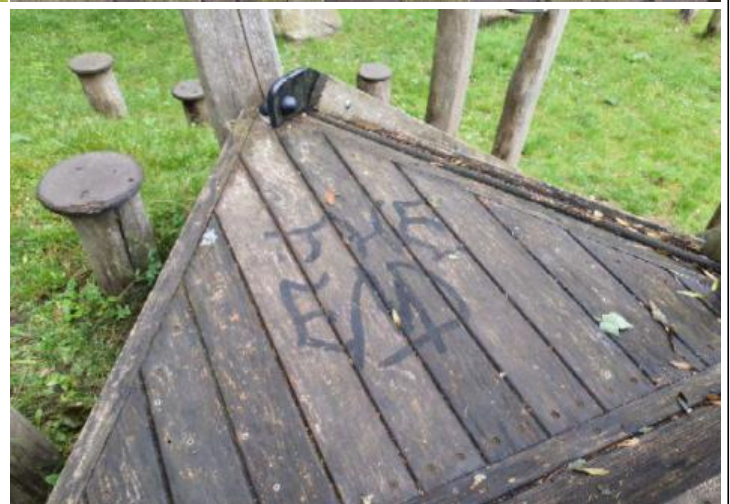
Item: Activity Equipment - Multi Play (Toddler)
Manufacturer: Kompan Ltd

Finding: There is some graffiti present

Action: Remove the graffiti

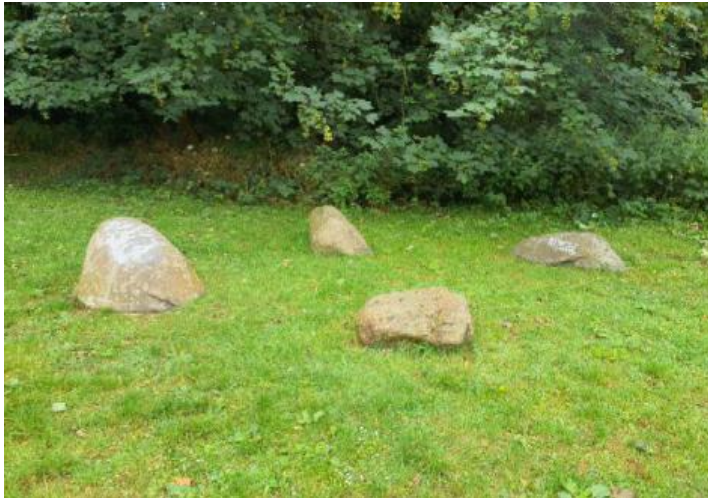
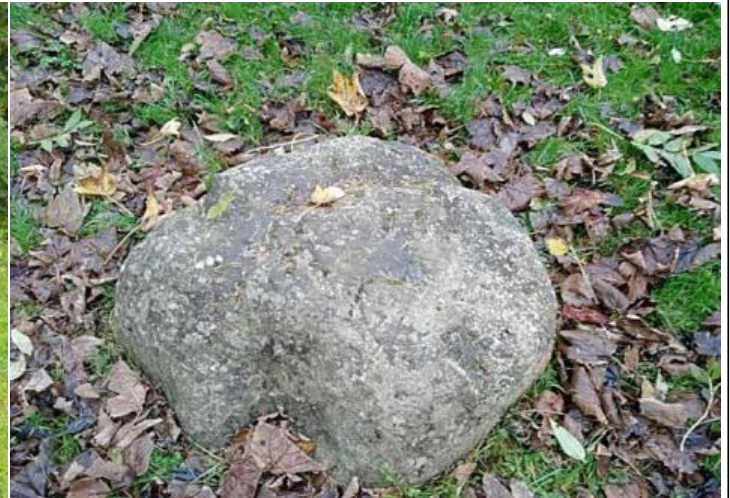
Item: Ancillary Items - Boulders
Manufacturer: Natural Feature

Finding: The rocks and/or boulders have moss/algae growth apparent

Action: Clean and maintain

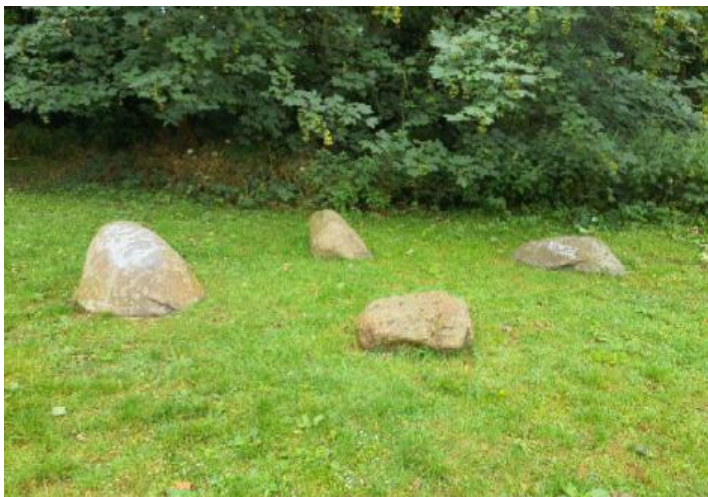
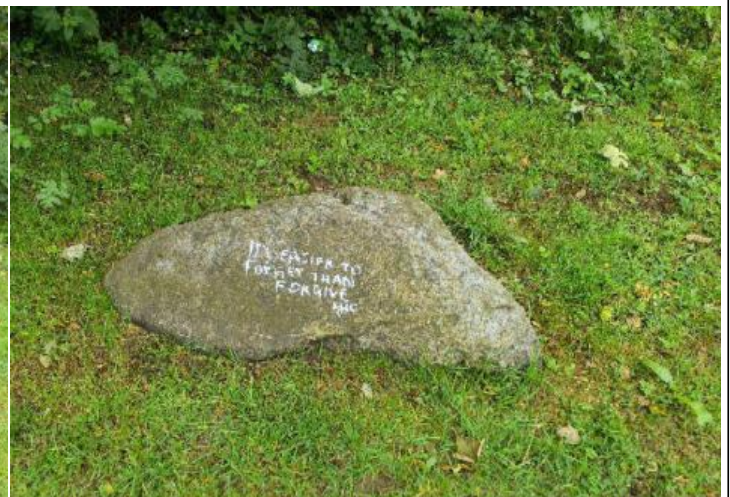
Item: Ancillary Items - Boulders
Manufacturer: Natural Feature

Finding: There is some graffiti present

Action: Remove the graffiti

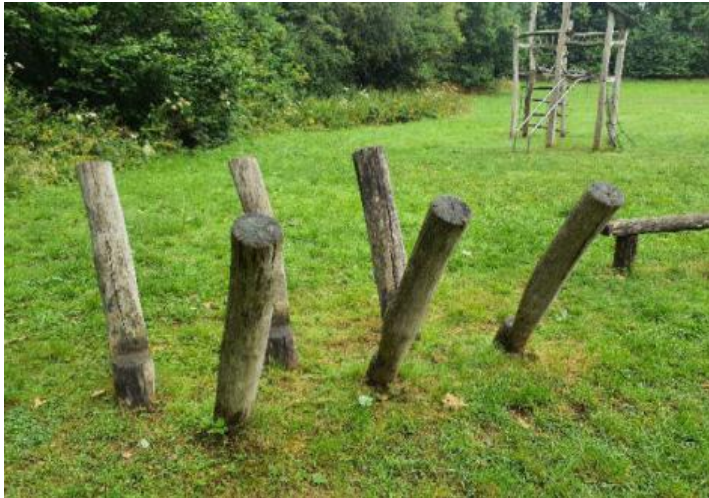
Item: Activity Equipment - Stilts
Manufacturer: Kompan Ltd

Finding: The timber has a number of splits/shakes or air cracks and this may affect the stability or allow water ingress fixing points of the structure and/or cause any instability which will accelerate the rotting process

Action: Monitor to ensure the splits do not cross through

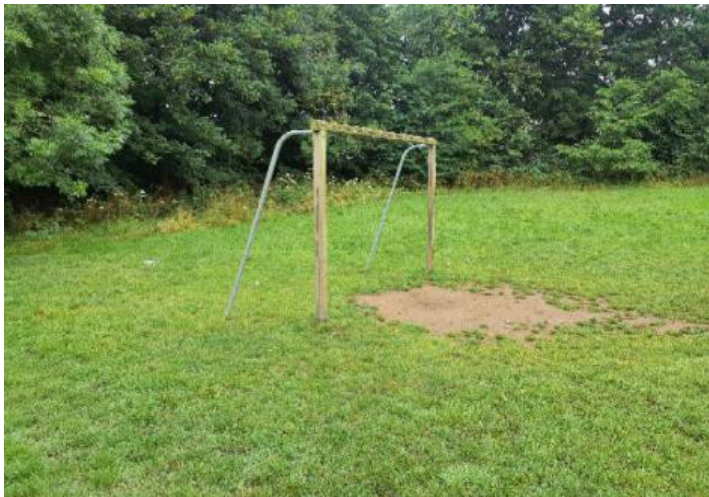
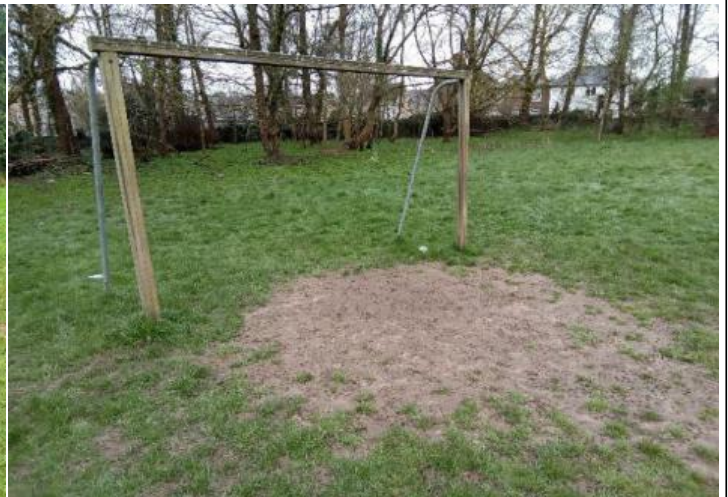
Item: Multi Use Games Area - Football Goal
Manufacturer: Kompan Ltd

Finding: The surface has eroded in some areas

Action: Reinstate the surface

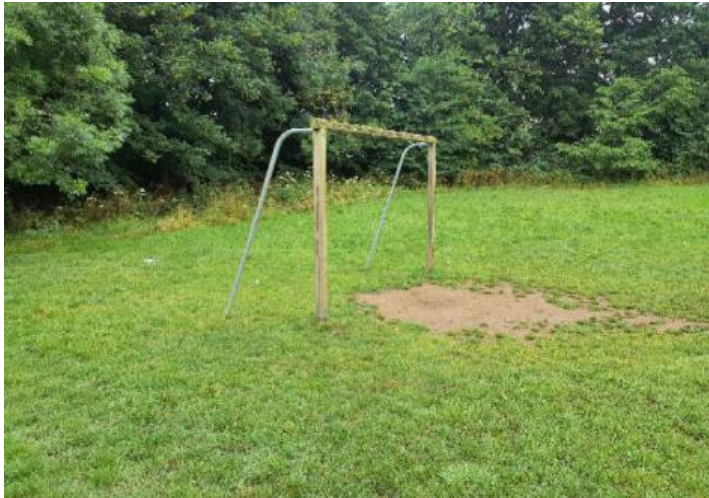
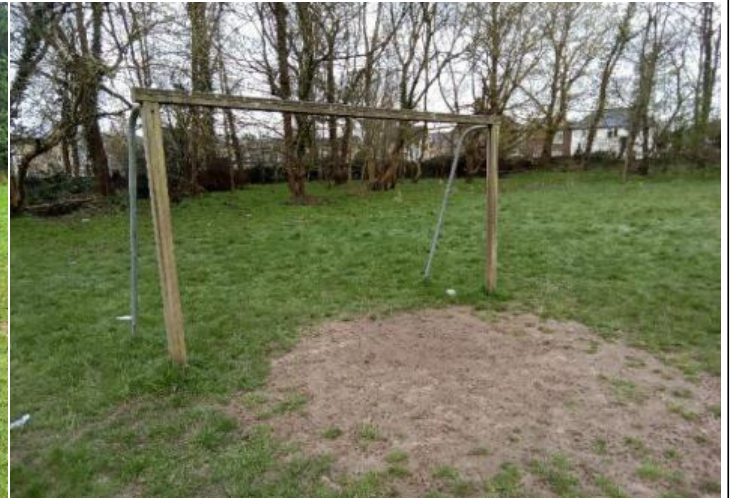
Item: Multi Use Games Area - Football Goal
Manufacturer: Kompan Ltd

Finding: NB: We have undertaken a maintenance inspection only of the football goal(s); full load testing falls outside the scope of our inspection.

Action: Implement load testing as required

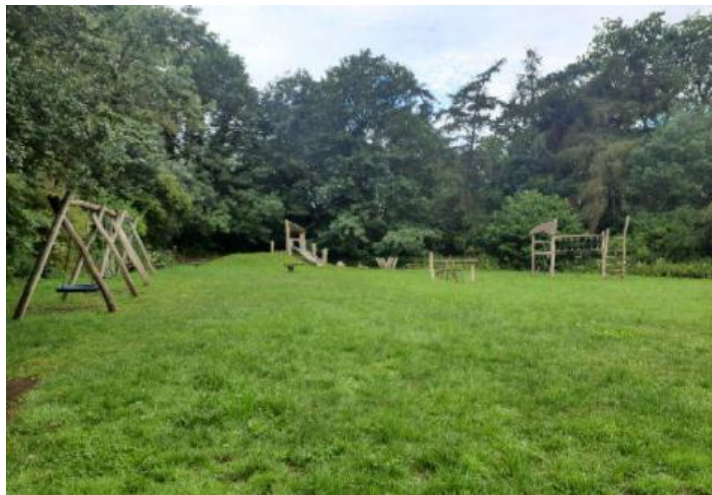
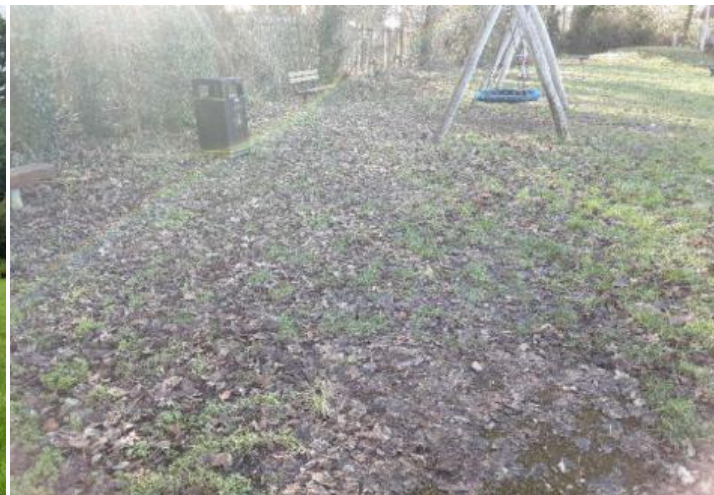
Item: Ancillary Items - Site General
Manufacturer: Owner/Operator

Finding: There is some tree debris on the surfacing

Action: Remove and maintain

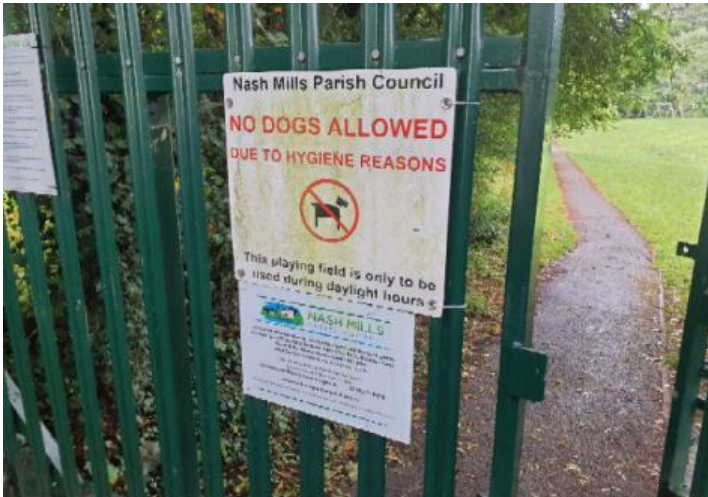
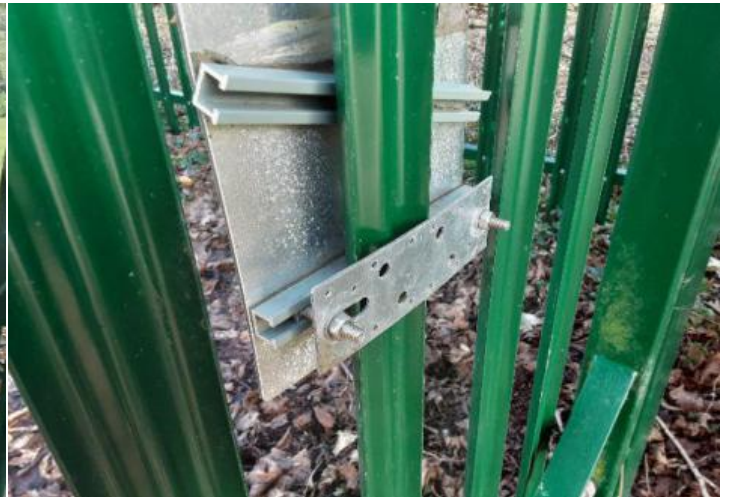
Item: Ancillary Items - Sign
Manufacturer: Owner/Operator

Finding: There are projecting bolt thread(s) present

Action: Remove excess thread length and deburr or provide cap

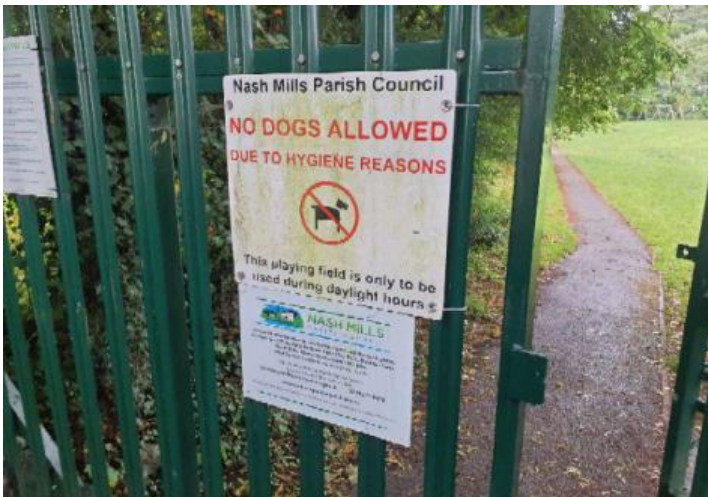
Item: Ancillary Items - Sign
Manufacturer: Owner/Operator

Finding: There is or are fixings missing on the item

Action: Replace all missing fixings

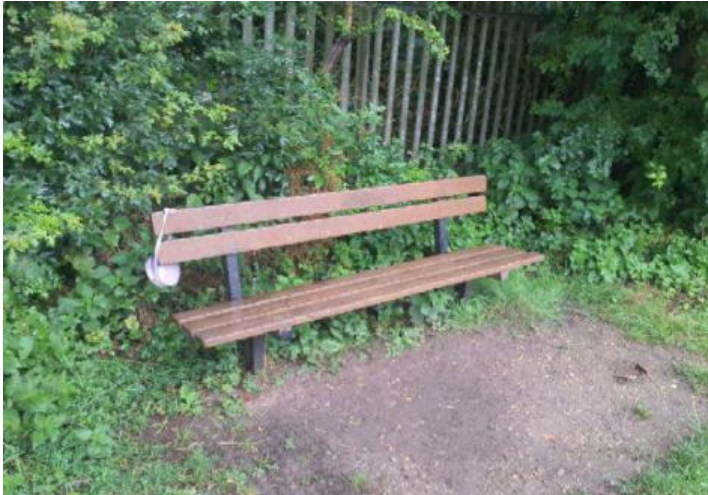
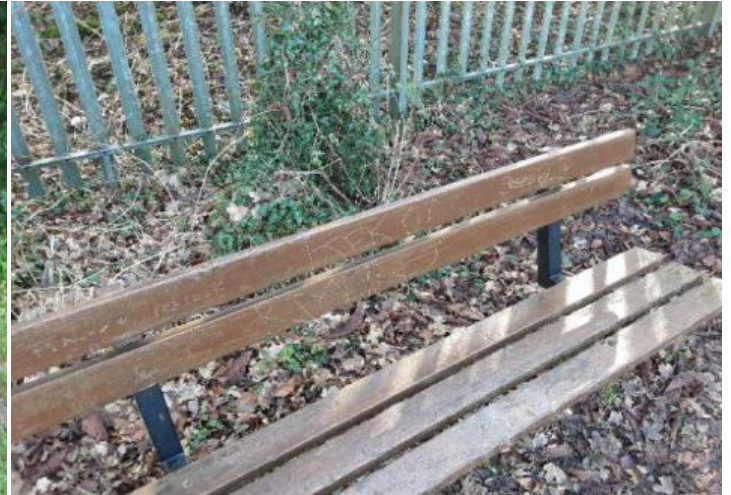
Item: Ancillary Items - Bench
Manufacturer: Not Identified

Finding: There is offensive graffiti present

Action: Remove as soon as practicable

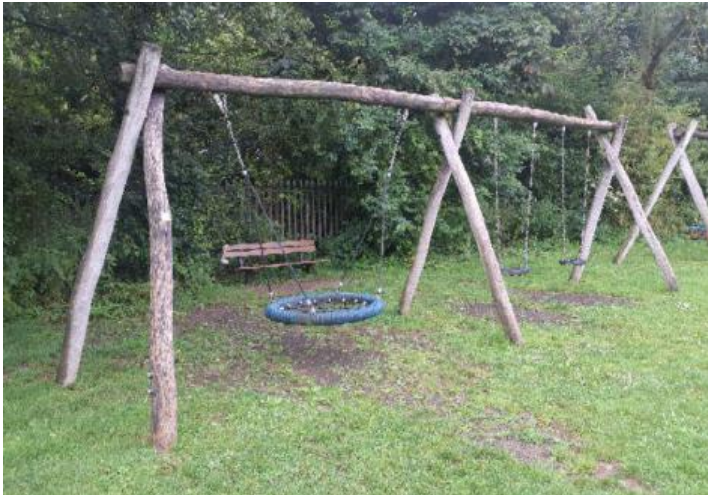
Item: Swings - 2 Bay 2 Flat 1 Basket Seat
Manufacturer: Kompan Ltd

Finding: The timber has a number of splits/shakes or air cracks and this may affect the stability or allow water ingress which will accelerate the rotting process

Action: Monitor to ensure the splits do not cross through fixing points of the structure and/or cause any instability
